HOW TO PERFORM ROOF INSPECTIONS

This guide also serves as a handy on-the-job reference manual for home inspectors, as well as a study aid for InterNACHI's *How to Perform Roof Inspections* online course and exam.

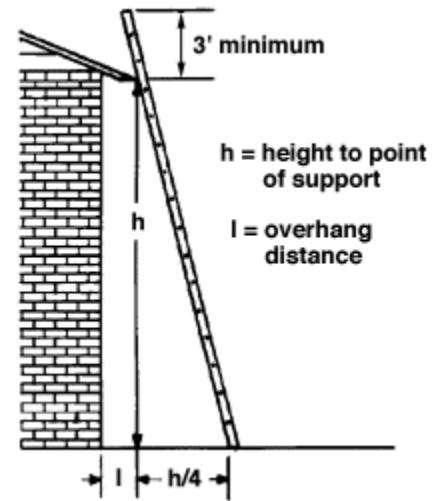
Think safety; clients are not too impressed with inspectors landing in the shrubbery, writhing in agony!

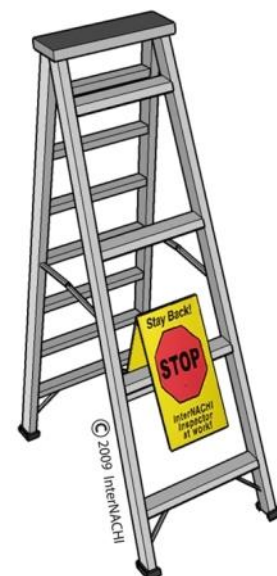
Overview and Requirements

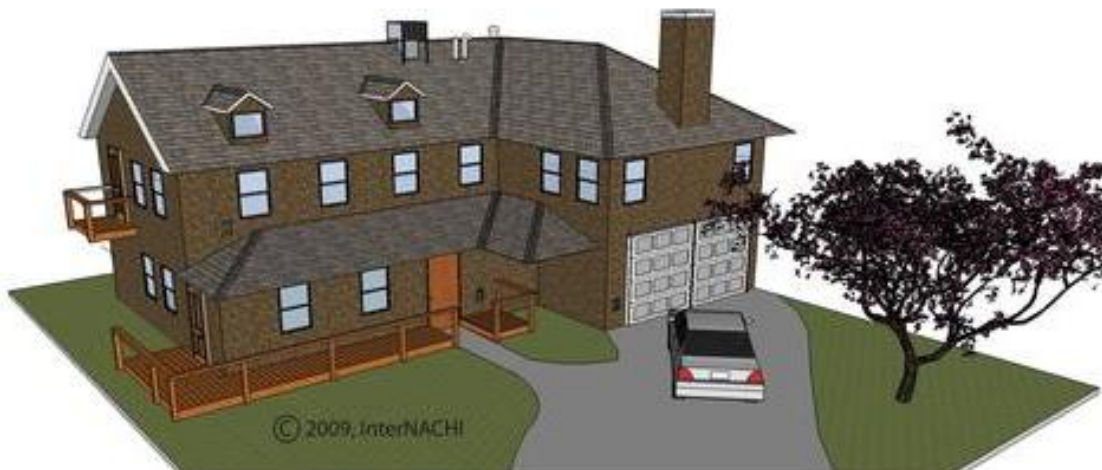
The Standards can be read in their entirety at www.nachi.org/sop.htm

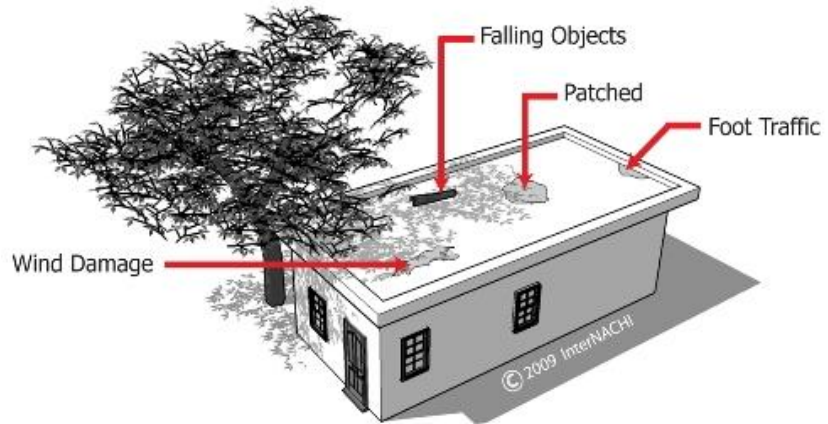
- weather;
- impact damage;
- environmental conditions;
- orientation;
- ventilation;
- insulation;
- structural issues; and
- installation defects.

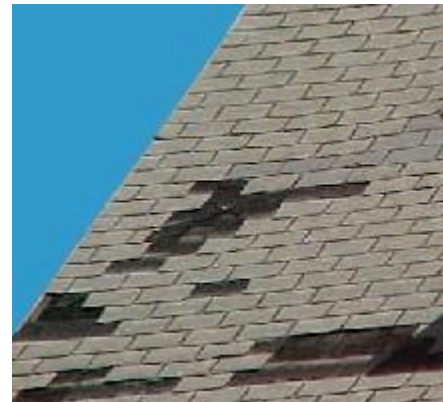
Above: a fiberglass asphalt shingle roof whose shingles became brittle over time, allowing the wind to get under them and blow them off the roof

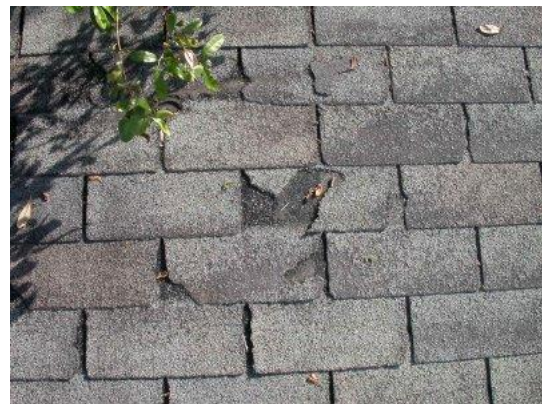
Above: damage caused by tree branches

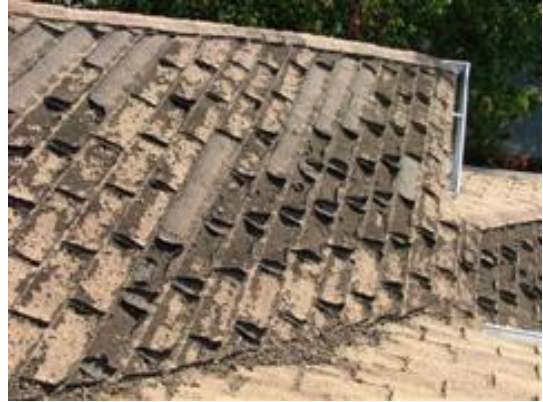
Above: an asphalt shingle roof that shows evidence of overheating, probably caused by both orientation and poor ventilation

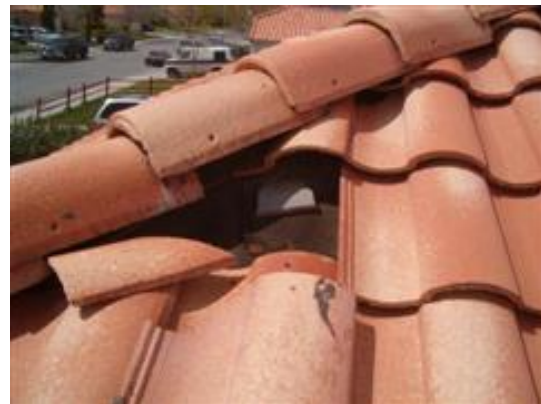
Above: impact damage on a clay tile roof showing broken and dislodged tiles

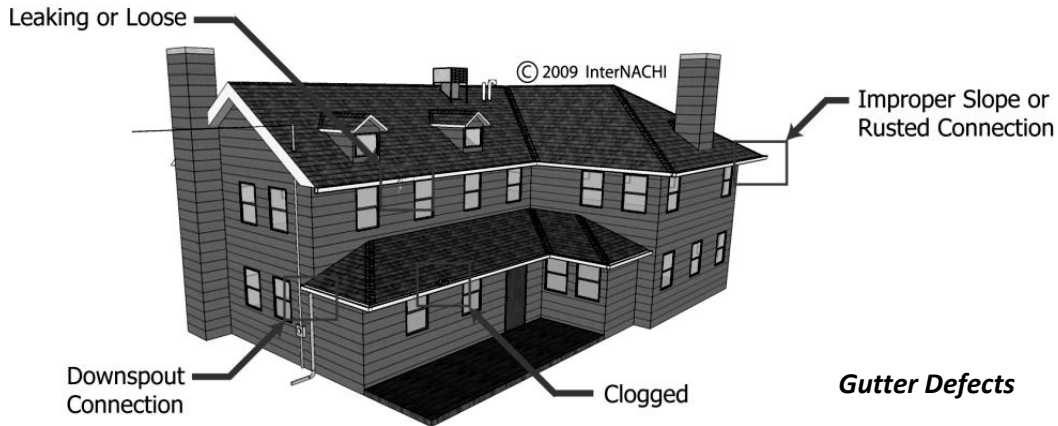
Effective roof drainage is a must for two reasons. First, the roofing system needs to drain quickly so that large volumes of water are not trapped on the surface. Second, water runoff from the roof needs to be managed so that it is not being directed toward the foundation.

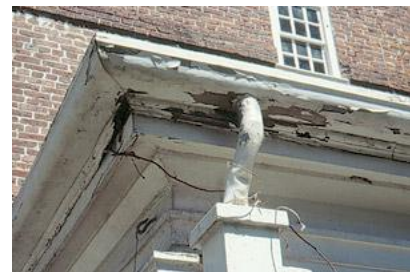
Above: a section of cornice guttering with visible rot; notice the downspout hidden within the column

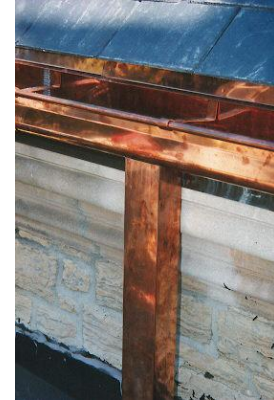
Above: copper guttering in new construction; note the copper drip edge.

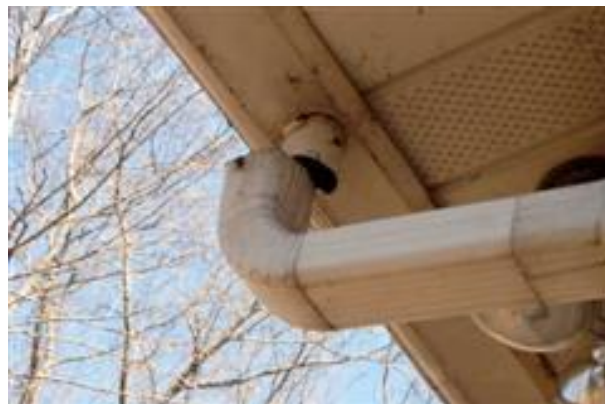
Above: The downspout has separated from the rusted steel guttering.

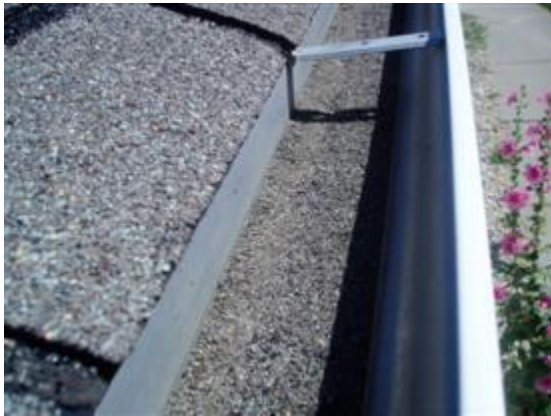
Finally, take a good look in the bottom of the gutters. The contents will typically point to roof covering problems. For example, if there is a large amount of asphalt shingle aggregate in the gutter, as in the photo at left, that's a sign that the roof covering is likely nearing the end of its lifespan.

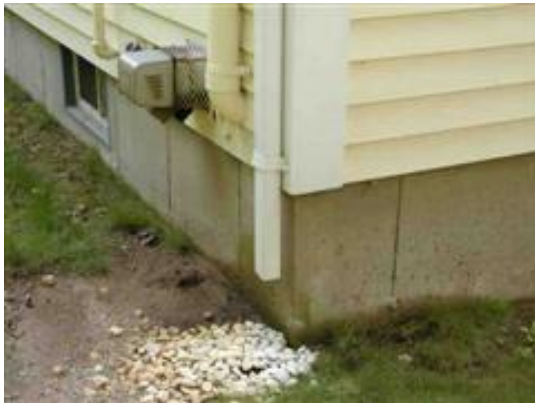
The gutter below is pulling away from the fascia; also note the visible rot on the fascia board.

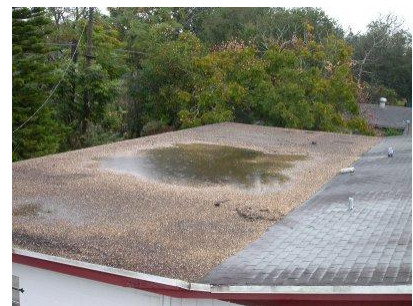
Water is ponding on the roof's surface (above) due to a lack of proper drainage pitch.

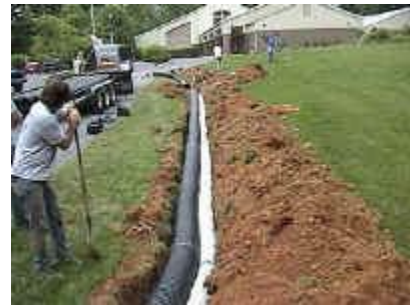
On-site drainage: The gutters connect to subterranean piping that simply takes the runoff to a low area on the property and discharges it to the ground, well away from the foundation.

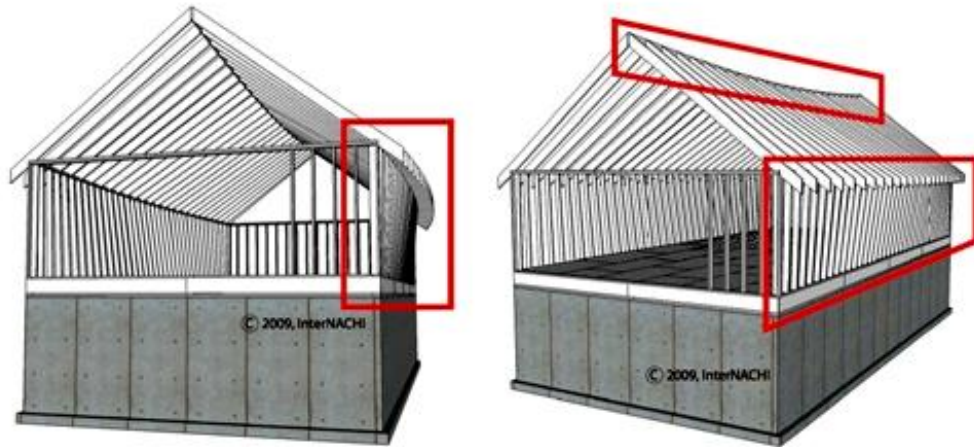
Many roof problems are caused by issues with the framing and sheathing. In this section, we'll focus on the defects that may be viewed from the exterior of the property. This is one of those cases where standing back and taking a good, hard look is better than getting "up close and personal" with the roof.

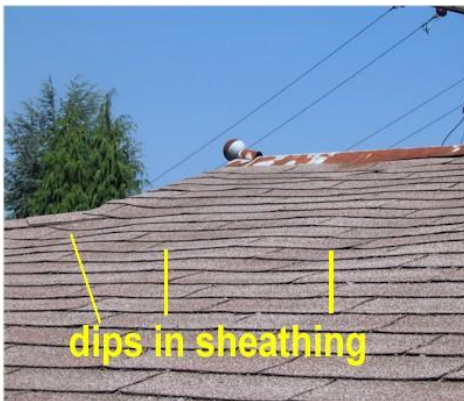
At left: visible dips due to de-laminating ply sheathing

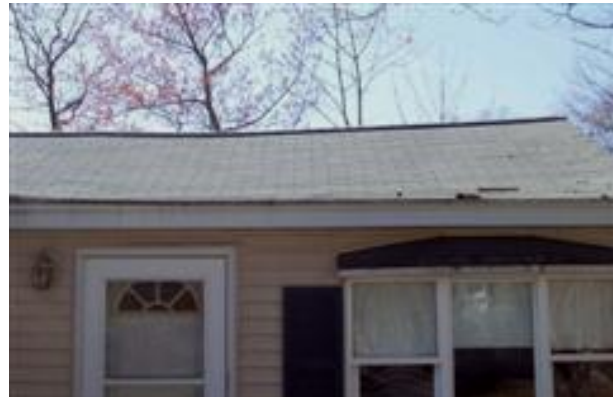
General Structural Inspection

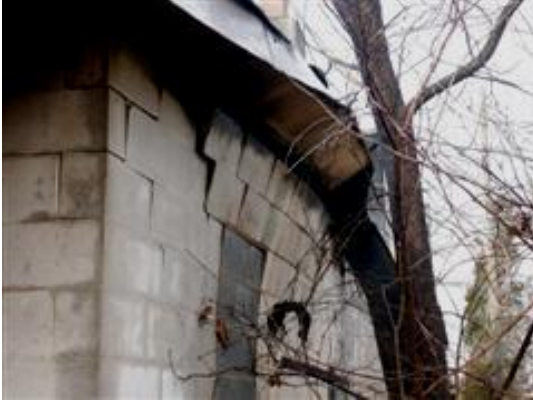
This wall (at left) was actually being pushed over after a fire had collapsed the roof. Visible at the top is rotation of the wall structure.

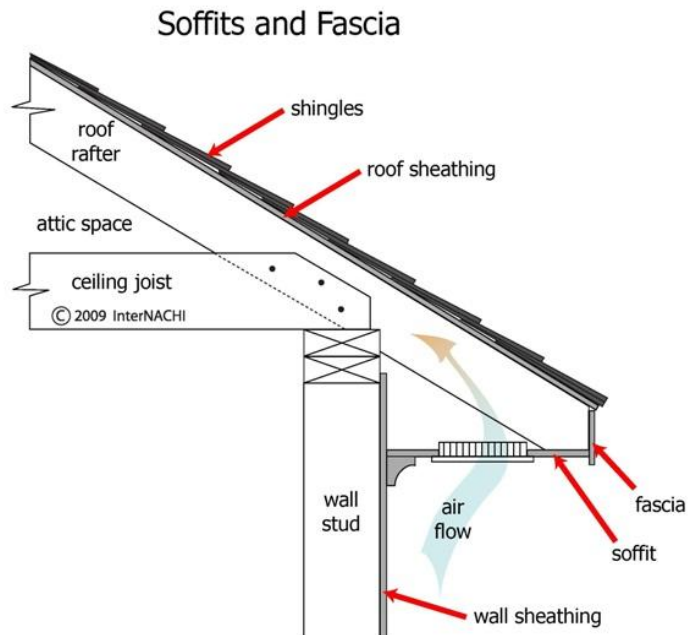
Rake or Barge Boards

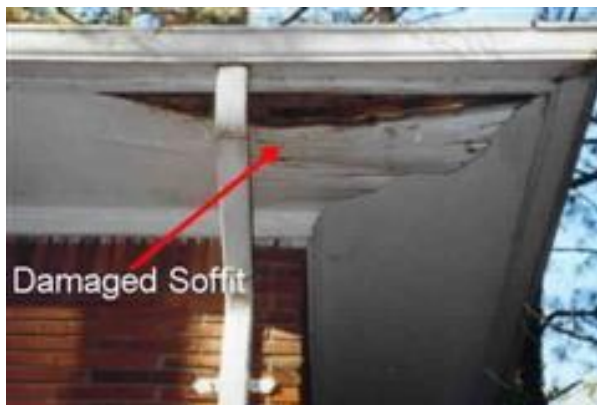
*At left: standard box soffit showing signs of de-lamination due to moisture intrusion
(Courtesy of Mike Rose)*

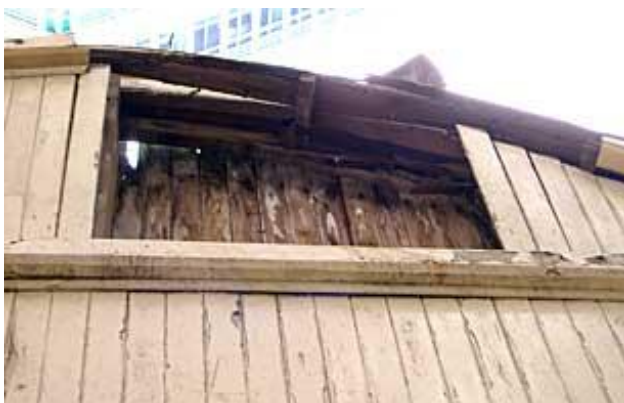
At left: older-style enclosed soffit clearly showing holes and missing boards, as well as signs of moisture in the roof sheathing

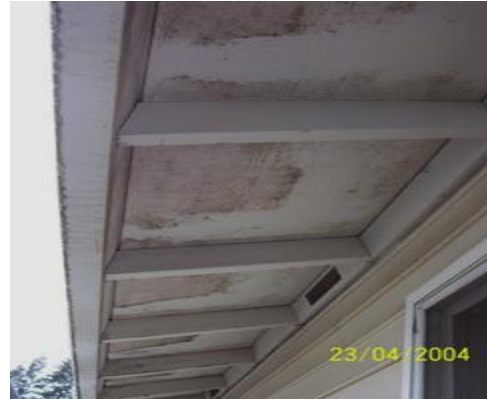
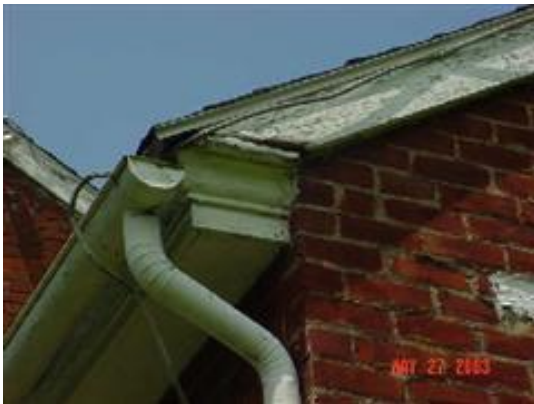
At left: rot in the lower part of the rake board; the wood has swollen and is pulling away.

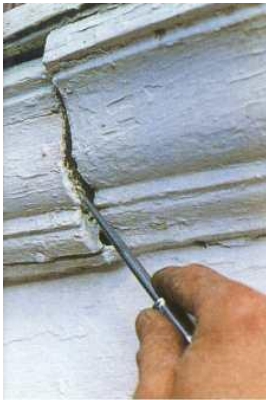
At left: Wood rot has loosened the cornice molding and is splitting around the nails.

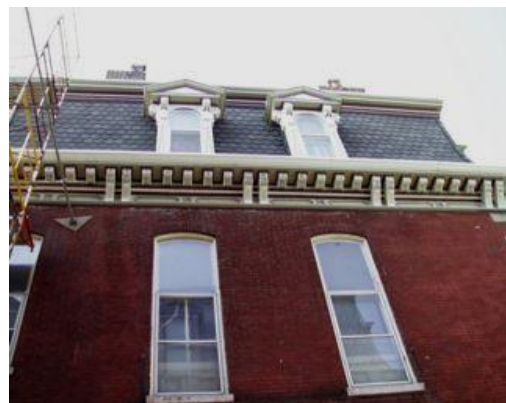
At right: an ornate cornice under a mansard roof with dentil molding

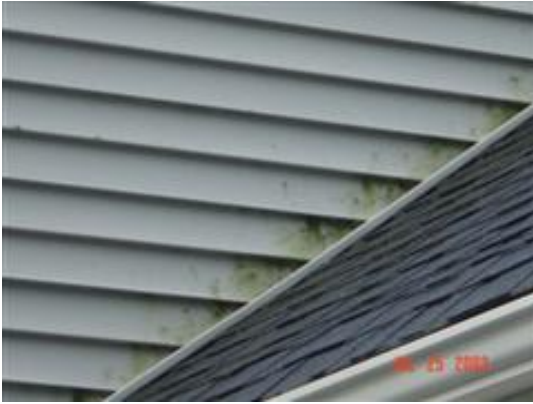
At left: Any trim that is this close to a roof's surface could potentially allow moisture to wick into the structure.

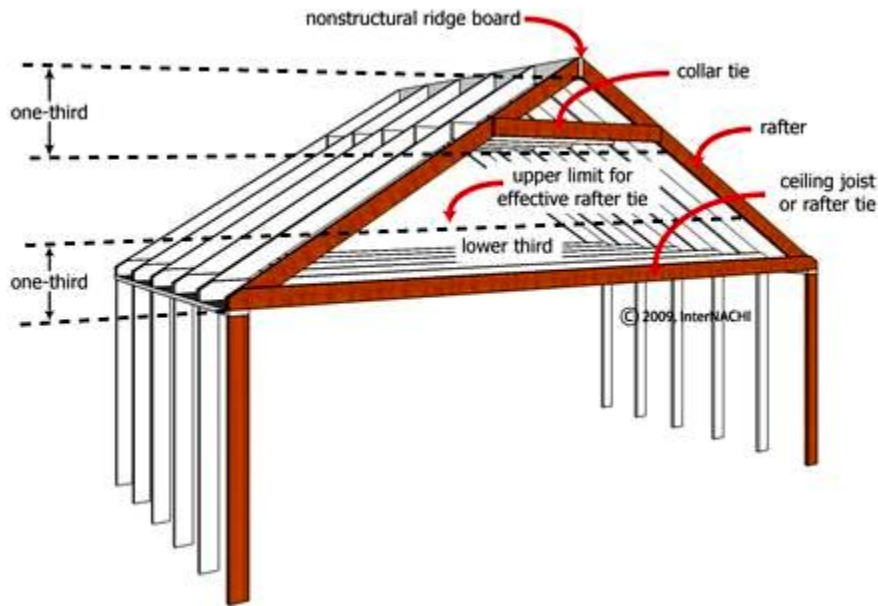
Although diagnosing the causes behind structural and cosmetic defects lies beyond the scope of a home inspector's duties, according to the InterNACHI Residential Standards of Practice, understanding some of those causes can help inspectors recognize certain defects more quickly so that he can report them and make appropriate recommendations to his clients.

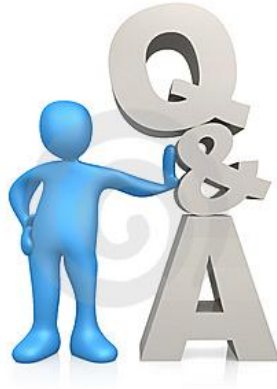
Answer Key to Quiz 3

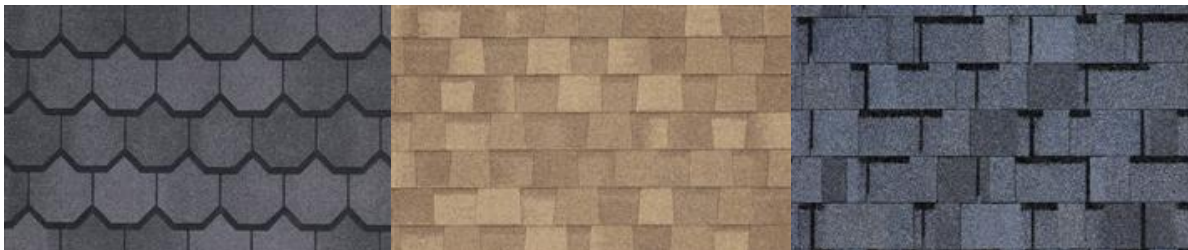
PROBLEMS WITH ASPHALT SHINGLES

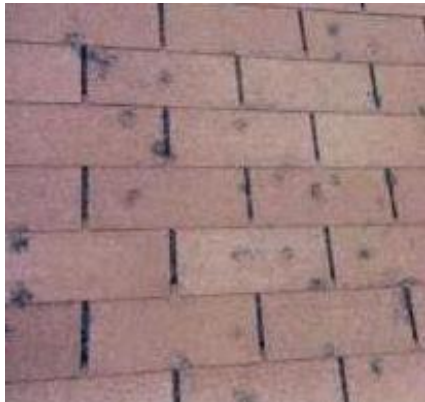
At left: a roof with visible hail damage

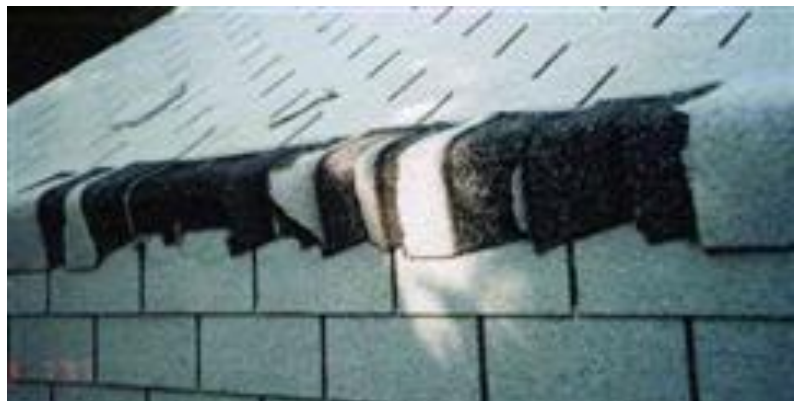
At right: Wind has blown off ridge shingles and damaged others.

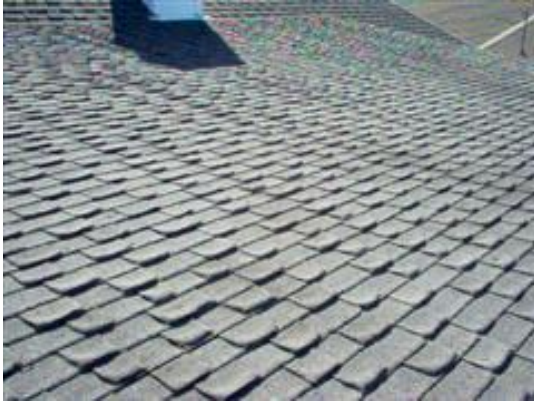
Above: Shingles overheated by the sun and/or poor ventilation are curling and cracking.

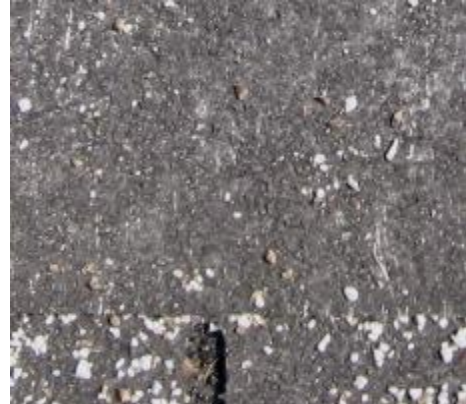
Above: an extreme close-up of a badly weathered fiberglass-based shingle whose fibers are exposed

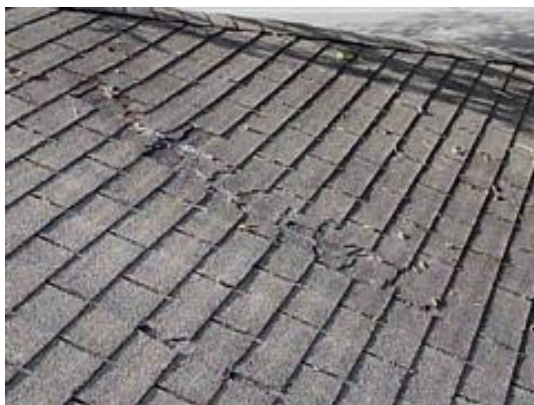
At left: another example of shingles that have been overheated by the sun and are now curling and cracking

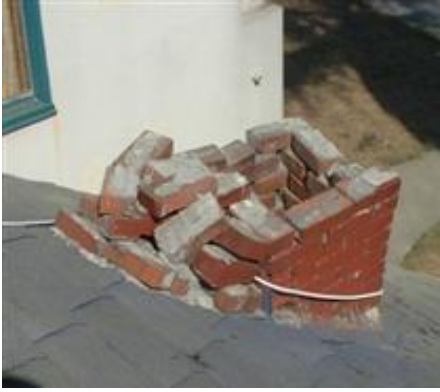
At left: A chimney has collapsed, damaging the shingles.

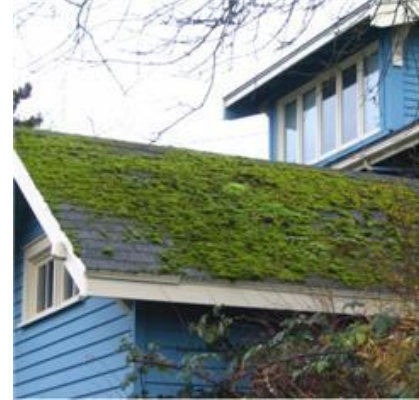
At right: A mossy roof is trapping moisture on the structure.

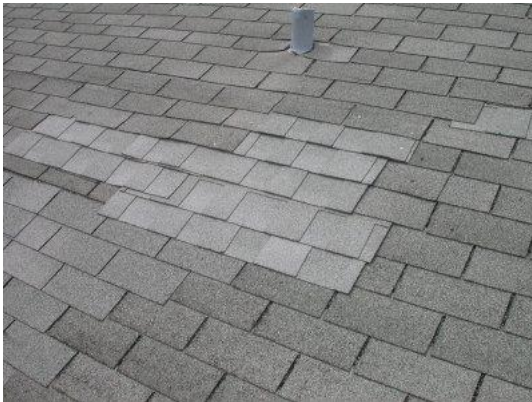
Above: Improper repairs have been made to this shingled roof.

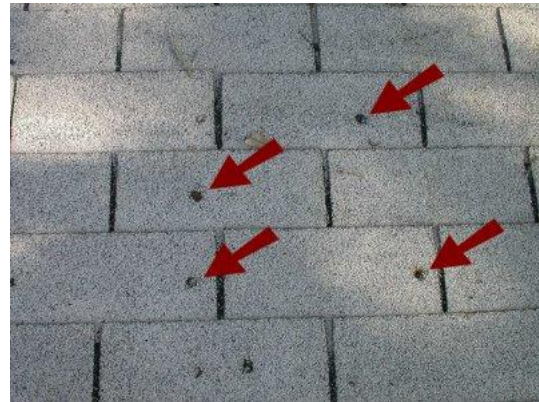
Above: Nail pops indicate where the fasteners have backed out of the roof.

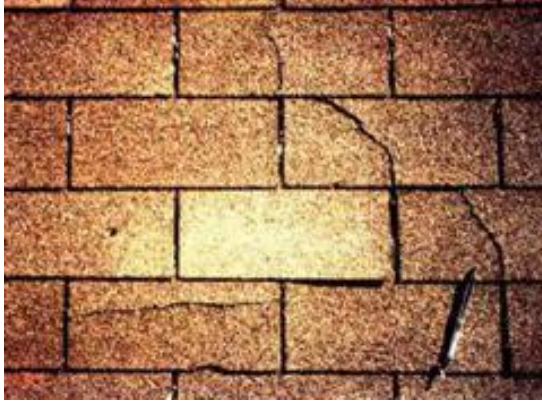
This kind of damage is typically seen on fiberglass-based shingle roofs.

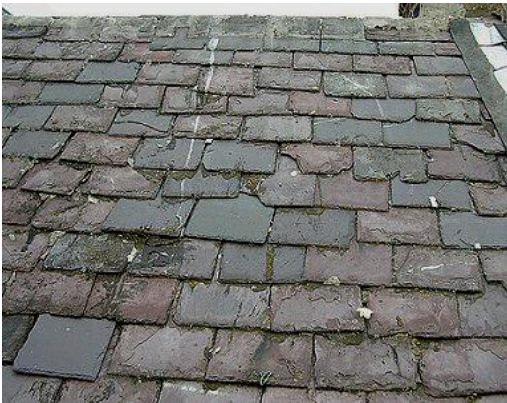
At left: an older slate installation showing many broken and dislodged tiles

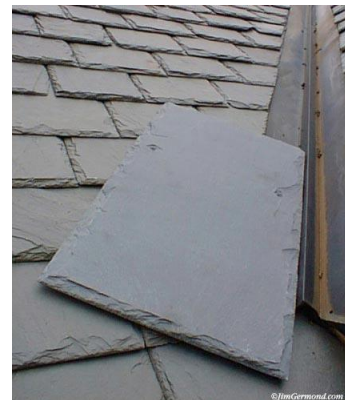
At right: a new slate roof; notice the crisp edges on the slate.

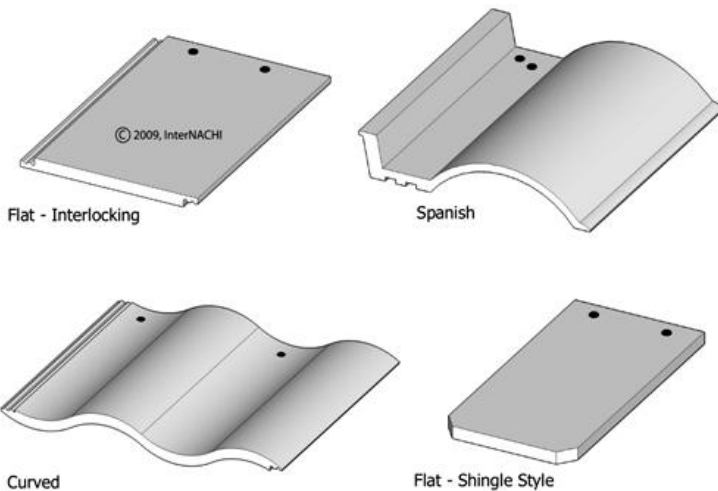
They are both made in similar sizes and shapes, such as flat, curved or corrugated, and may or may not be of an interlocking design. In most cases, tile designs are produced to be installed as ridge caps and used in other specialized locations.

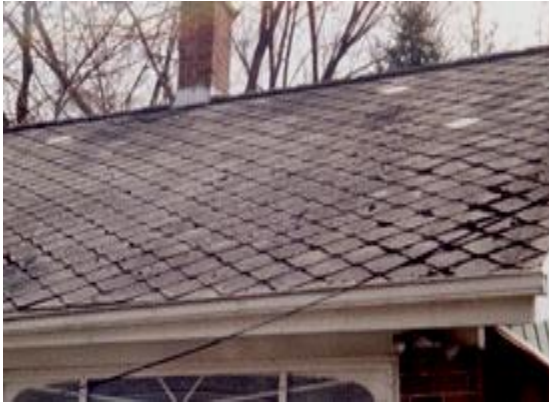
Above: diamond-pattern asbestos cement shingles

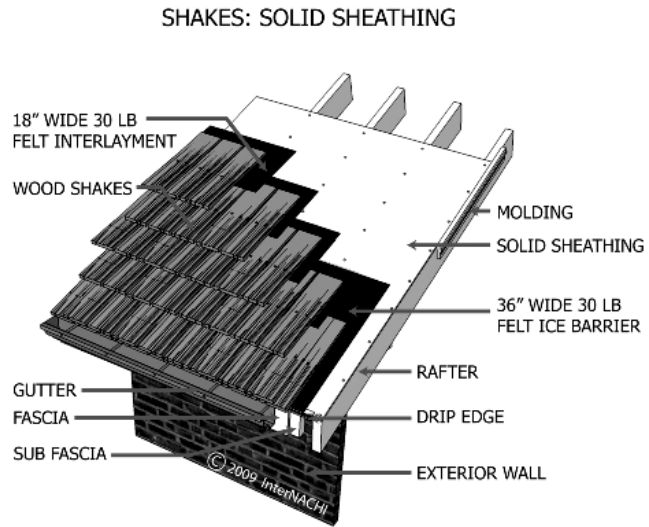
There are different wood species, grain patterns, and lengths of wood shingles and shakes, and such details can be extensive. This manual covers the fundamental points that the inspector must know in order to be able to evaluate most wooden roof coverings.

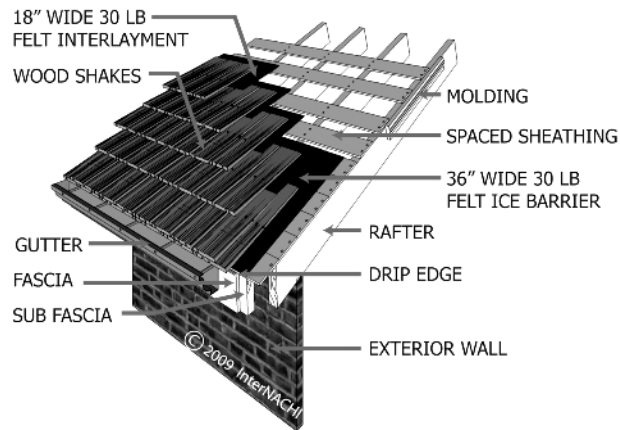
Poor Installation and Repairs

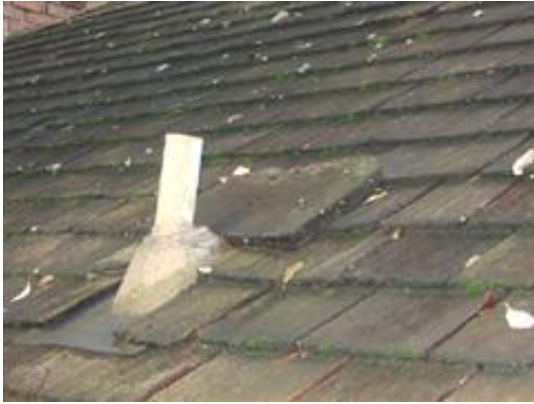
At left: This is a damp shingle roof already showing signs of rot in places.

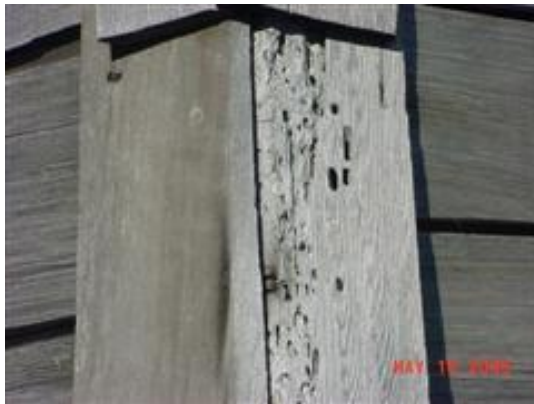
*Above: evidence of boring-insect damage to this shake ridge
(Courtesy of Kevin Wattenbarger)*

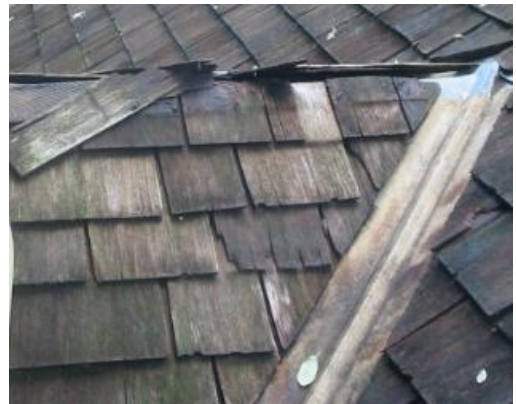
*Above: shingle ridge detail showing broken shingles and considerable erosion; also note the open W-valley flashing.
(Courtesy of Pat Dacey)*

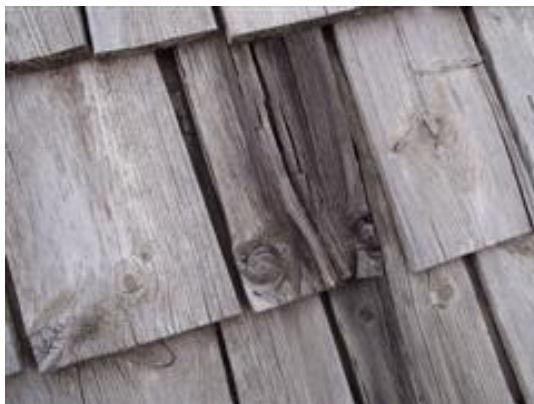
Above: This is an example of the bottom of the shingle/shake market: untreated pine shingles, complete with knot holes. Notice all the splits. This roof will need replacement.

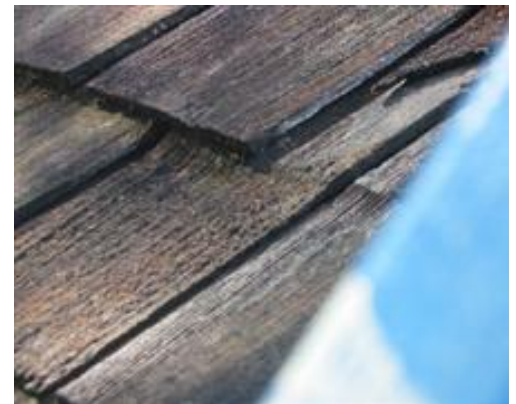
*Above: This is typical erosion of a shake/shingle roof. Even if it has no other defects, this roof is at the end of its lifespan.
(Courtesy of Pat Dacey)*

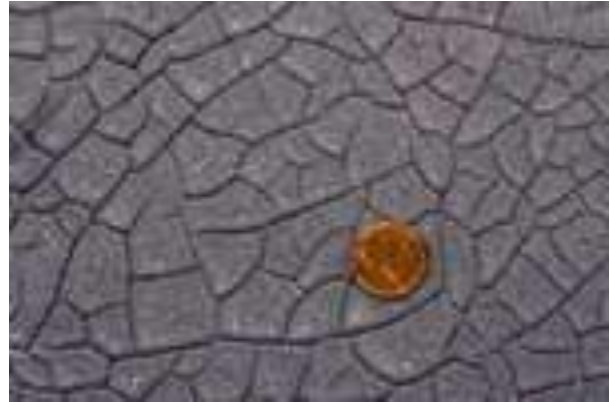
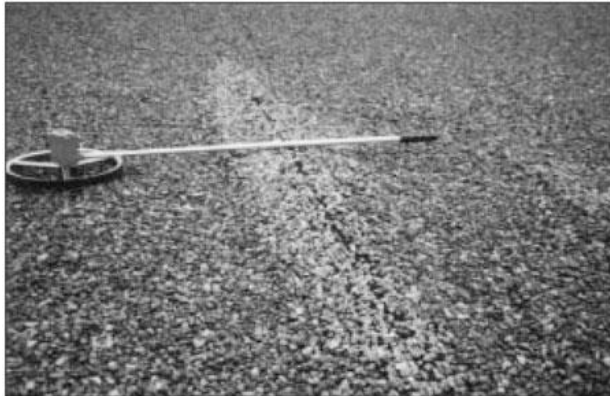
At left: This is a blister in an asphalt roof caused by heat build-up in a void.

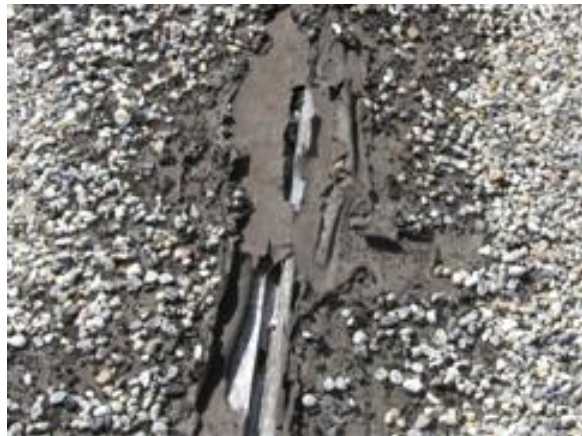
FLAT ROOFS: MEMBRANE

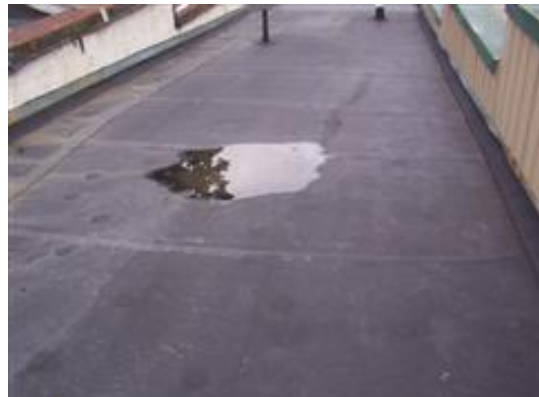
At right: This is an EPDM membrane covering. The ponding should be reported.

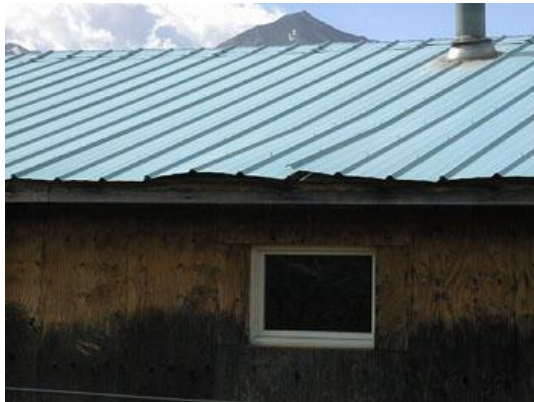
Above: This photo shows a standard corrugated steel roof (top-fixed). The panels have lifted, probably due to wind uplift and poor fastening.

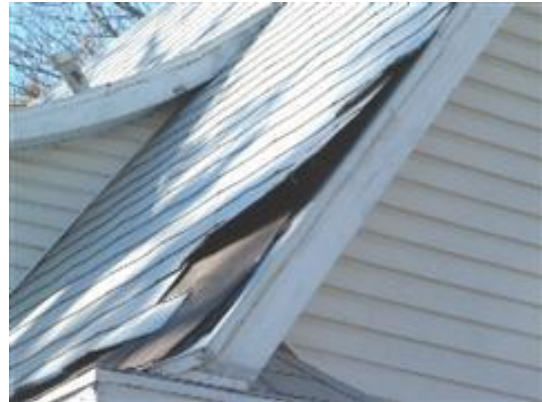
Above: This is an aluminum tile roof showing severe wind damage.

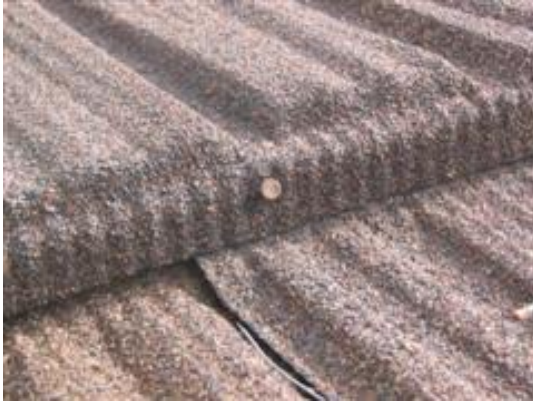
Below: This a commercial metal roof showing the result of condensate from an HVAC system acting on the roof.

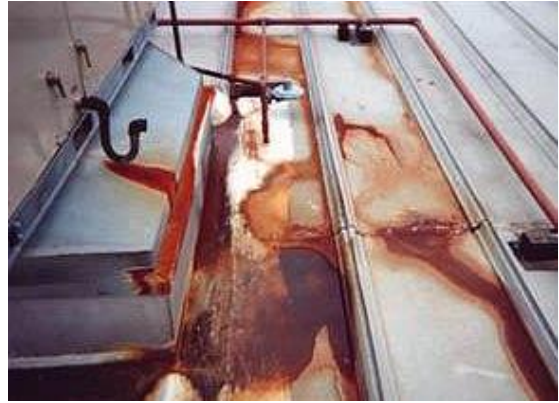
What to report for metal roofing:

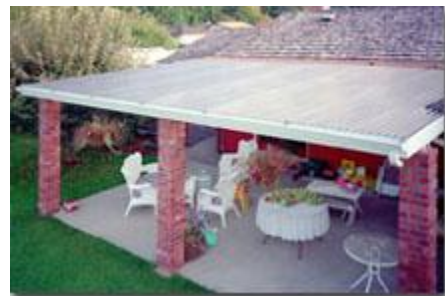
Nearly everyone has seen this material installed over a carport or homeowner-built lean-to. Obviously, any attempt to walk this type of roof is extremely unsafe.

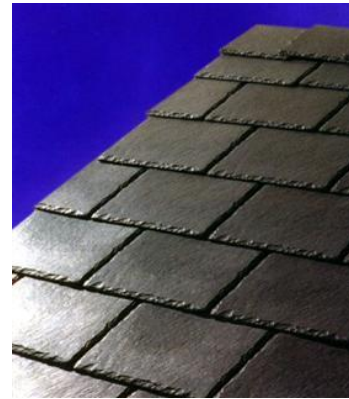
These are rare. One style has a fully interlocking design over sheet sheathing. It is a very tight system, so ridge and soffit vents should be installed to provide adequate ventilation.

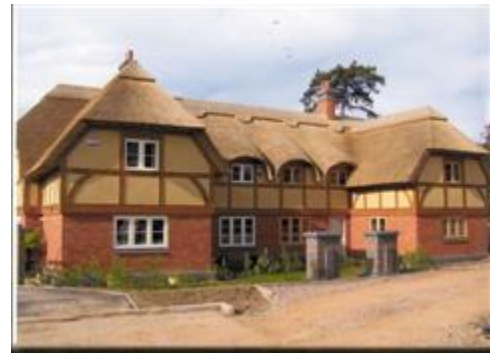
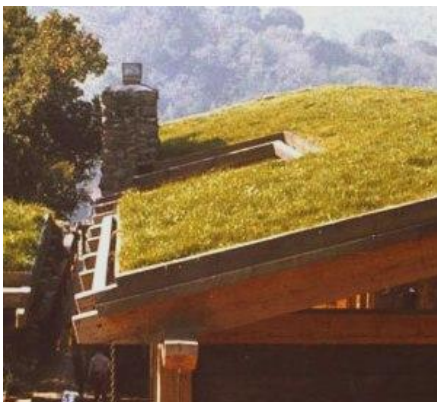
Grass Roof Coverings

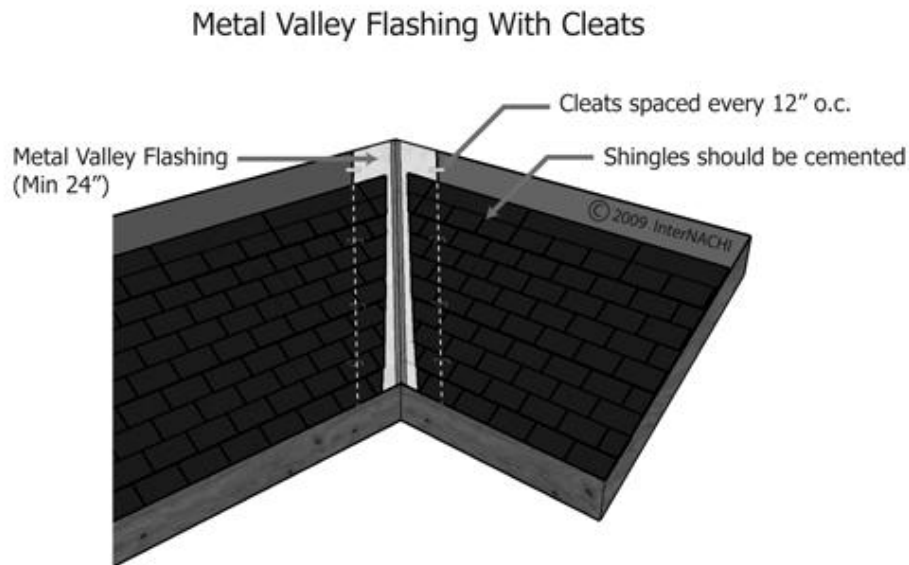
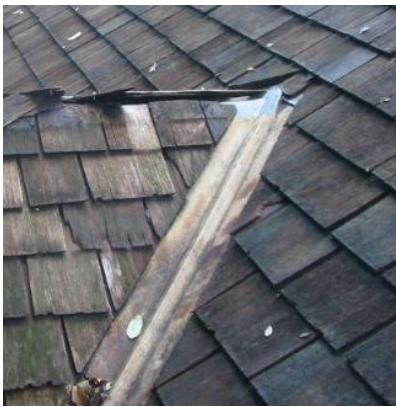
Above: a metal open valley on a poor-condition wood shingle roof

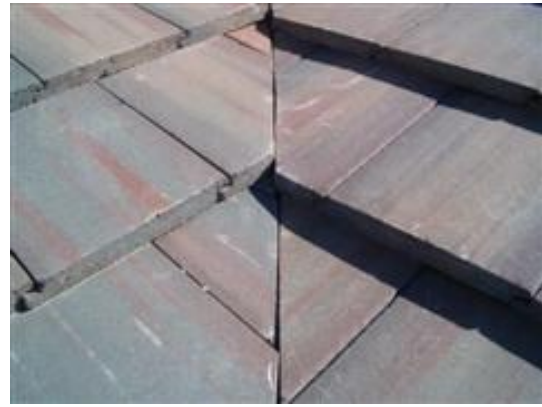
Above: This is a valley on a cement tile roof. Notice how close together the planes are. They should be 1-1/2 inches from the centerline of the valley. (Courtesy of J. Pope)

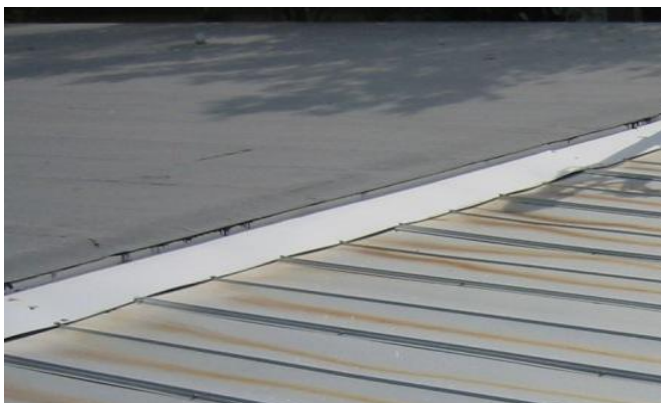
The photo at left shows both poor flashing between surfaces and improper use of 3-tab shingles on the lower roof.

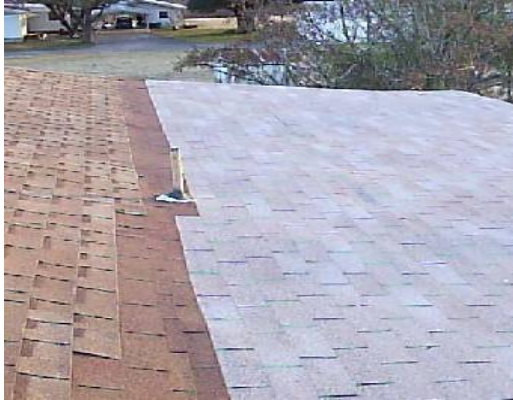
Above: another example of poor flashing between surfaces and improper use of 3-tab shingles on the lower roof

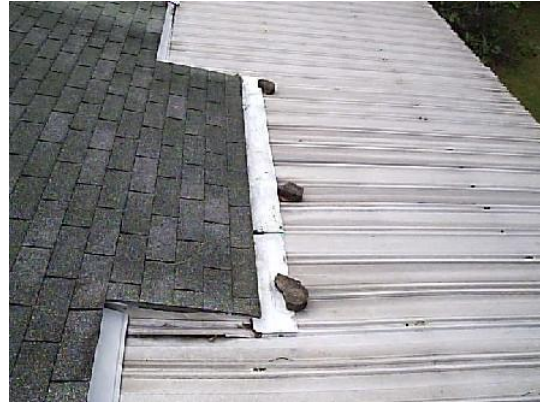
Above: another classic DIY flashing

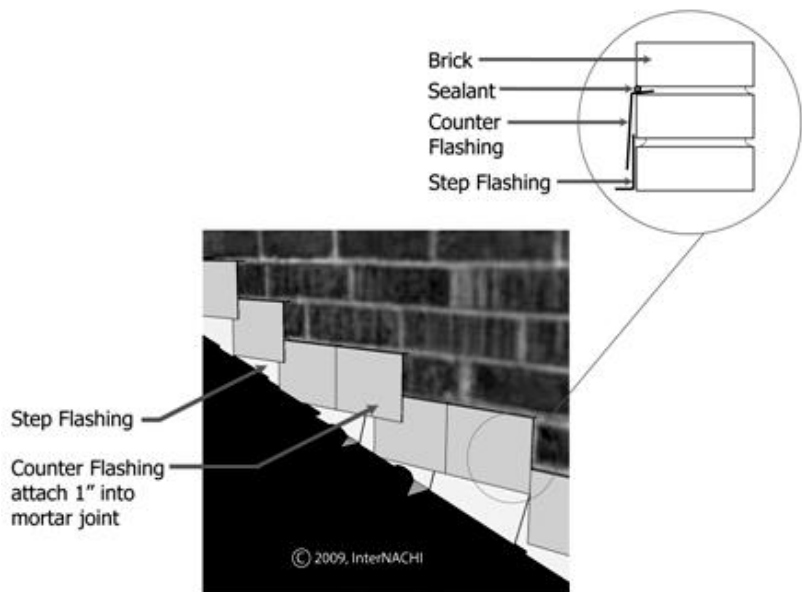
Masonry Sidewall Roof Flashing

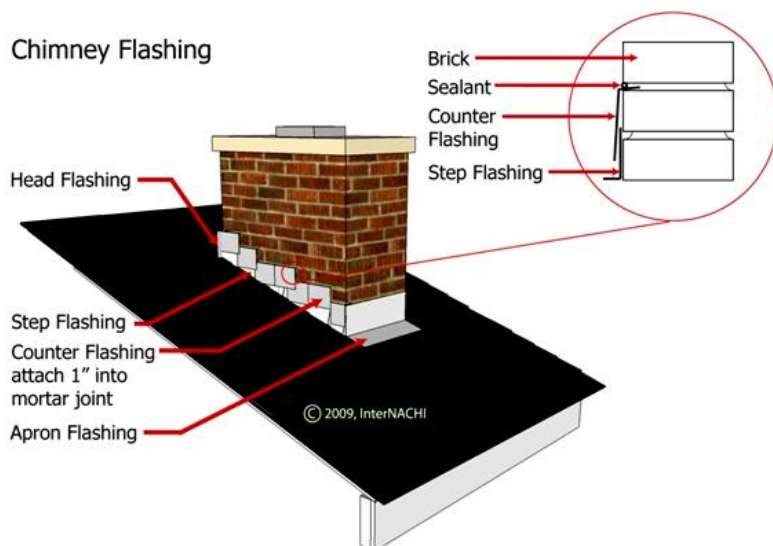
Apron flashings should be at the lowest face of the chimney, directing moisture away from the top-most edge of the shingles or tiles where they abut the chimney.

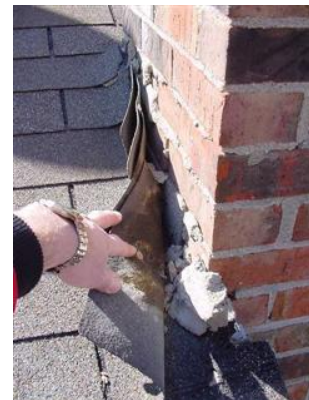
VENTS AND OTHER PENETRATIONS

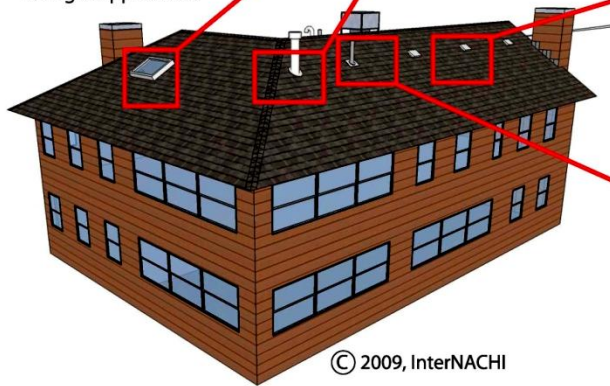
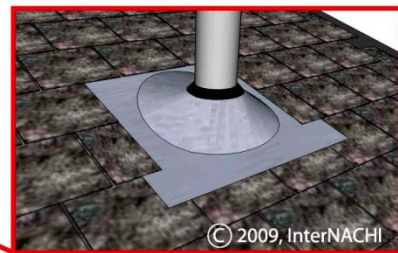
plumbing vent flashing and shingle application

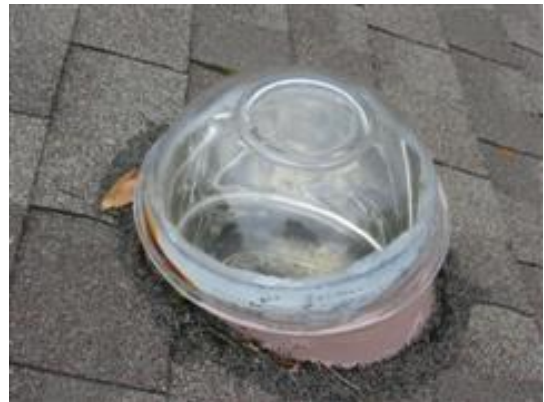
Through-the-roof dome lights, like the one pictured below, are most commonly retro-fitted and frequently cause leakage problems.

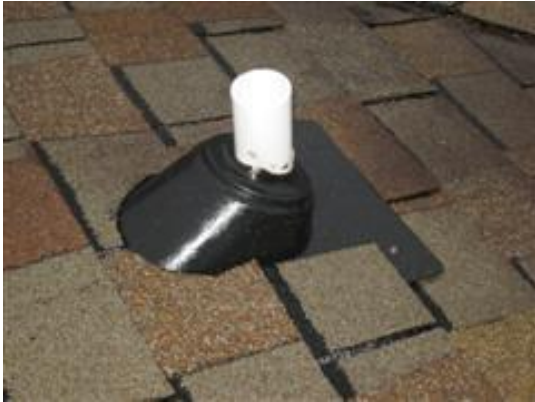
At left: This plastic vent flashing has been installed upside down. This will probably allow moisture to travel down the outside of the vent pipe.

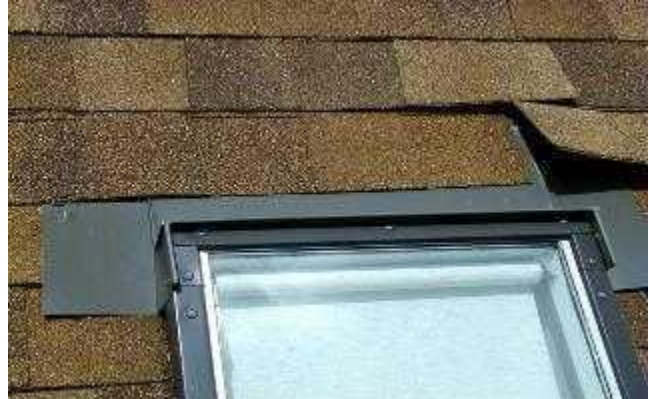
Below: This galvanized flashing has been installed improperly. The upper part of it should be under the shingles, and the roofing tar is a further sign of a poor repair.

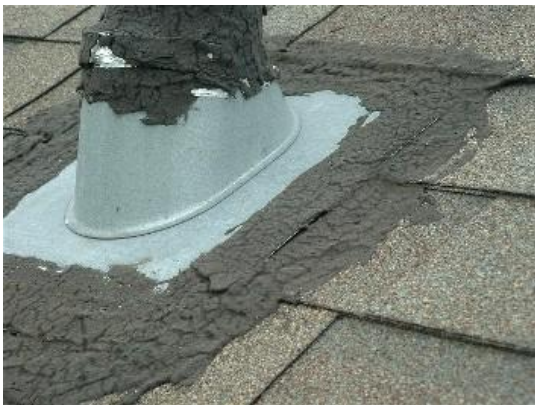
Below: A skylight in a metal roof shows damage to the roof on the top-side.

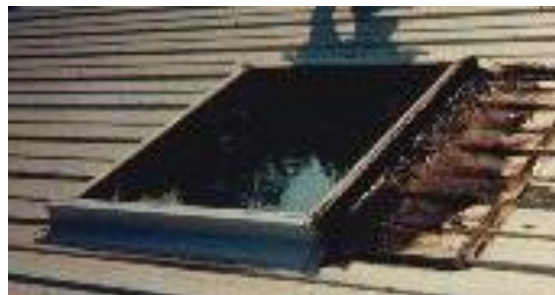
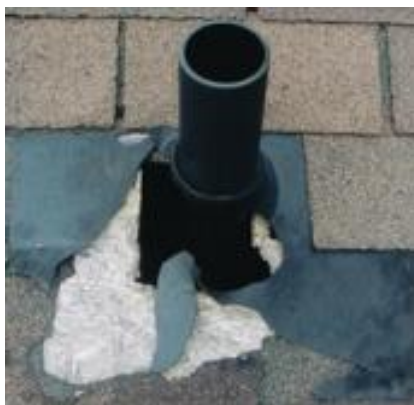
Above: This is a plastic vent flashing which was damaged by raccoons.

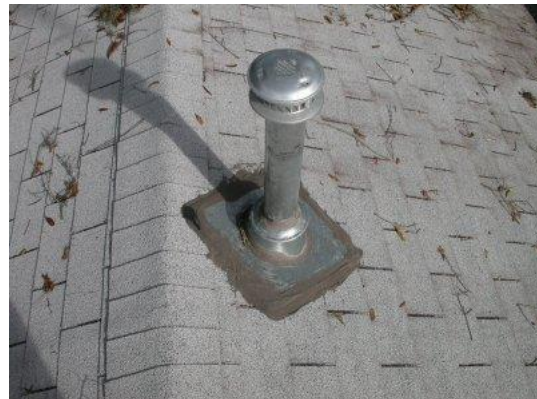
At right: This flashing has been improperly installed because the base should be underneath the shingles.

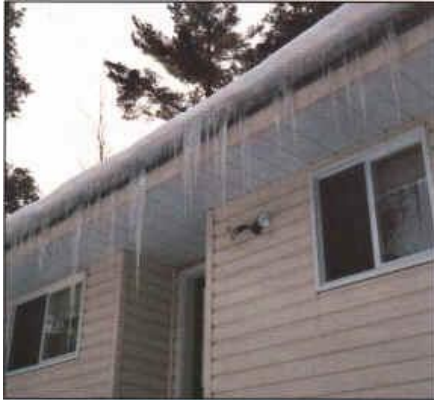
Above: Here is a typical ice dam, causing moisture to back up under the shingles.

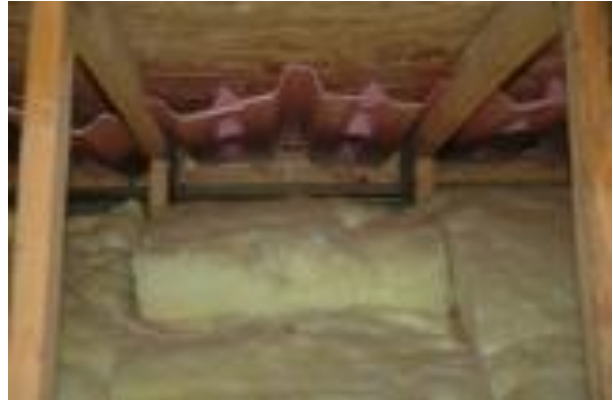
Above: Poorly installed insulation is blocking the soffit vents. Also, the baffles are incorrectly installed. (Courtesy of John Hastings)

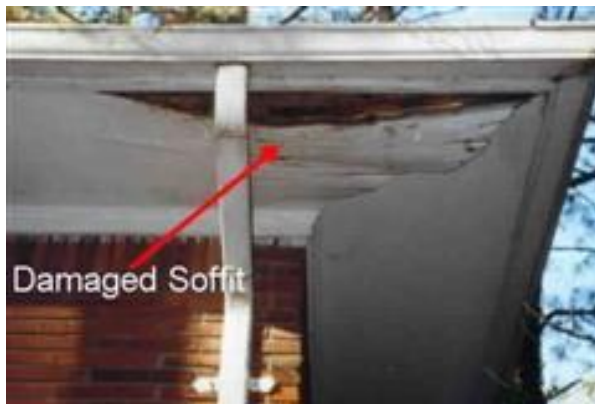
Above: This kind of damage is a typical sign of previous ice damming in some climates. (Courtesy of Mike Rose)

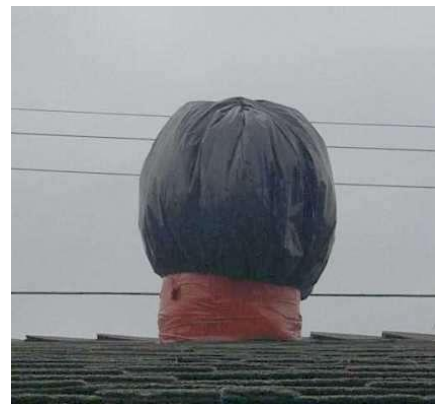
Above: Someone has covered this turbine with a plastic garbage bag in order to save energy.
