HOW TO PERFORM ROOF INSPECTIONS

This guide also serves as a handy on-the-job reference manual for home inspectors, as well as a study aid for InterNACHI's *How to Perform Roof Inspections* online course and exam.

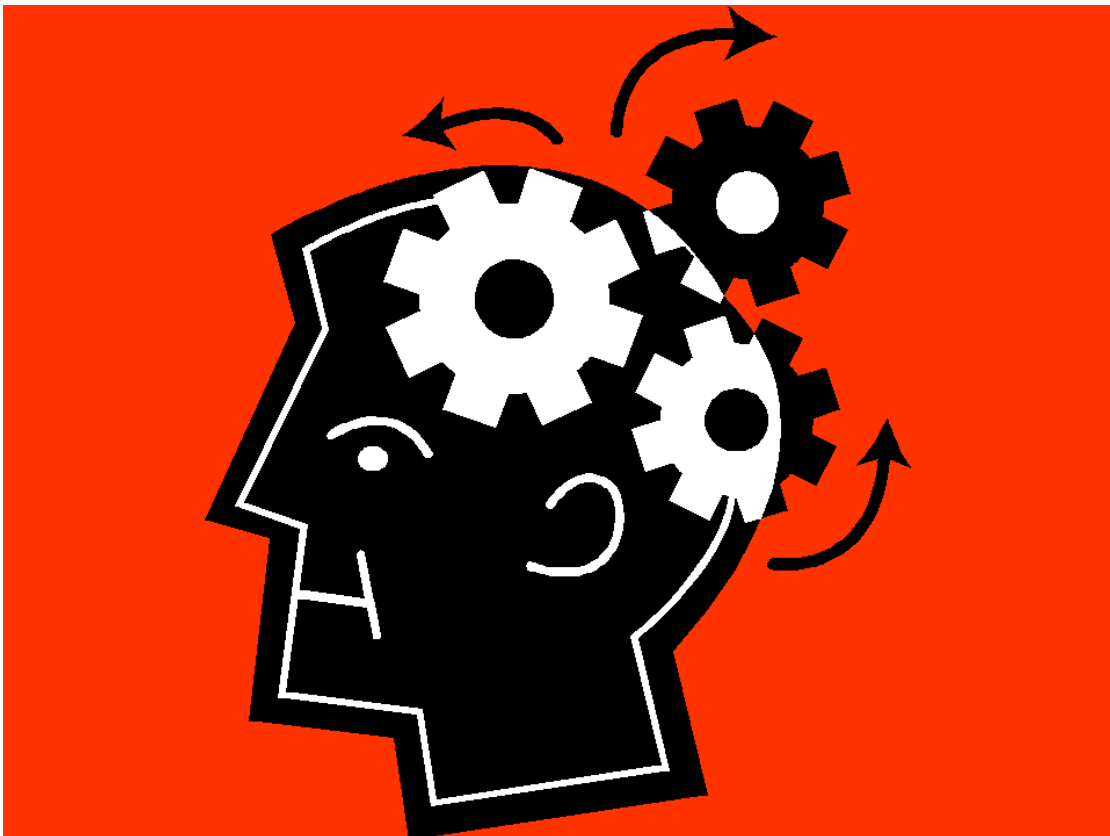
1. An attic with an area of 600 square feet with ridge and soffit vents should have a total vent area of 2 square feet.
2. For most roofs, the most effective venting system is ridge and soffit vents.
3. An attic space with only gable vents should have a vent area of 1 square foot per 150 square feet of floor area.
4. T/F: Roof vents are required for roofs with unconditioned attic spaces.
Answer: True
5. Flat roofs normally have passive venting systems.
6. T/F: Ice damming is caused by both poor venting and poor insulation.
Answer: True

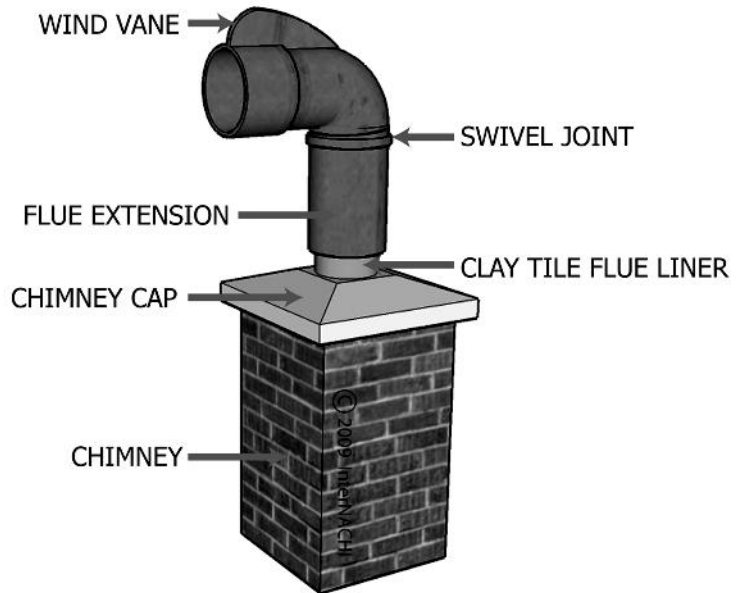
General Chimney Requirements

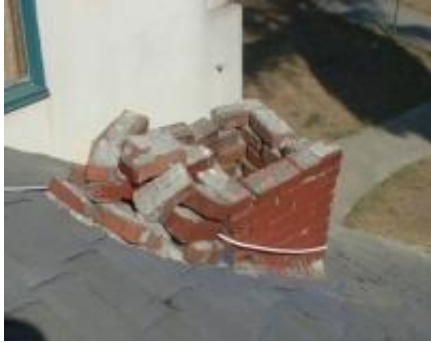
*Above: This chimney has not been maintained at all, leading to a full collapse.
(Courtesy of Jeff Pope)*

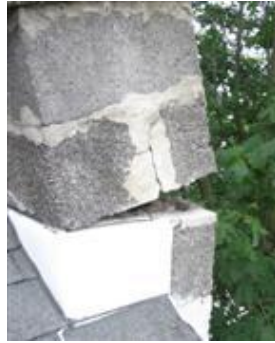
*Above: A block chimney is showing such severe cracking that the top three courses are completely loose.
(Courtesy of Joe Myers)*

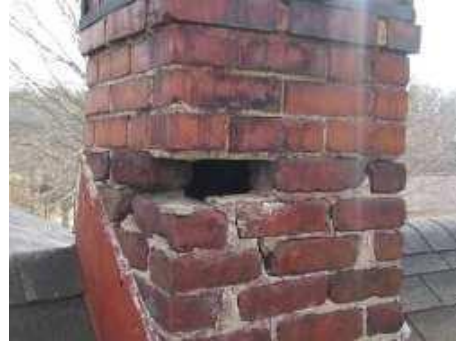
Above: A brick is missing and the mortar is spalling out.

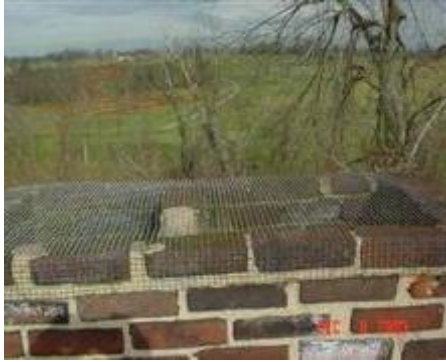
Above: This chimney has no cap or liner all. It is no longer legal to build an unlined chimney.

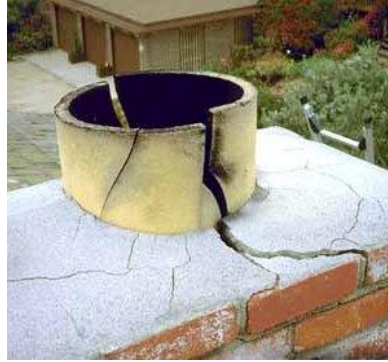
Above: Cracking can be seen both in the liner and in the chimney cap. This damage was caused by a flue fire.

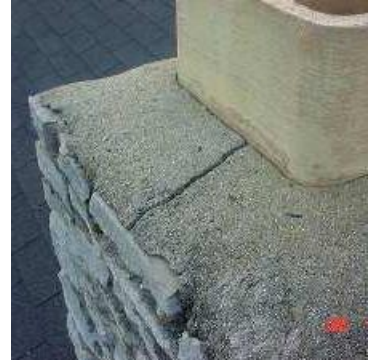
Above: cracking in the chimney cap

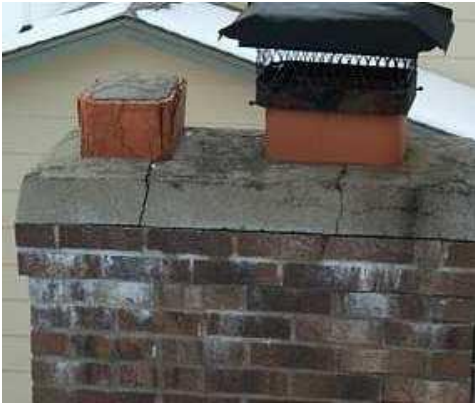
Above: The flue on the left has been sealed with concrete, and the flue on the right has a rain cap. However, the chimney cap itself is cracked and the brick work is showing signs of efflorescence.

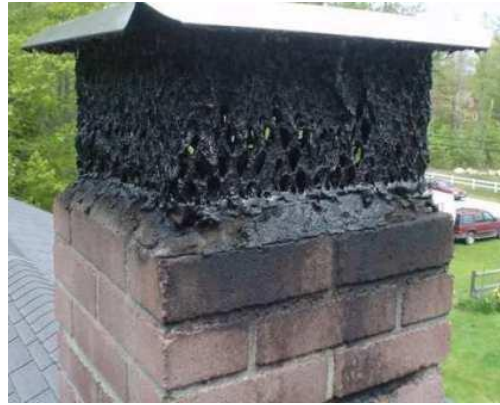
Above: This rain cap is completely choked with creosote, which is not unusual to find when the homeowner has been burning unseasoned timber.

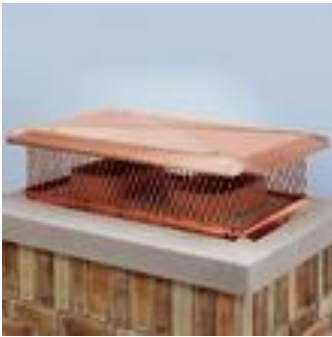
At left: A specially designed copper rain cap protects this double-flue chimney.

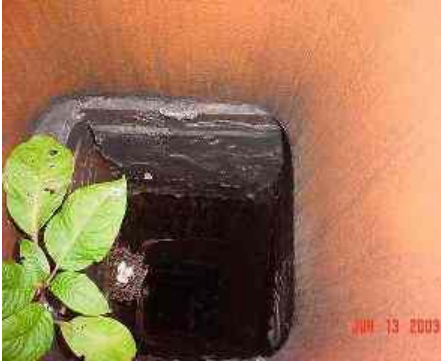
Above: This is the view down an unlined chimney flue. Vegetation is growing through it, and a bird has built its nest in it, too.

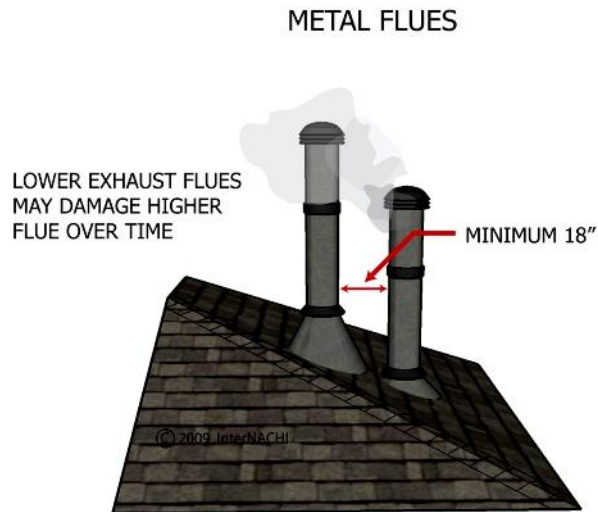
The term "manufactured chimney" generally relates to prefabricated chimney components, as opposed to a traditional chimney that would normally be manufactured from masonry products.

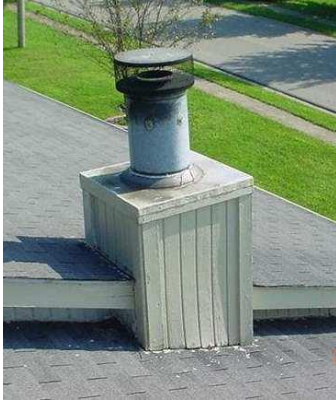
In this poorly designed chimney at left, there is no separation between the timber components and the roof, and there are a couple of dead areas which will trap moisture and promote rot.

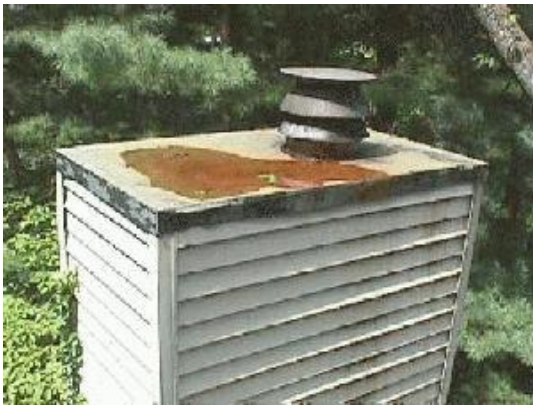
At left: Water is ponding on the top of the chimney cap. This will cause it to rot very quickly. Also note the lack of a proper drip edge.

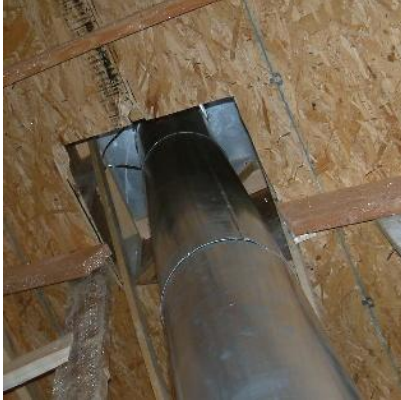
At left: This is a manufactured chimney going through the roof sheathing. The clearance on the right side is probably less than 2 inches. Also, notice how the rafter has been cut.

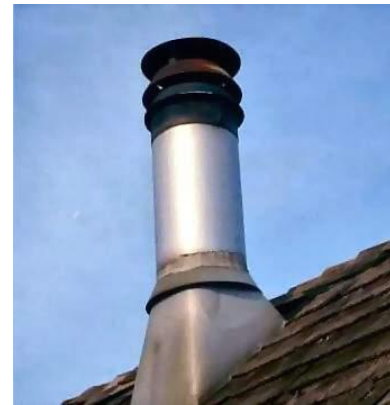
When inspecting manufactured chimney systems, the inspector should pay particular attention to:
