Inspection Report

Nick Gromicko

Property Address:
1665 Wood Dale
Wichita KS 67230

Fidelity Property Inspections LLC

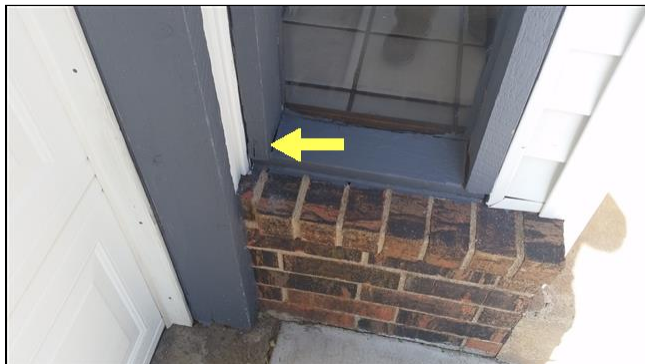
2.0 Item 1(Picture)

**2.0** Wood trim rot present at the window trim at the front of the home. Recommend having a reputable contractor repair.

Wood trim rot present at the window trim at the front of the home. Recommend having a reputable contractor repair.

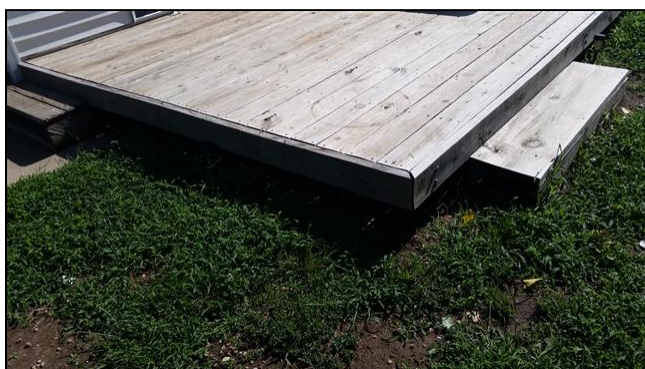
2.4 Item 1(Picture)

2.4 (1) Wood to ground contact observed. This will cause deterioration and attract termites. Ideally, there should be concrete footers installed. At a minimum, monitor and keep the home treated for termites. Additionally, recommend staining the wood to prolong the life of the wood.

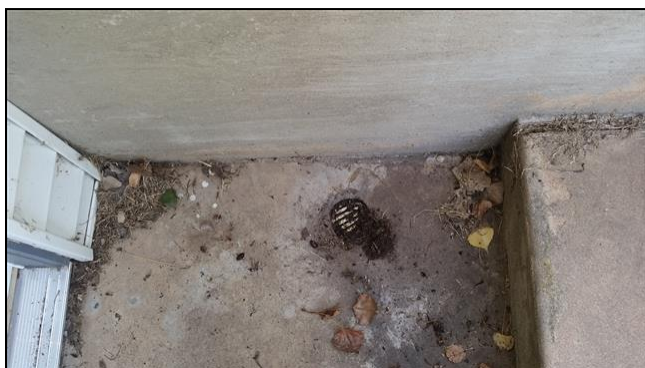
2.4 Item 2(Picture)

2.4 (2) The drain at the rear patio door was covered with debris. Recommend periodically cleaning to maintain proper drainage.

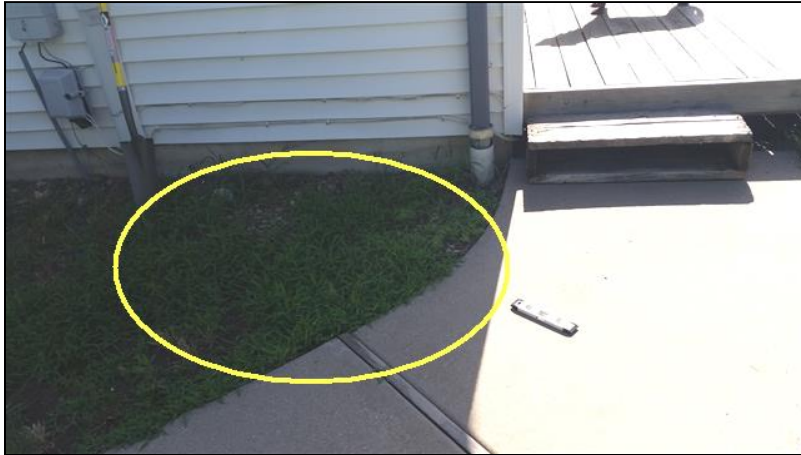
2.5 Item 1(Picture)

2.5 There is a negative slope at the rear of the home. This can cause or contribute to water intrusion or deterioration and settlement. I recommend adding fill dirt to correct landscape to drain water away from home.

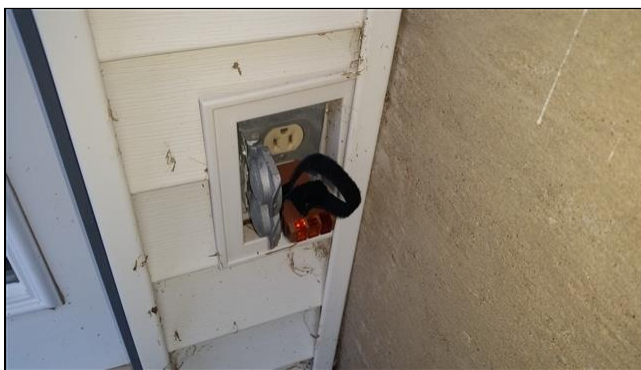
2.7 Item 1(Picture)

2.7 An open ground outlet was observed at the rear of the home near patio door. Recommend having a reputable electrician evaluate and repair

An open ground outlet was observed at the rear of the home near patio door. Recommend having a reputable electrician evaluate and repair

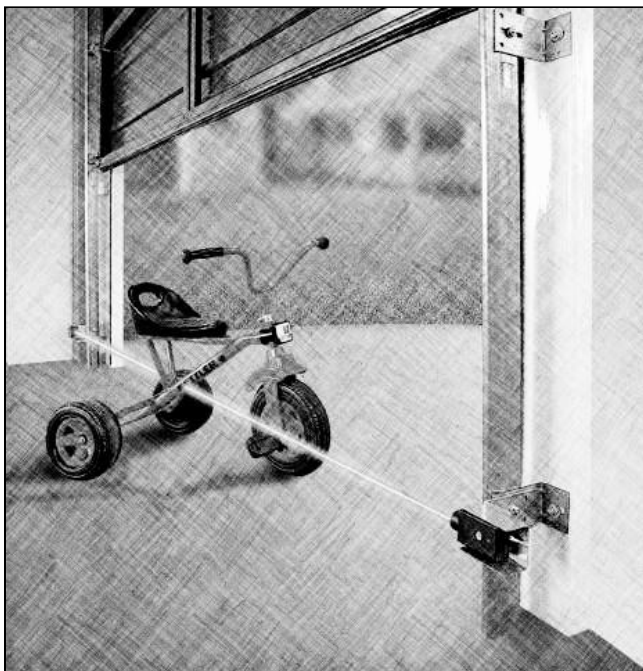
3.3 Item 1(Picture)

**3.3** There are no auto reverse sensors installed on the garage door. The sensors prevent accidental damage to cars as well as help prevent injury to children and pets. Recommend installing approx 6 inches off the floor.

There are no auto reverse sensors installed on the garage door. The sensors prevent accidental damage to cars as well as help prevent injury to children and pets. Recommend installing approx 6 inches off the floor.

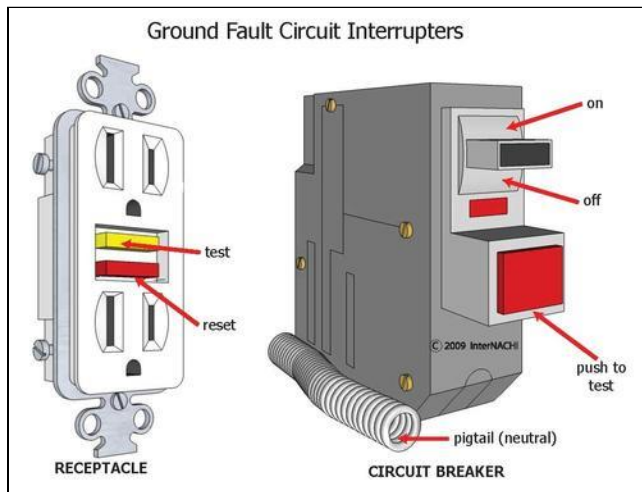
5.3 Item 1(Picture)

**5.3** No GFCI Outlet: Location/s (second level bath)

Although this condition may have been commonly considered safe or acceptable at the time the home was originally constructed, as general knowledge of safe building practices has improved with the passage of time, building standards have changed to reflect current understanding.

Consider having GFCI protection installed as a safety precaution for outlets within 6 feet of a plumbing fixture. This can be achieved by either method below:

1. Replacing the current standard outlets with GFCI outlets
2. Replacing the breaker currently protecting the electrical circuit which contains the outlets with a GFCI breaker.

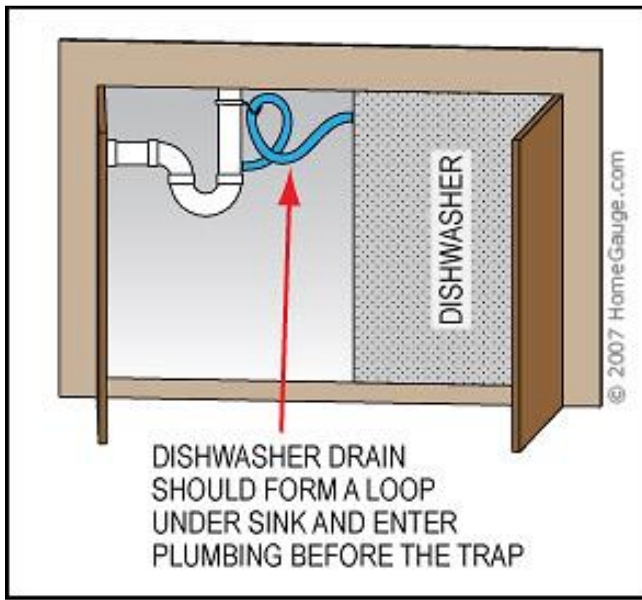
6.3 Item 1(Picture)

6.3 The dishwasher should have a loop in the line to prevent backflow. see illustration

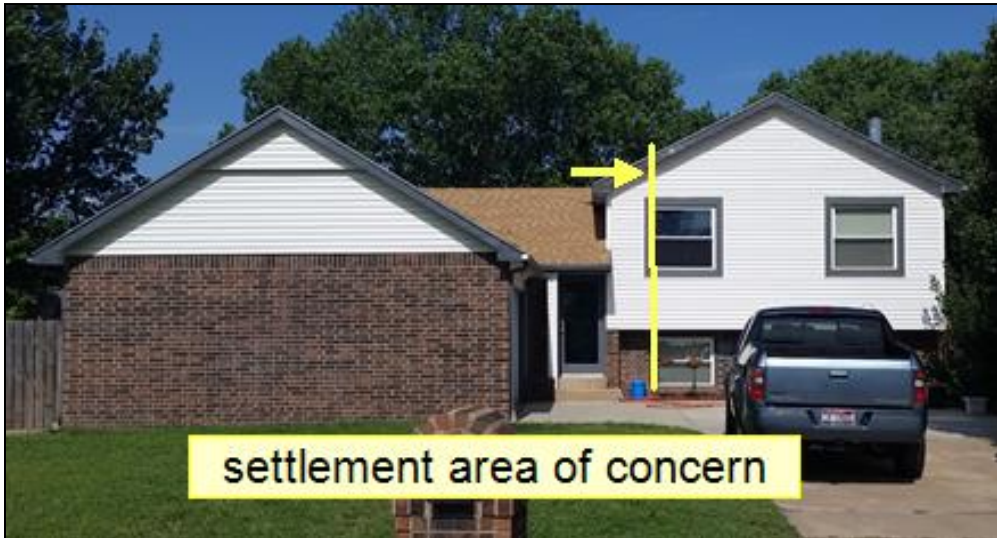
7.0 Item 1(Picture)

7.0 There is some exterior cracking visible. There are corresponding interior cracks in the sheetrock near the windows. The second level floor is noticeably not level. The upstairs bedroom doors are out of square. Cracks can be felt through the basement carpeting in the same area of the home. In the inspectors's opinion there has been extension wall texturing in an attempt to conceal interior wall cracks. There are also relatively fresh cracks in the texturing. Recommend a complete evaluation by a structural engineer.

There is some exterior cracking visible. There are corresponding interior cracks in the sheetrock near the windows. The second level floor is noticeably not level. The upstairs bedroom doors are out of square. Cracks can be felt through the basement carpeting in the same area of the home. In the inspectors's opinion there has been extension wall texturing in an attempt to conceal interior wall cracks. There are also relatively fresh cracks in the texturing. Recommend a complete evaluation by a structural engineer.
