THE HOME INSPECTION REPORT

07082402B - [REDACTED]

[REDACTED] Street, Reading, PA 19604

8/24/2007 12:00 pm to 3:00 pm

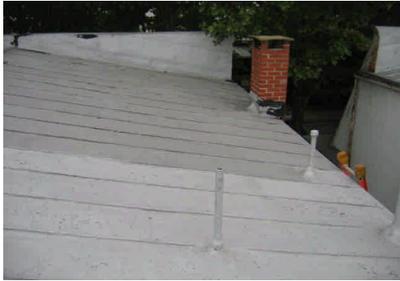
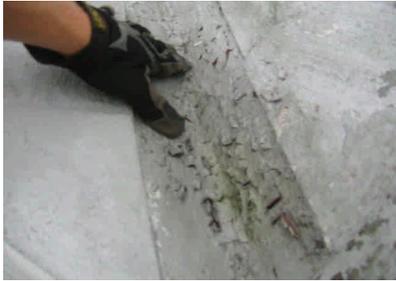
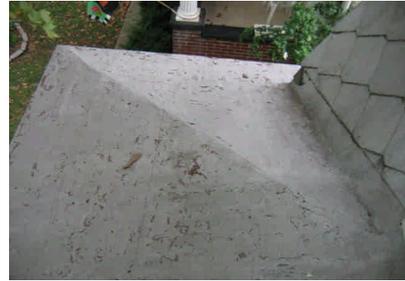
The metal roof coating is old, cracked, and deteriorated. The coating is in poor condition. Prone to water penetration. Some metal surfaces exposed and rusting. Correction and further evaluation by a roofing professional is needed. Located at the main house, front and rear secondary roofs.

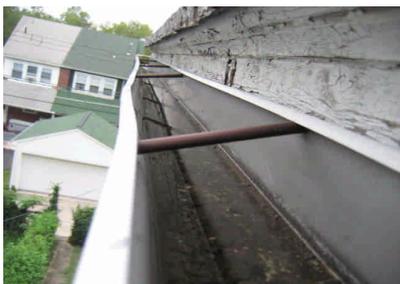
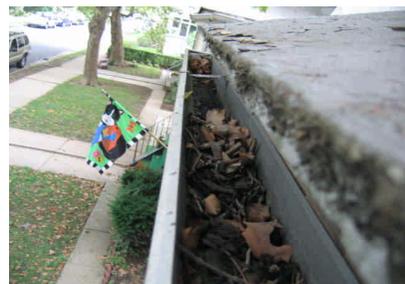
Dirty gutters. Debris and leaves inside them. The gutters need to be cleaned and serviced to drain properly.

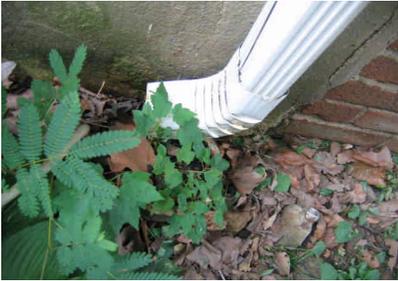
The downspout is not diverting water away from the house foundation. Improvement recommended.

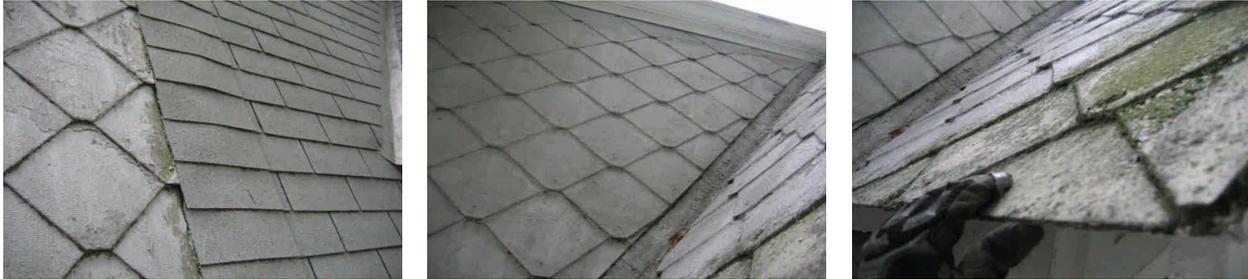
The ceramic roof covering is heavily covered with aluminum roof coating. Indicating previous and active roof leak problems. Indicating the unreliability of this roof to be water-tight. We recommend that the ceramic tile materials further evaluated by a professional roofer. It will likely need to be torn off and replaced.

There is an active roof leak coming from the ceramic roof. Detected from inside. At the front corners of the first floor living room and second floor bedroom.

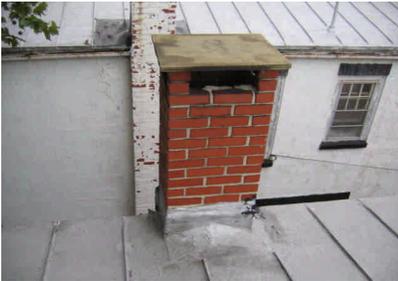
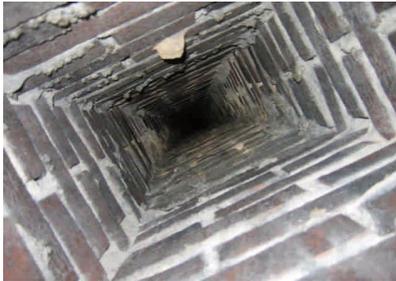
The chimney stack is an unlined one. There is no modern interior flue lining inside the old brick masonry chimney. We recommend installing a flue lining by a professional. Correction and further evaluation is recommended.

Considering the dangers of old unlined or damaged chimneys, and the many cost effective options now available to make these chimneys safe components of the home's heating system, we recommend having a certified chimney professional inspect the chimney, determine what type of liner is appropriate, and the costs.

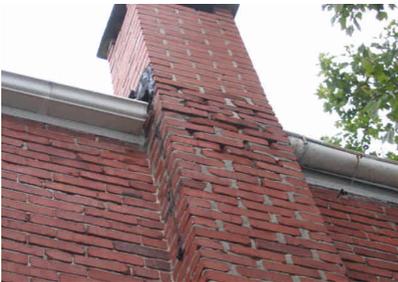
The brick chimney stack exterior has damage. The mortar joints are weathered and have been affected by water over the many years. Near the roof area. Correction and further evaluation is recommended.

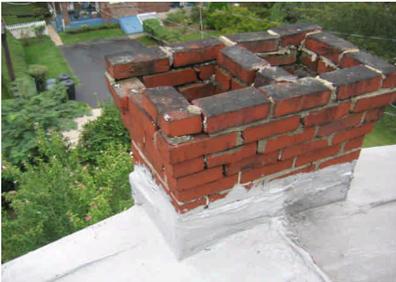
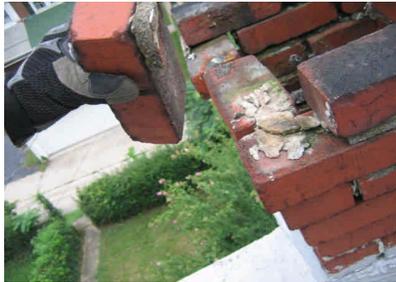
The brick chimney stack has major damage. The bricks are loose. Some missing. The mortar joints are weathered and have been affected by water over the many years. Old stack. Correction and further evaluation is recommended. Even though it is no longer used, loose bricks falling could damage the roof, or pose as a safety hazard.

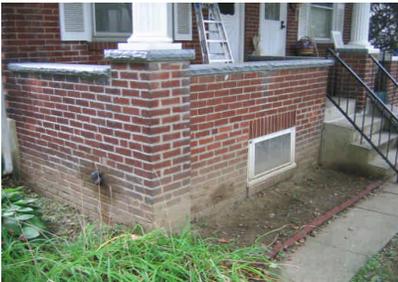
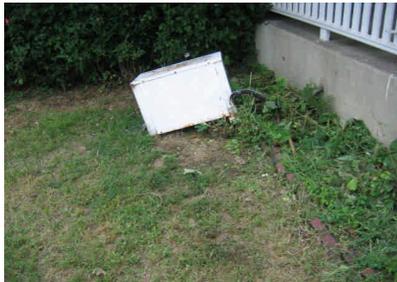
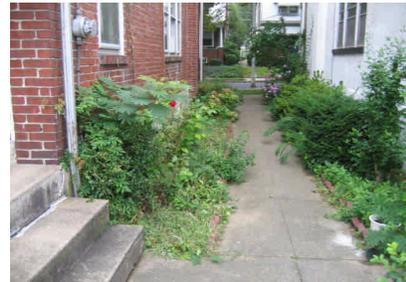
Grading and drainage is either negative or neutral adjacent to the structure's foundation, and may cause moisture or water penetration. Ideally the grading and hard surfaces should slope about 6 inches over the first 10 feet away from the house foundation.

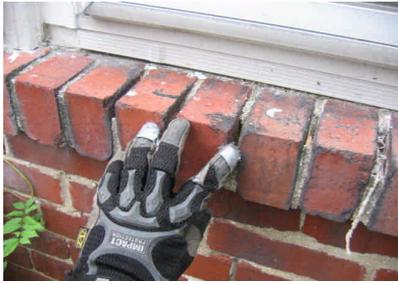
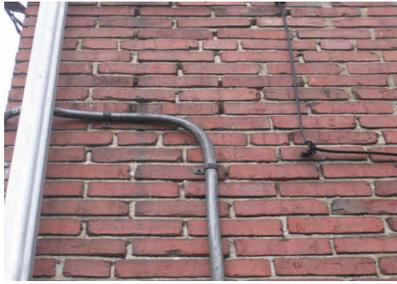
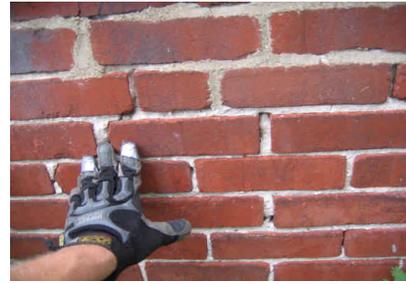
Mortar joints of the brick exterior walls are showing signs of weathering. Cracking and missing areas. This will continue to happen over time and will require pointing. Correction and further evaluation is recommended. Located all around the house here and there.

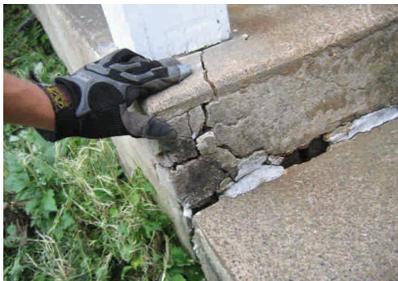
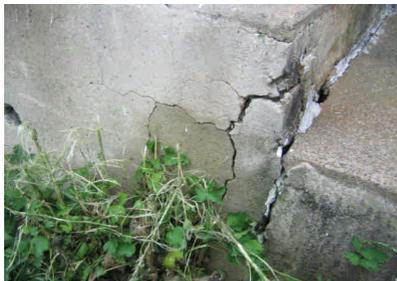
Major damage to the masonry corner of the rear porch, above which rests a load-bearing post.

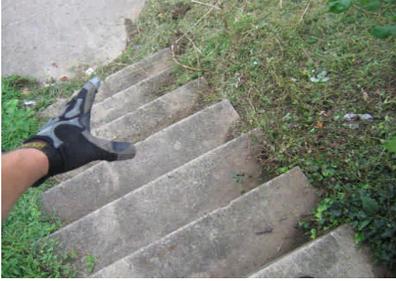
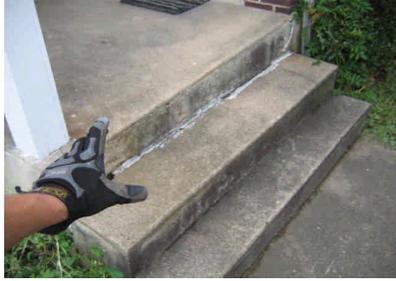
Missing handrail at the exterior steps. In the far rear of the property and at the rear porch. We recommend installing handrails on steps that have two or more risers, particularly if children or the elderly visit or occupy the home.

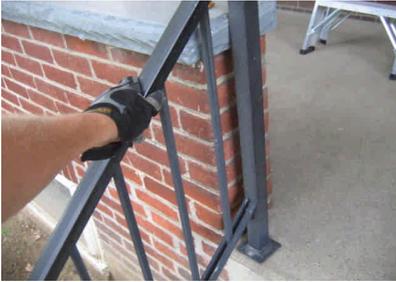
The handrail on the front porch steps is slightly insecure and represents a safety hazard, and should be repaired.

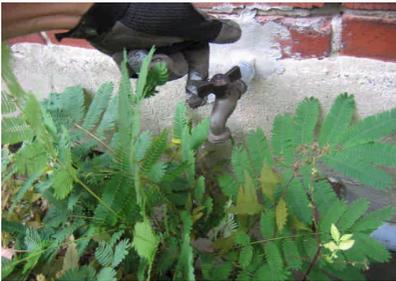
The faucet is not frost-free. Consider replacing the faucet with frost-free hose bibs. To prevent freeze-burst problems in the winter. Or be sure remove the hoses and drain the faucets before winter, to prevent freezing and bursting problems.

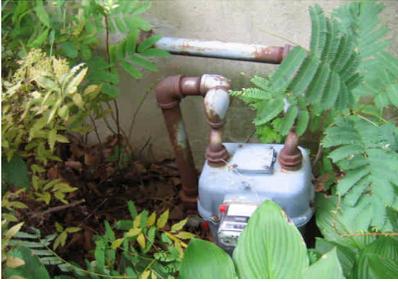
The main gas shut-off valve is located near the gas meter at the side of the house.

The gas meter has some surface rust on it.

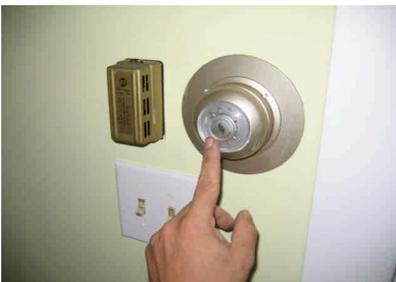
Thermostat

There is a thermostat located on first floor.

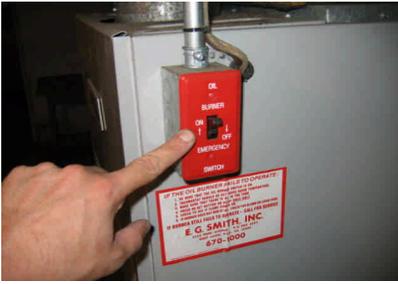
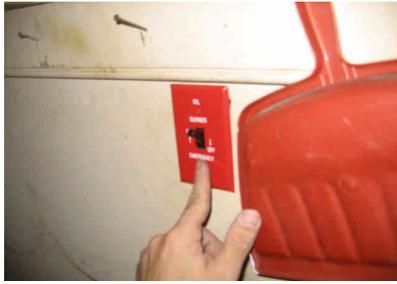
Electric shut-off switch

The electrical shut-off switch is located on the side of the heating system.

The electrical shut-off switch functioned. Good. I would use this switch when inspecting the air filter.

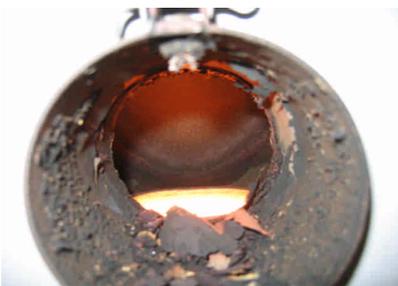
A relatively small amount of the chamber area was viewed through the viewing portal. No major defects, like large open cracks or missing pieces, of the refractory material inside the chamber was apparent. The refractory chamber interior should be inspected every year when the total system is serviced and cleaned.

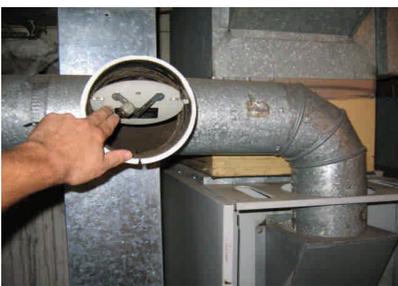
Damper on Flue Pipe

Damper on flue pipe appears functional.

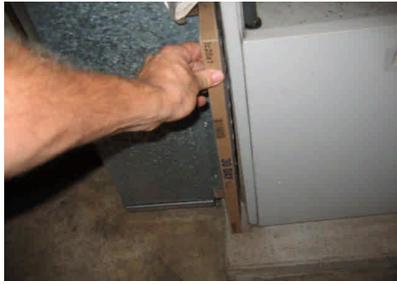
Air filter

The air filter is disposable and clean. Check every 30 days. Replace when necessary.

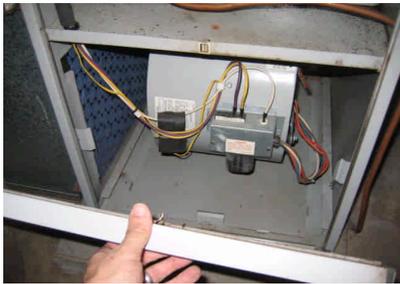
Safety switch at the panel to the blower fan is not installed.

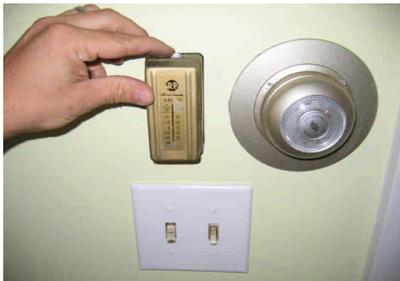
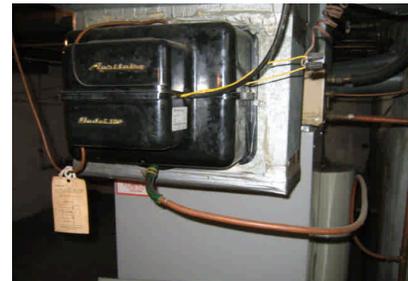
I could not get the humidifier to turn on.

The humidifier needs service and cleaning.

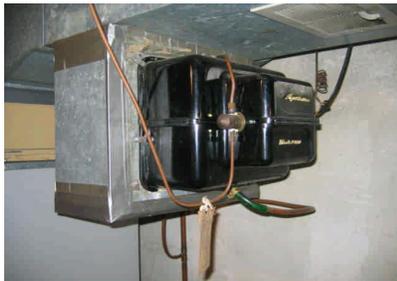
Humidifier

The humidifier needs serviced and cleaned every year. The evaporator needs replaced annually. In the wintertime, when not in use, the water valve should be turned off, and the control should be turned off too.

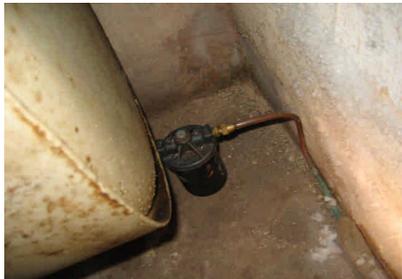
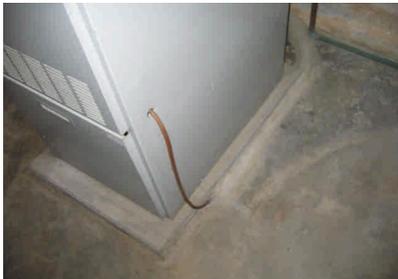
The oil supply line is buried within concrete - could react with the concrete and then corrode the copper line over time. Ideally the copper line would be above the concrete surface, not imbedded. Recommend asking your oil supply company or heating professional to evaluate the pipes condition. A replacement of the line may be recommended.

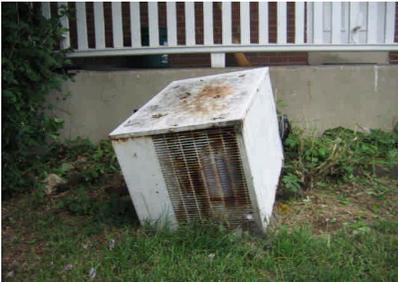
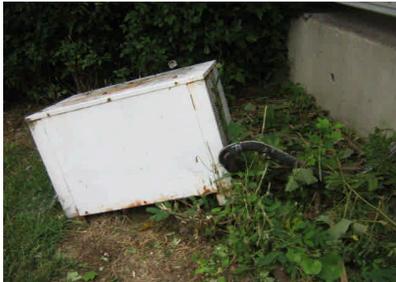
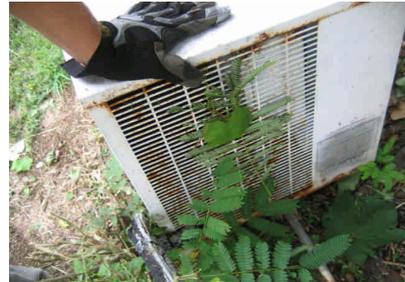
Exterior Condenser Unit(s) For Your Information

The outdoor condenser unit for the air conditioning system appears off-level. Should be leveled by a HVAC professional. To prevent damaging the unit.

The base support is missing.

The electrical disconnect for the exterior condenser unit is missing. Hazard. A disconnect is required.

The exterior condenser unit is obviously damaged and will not turn on.

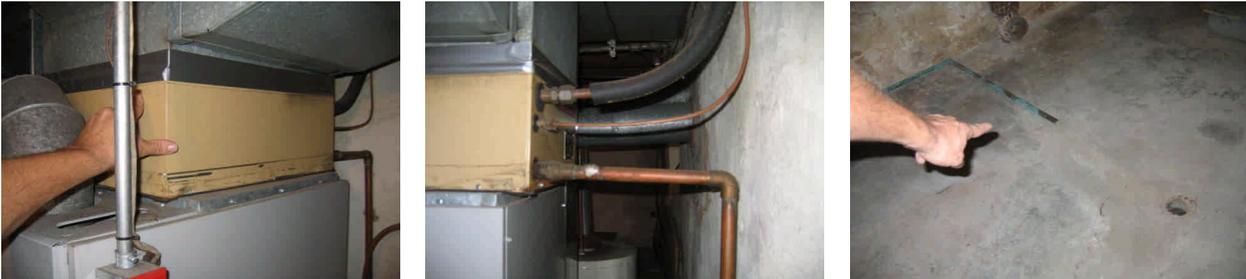
Interior Evaporator Unit(s) For Your Information

The thermostat for the cooling is the same as the heater's thermostat. The electric shut-off switch is the same as the heater's. The air filter is the same as the heater's filter.

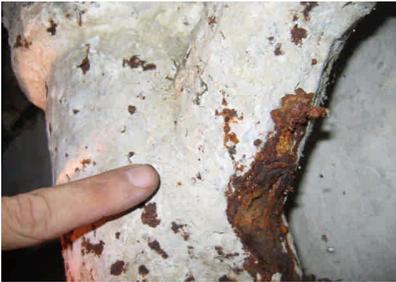
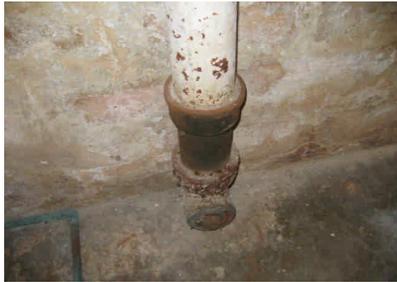
Condition of Drain Waste & Vent Pipes

There is rust and corrosion on the cast iron drain pipes. The corrosion holes are active leaks. Replacement of the pipes is needed.

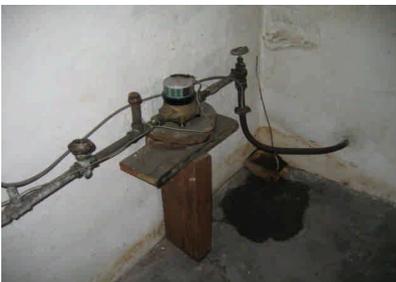
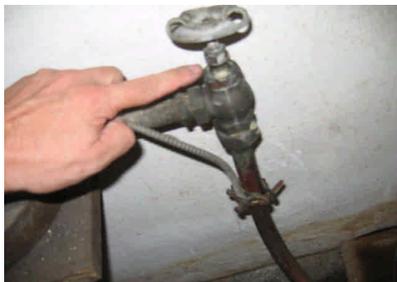
Main Water Shut-off Valve

There is a water leak at the main water shut-off valve. Bad.

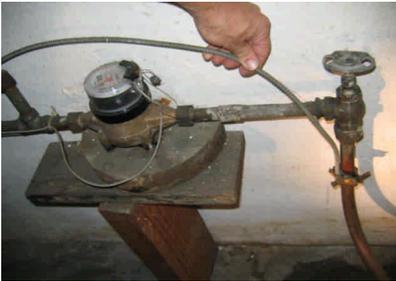
Water Meter

The water meter is located near the main water shut-off valve.

There is a jumper cable installed over the water meter - Good.

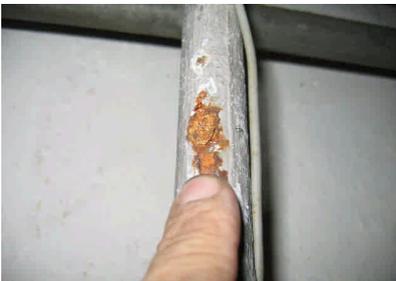
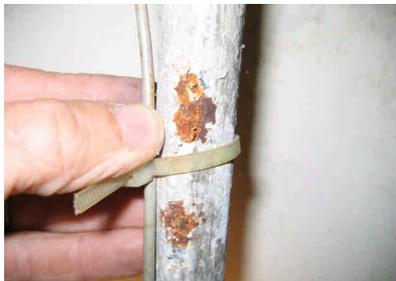
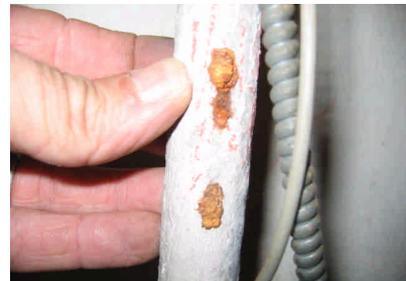
Water Supply Pipes
Copper Water Pipes

The visible water supply pipes appear to be copper. No active water leaks were apparent. Good.

There are water supply pipes that are galvanized, and are assumed to be original and very old. They may produce rusty looking water. The water volume in such pipes will gradually be reduced by a build-up of minerals within them. There are corrosion holes leaking water in a section of pipe near the meter. We recommend replacing the water lines with copper or other modern water supply piping material.

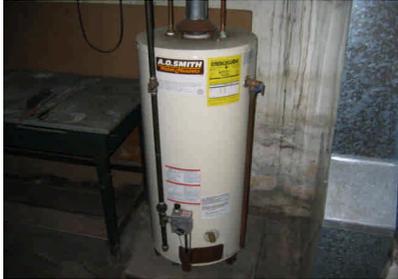
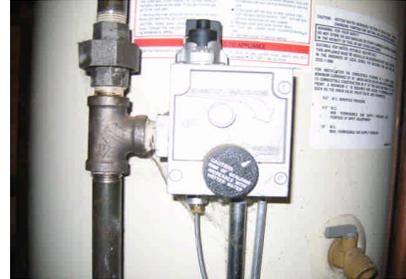
Gas Water Heater For Your Information

There are a wide variety of residential water heaters. They can be expected to last at least as long as their warranty, or from five to eight years, but they will generally last longer. However, few of them last longer than fifteen or twenty years and many eventually leak.

The water heater is 30 gallons in size.

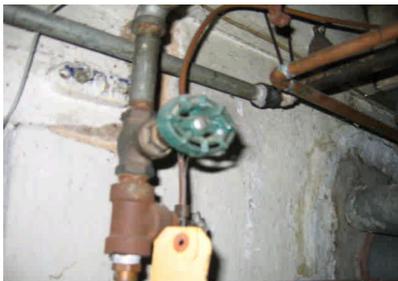
Water Shut-Off Valve & Connectors

The water shut-off valve to the water heater tank is installed. Not leaking.
This valve turns off the cold water supply to the tank. Good.

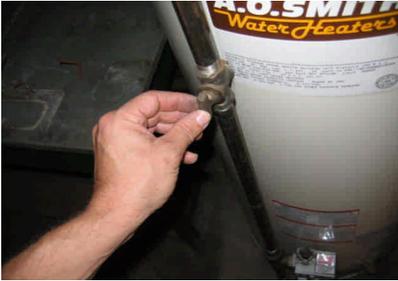
Gas Shut-Off Valve

The gas shut-off valve at the water heater is installed within reach of the tank. This valve turns off the gas supply to the tank. Good.

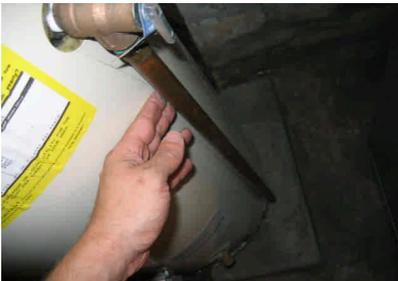
Relief Valve & Discharge Pipe

The water heater is equipped with a pressure-temperature relief valve. The pipe is extended to the floor. For safety. Good.

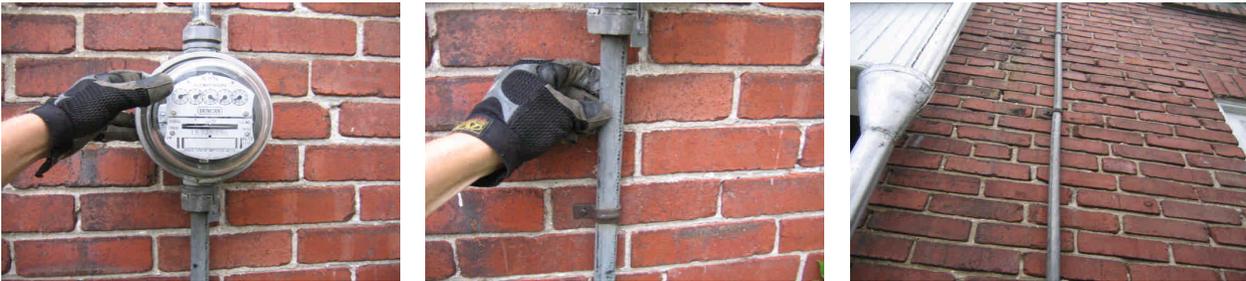
Number of Meters & Location

There is one electric meter.

The meter is located on the left-side of the house.

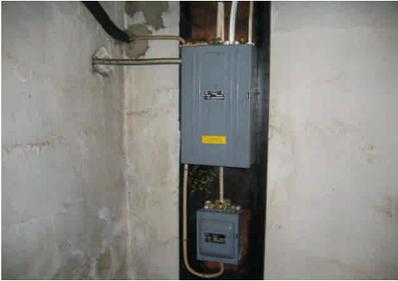
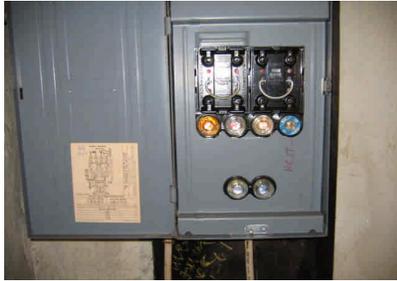
Location of Panel

The main panel is located in the basement.

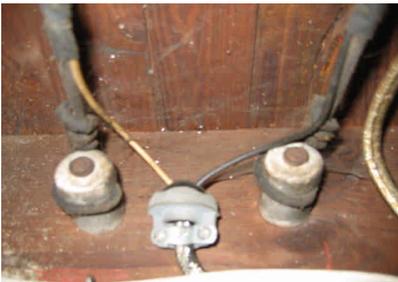
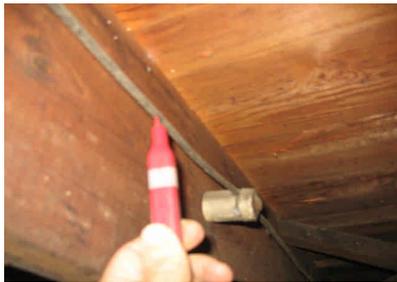
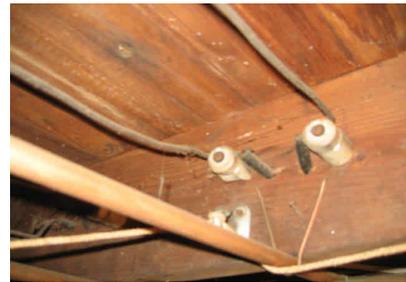
Wiring Type

Knob & tube wiring is an old, antiquated, ungrounded wiring method. There can be potential fire hazards, with the brittle condition of the wiring, improper wiring splices, and insulation installed over the wires. The Modern wiring should not be spliced to the knob & tube wiring without consulting a professional electrician. NEC Article 324-4 states that house insulation must not cover knob & tube wiring which is often found in the attic or wall spaces. Especially not combustible cellulose insulation. Consult your home owner's insurance company about the knob & tube wiring being used in the house. We recommended having an electrician inspect the knob & tube wiring for defects or hazards. We recommend replacing the knob & tube wiring with modern wiring methods. Correction and further evaluation by an electrician is recommended.

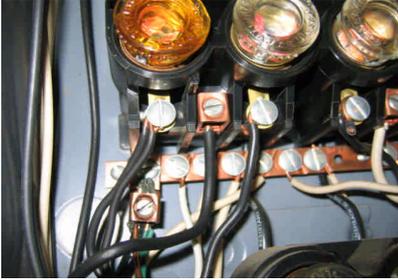
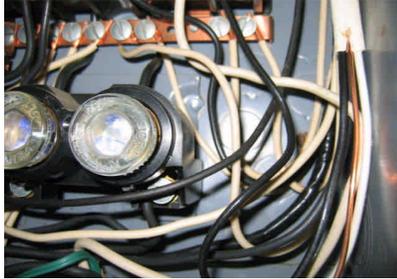
Double Tap

There are fuses within the main electrical panel that are doubled up (referred to as a "double tap"). A double tap is when two circuit wires are connected to only one fuse. The circuits should be separated so that each circuit is serviced by its own circuit breaker. A licensed electrician should be consulted to make the necessary corrections.

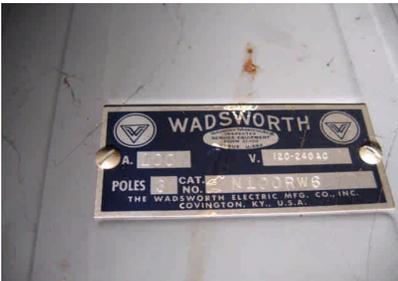
Inspection Sticker

There is an inspection sticker. Dated 1966. Ask seller if there's been any electrical work performed, and permits for that work issued, since the panel was installed or inspected last.

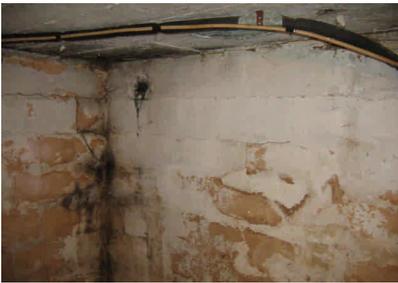
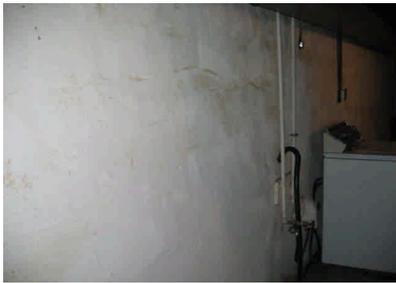
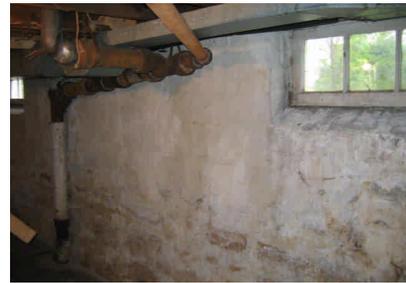
Basement For Your Information

This residence has a basement. We try to enter and inspect all accessible areas, looking for any evidence of structural material defects. We look for cracks, but those that are less than ¼" and which do not exhibit any vertical or horizontal displacement are generally not regarded as being material structural defects. We look for signs of water penetration too, but please consult the seller's disclosure.

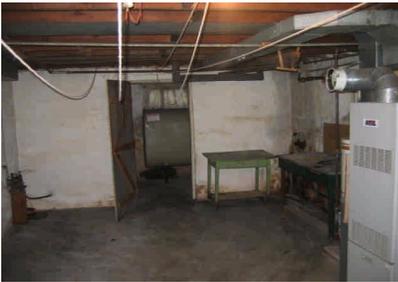
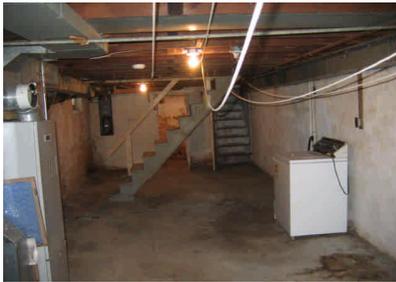
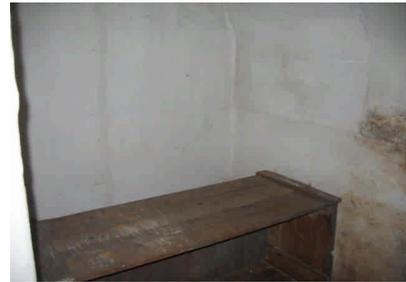
Basement Restrictions

We do all we can to see everything in the unfinished basement. There are restrictions to the inspection though. Including but not limited to the electrical wires, pipes, storage, ductwork, insulation, floor coverings, etc.

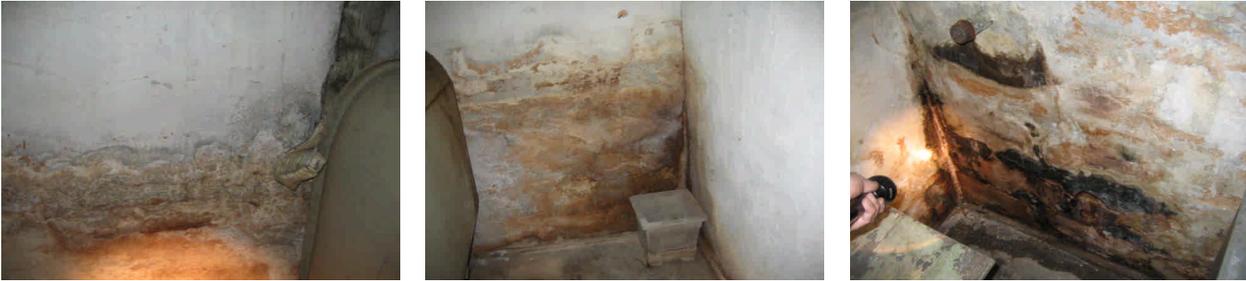
Masonry, mortar, and sand have fallen away from the stones. This is not uncommon for an older stone foundation. Periodic repair/maintenance will be needed to maintain its integrity.

There are signs of water penetration through the stone foundation. Water often comes through stone foundations. Stone and mortar foundations are porous. Water penetration, dampness, and high humidity levels are common.

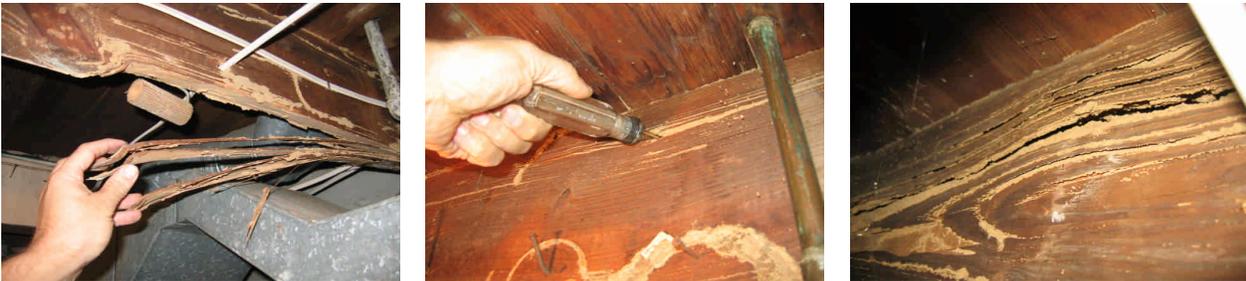
There is major structural damage caused by termite infestation. Numerous floor are completely destroyed. Material defect. Correction and further evaluation is recommended.

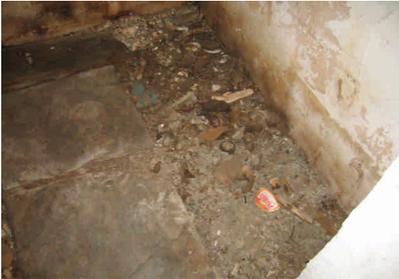
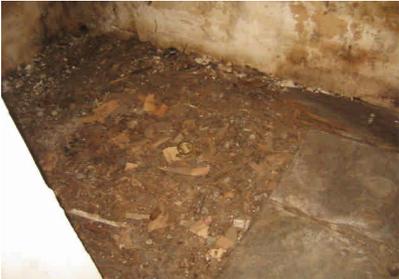
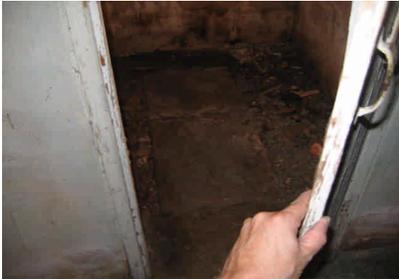
There is exposed dirt at the rear room of the basement. Missing a vapor barrier. This introduces high humidity into the house.

CORRECTION AND FURTHER EVALUATION RECOMMENDED:

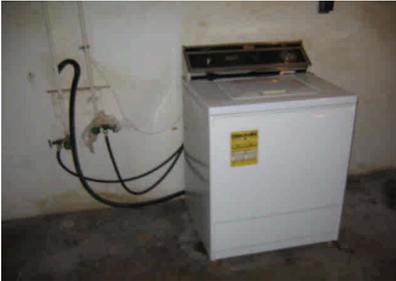
Faulty dryer vents have been responsible for thousands of fires, hundreds of injuries, and even deaths. The best vents are a smooth-walled metal type that travels a short distance; all other types should be regarded as suspect, and should be inspected bi-annually to ensure that they do not contain trapped lint or moisture.

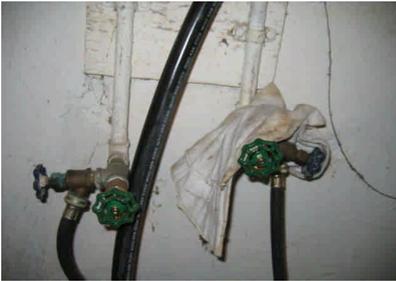
The dryer vent is not installed. I don't believe there ever was a dryer appliance installed.

Rubber hoses should be replaced with more reliable ones - pressure-tested hoses. Such as stainless-steel, braided mesh hoses.

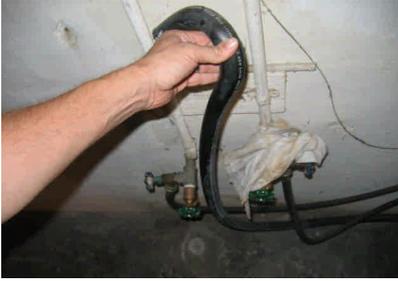
Laundry Tub or Drainage

I don't see any proper drainage system installed for the clothes washer.

CORRECTION AND FURTHER EVALUATION RECOMMENDED:

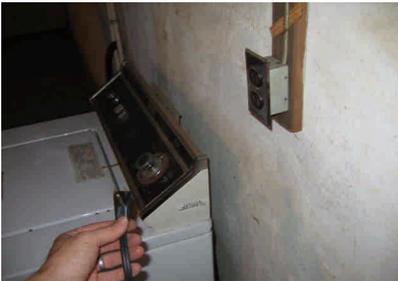
Electric Receptacles

Missing GFCI protection at the electric receptacles near the washer.

CORRECTION AND FURTHER EVALUATION RECOMMENDED:

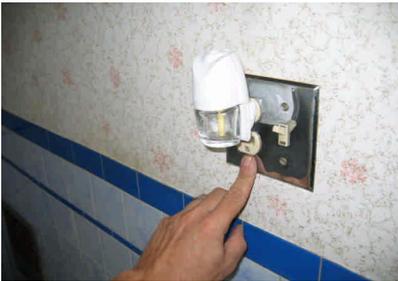
The receptacles in this 2nd floor bath are not protected by a functional GFCI (or ground fault circuit interrupter).

CORRECTION AND FURTHER EVALUATION RECOMMENDED:

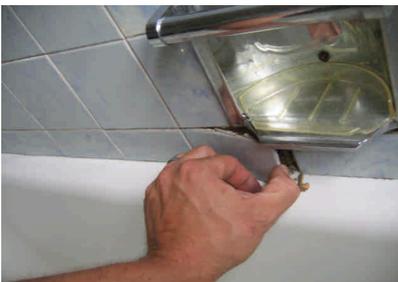
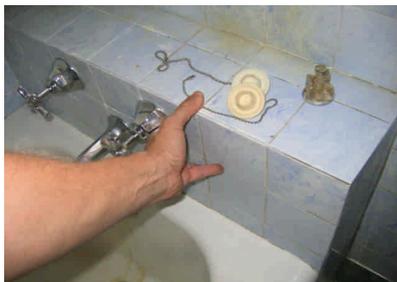
Tub-Shower

There are loose and hollow-sounding tiles in the tub/shower area, which should be evaluated for repair to ensure that moisture damage has not already resulted behind the tiles.

CORRECTION AND FURTHER EVALUATION RECOMMENDED:

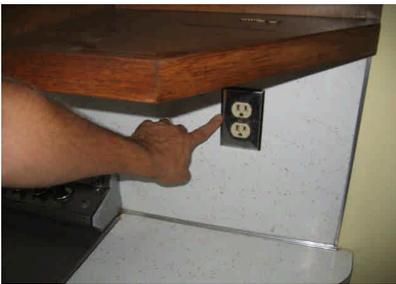
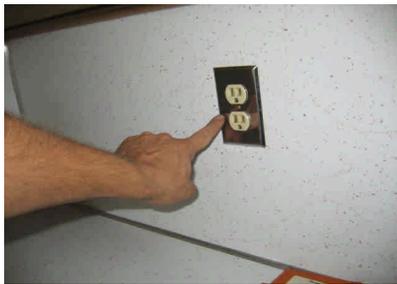
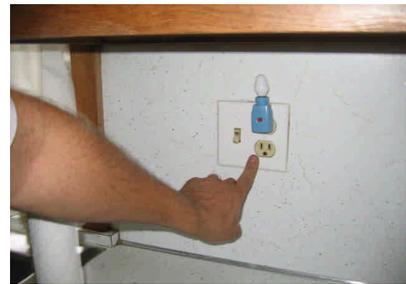
Missing GFCI-protection at the kitchen counter receptacles. All of the countertop and island receptacles should be upgraded to have ground fault GFCI protection, which is mandated by current standards and is an important safety feature.

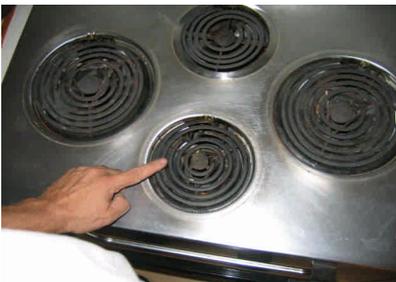
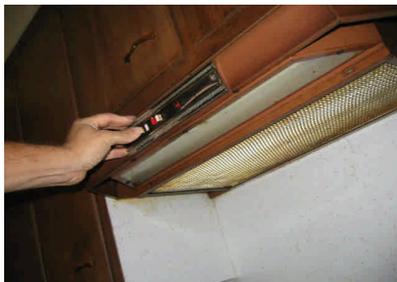
Electric Cooktop

The electric stove is old.

Unable to turn on the front element of the stove appliance.

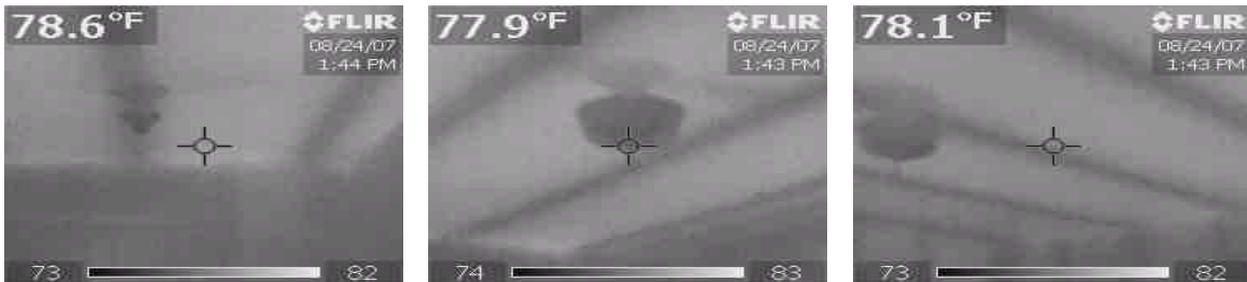
Apparently very little or no insulation is detected in the ceiling of the 2nd floor rooms.

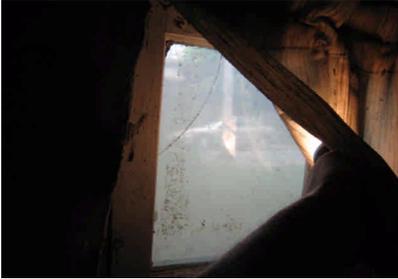
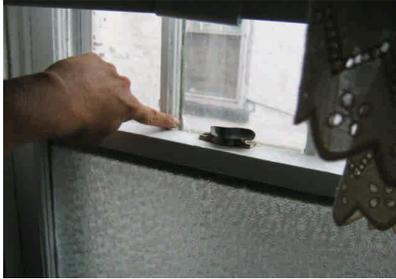
Windows Cracked Windows

There are cracked windows. Replacements needed. Located at the basement. And bathroom.

CORRECTION AND FURTHER EVALUATION RECOMMENDED:

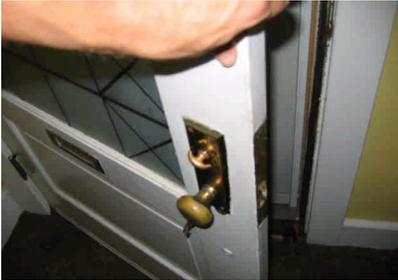
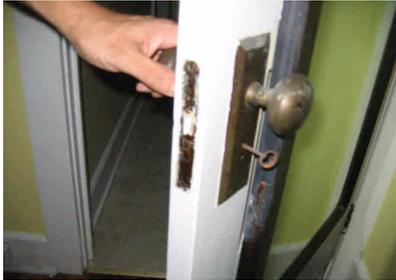
Locks

A skeleton key lock on a door is a hazard. It does not matter if it is an interior door or exterior door. Skeleton keyed locks on doors should be abandoned and replaced with modern door locks, for safety. Located at the bedrooms and exterior doors.

CORRECTION AND FURTHER EVALUATION RECOMMENDED:

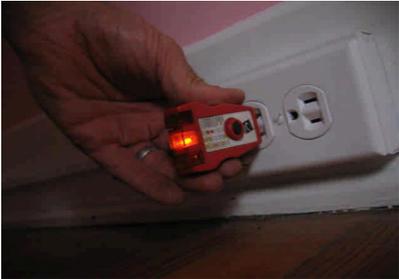
3-prong with no grounding

A representative number of readily accessible 3-prong electrical wall outlets were tested. There are wall outlets with 3 prongs that were tested as being without a grounding wire connection. The receptacles are 3-prong receptacles, which have a hot, a neutral and a grounding prong at the receptacle, but there's no grounding wire connection at the prong. This is an indication of newer, updated 3-prong receptacles installed on older wiring in the house, or possibly improperly wired receptacles. Further evaluation is recommended. If a grounding connection is necessary for your fixture (lamp, TV, computer), then do not use the improperly wired 3-prong receptacles.

IMPROVEMENT AND REPAIR RECOMMENDED:

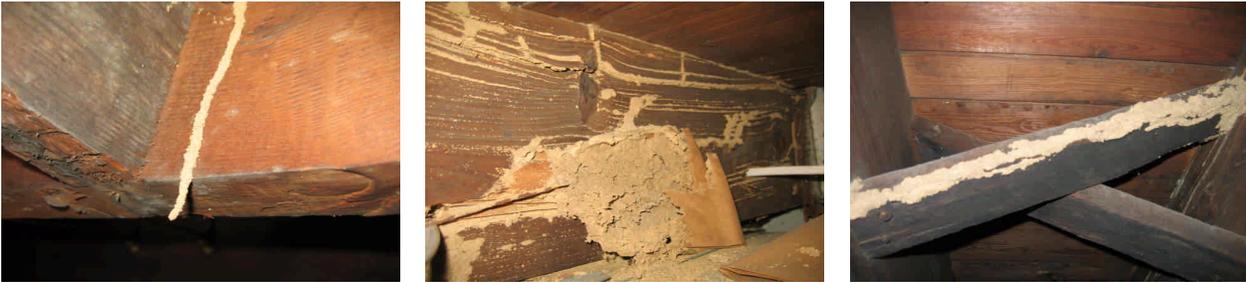
Intact termite mud tubes or tunnels.

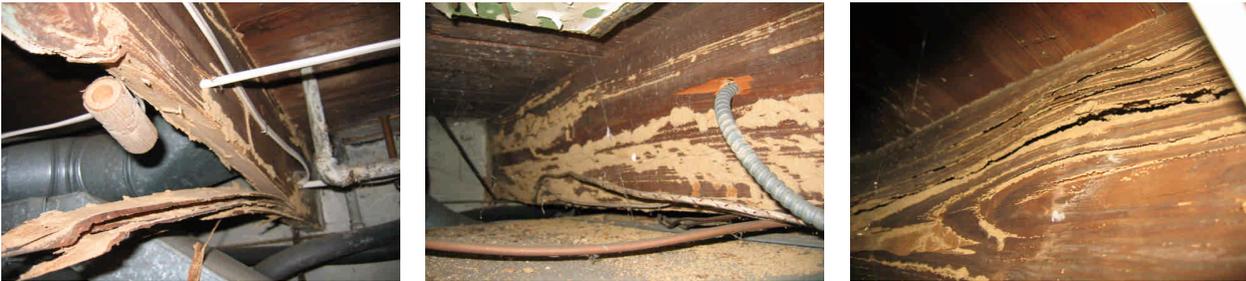
Wood damage caused by infestation. Visible from basement.

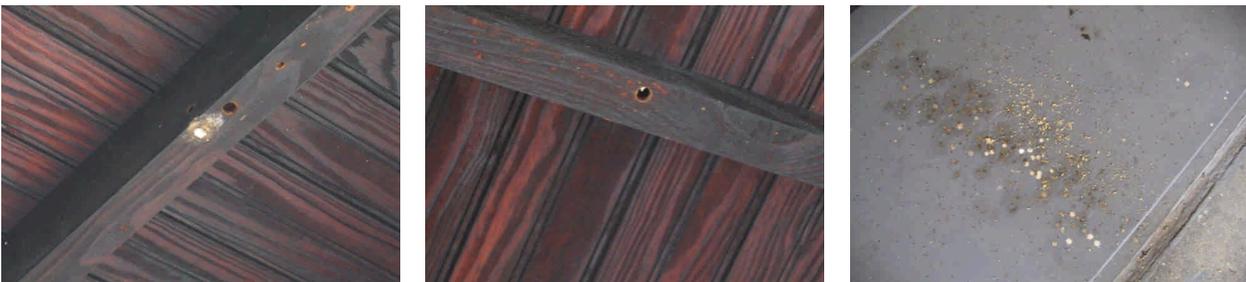
Carpenter Bees Signs of Infestation

Carpenter bee holes at rear porch rafters.

Saw dust piles below holes.
