PEACH Inspections

THE HOME INSPECTION REPORT

07083102B - [REDACTED]

[REDACTED] Drive, Lansdale, PA 19446

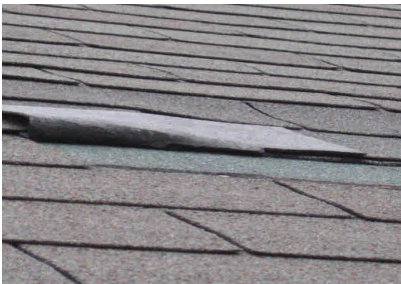
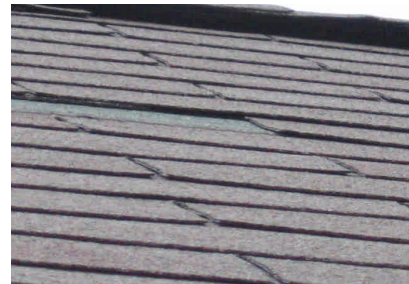
There are a few cracked and missing shingles. Prone to leaking. Located at the left-side of the front dormer. Correction and further evaluation by a professional roofer is recommended.

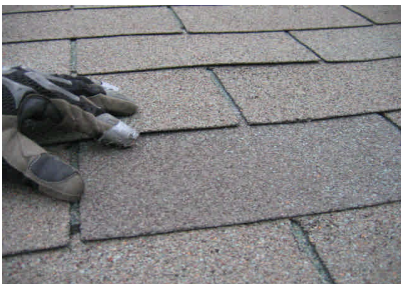
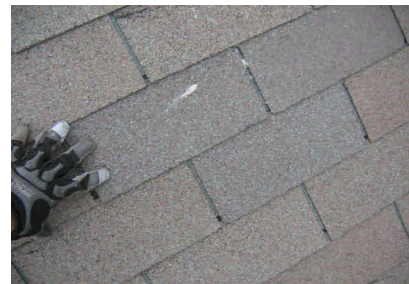
There have apparently been several repairs made on the roof. Repairs to the shingles are visible. Recommend asking the seller about the repairs to the roof.

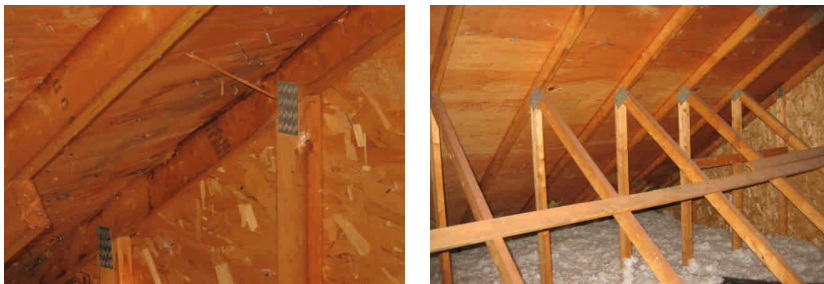
There are water marks visible from the attic. Possibly indicating an active roof leaks. Located at the rear right corner of the attic. And at the front left area, below the missing shingles.

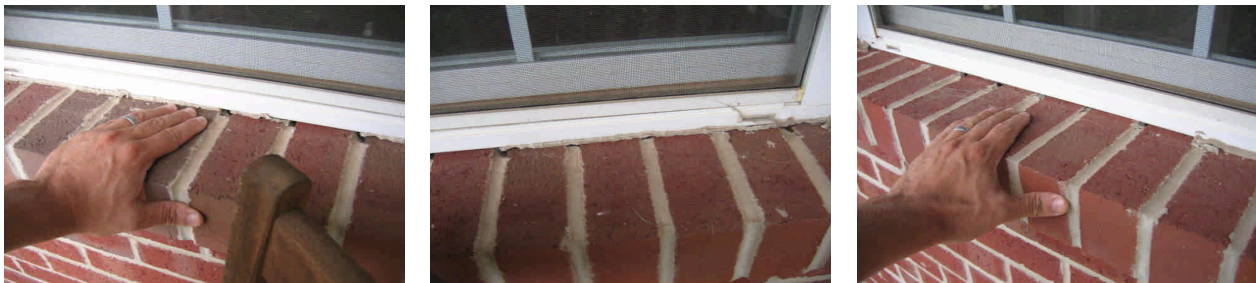
Open spaces at the window sills. Prone to water penetration. Front windows at porch, with brick exterior. Missing flashing, missing sealant.

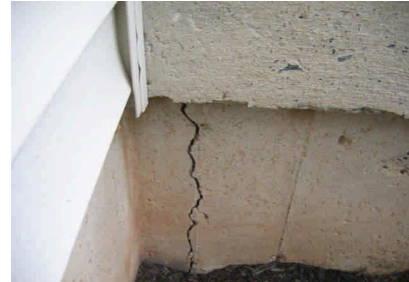
There is a crack in the exposed porch foundation. Located on the left-side. Apparently from settlement. Sealing or patching the crack with structural epoxy is recommended.

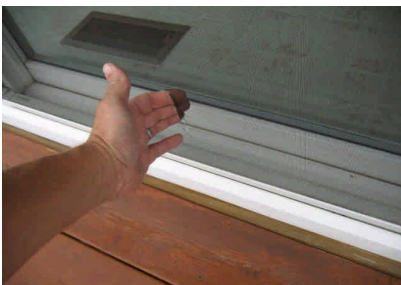
There is a screen door at the rear slider. The screen is torn or damaged. Repair or replacement of the screen material itself is recommended. This is a common problem.

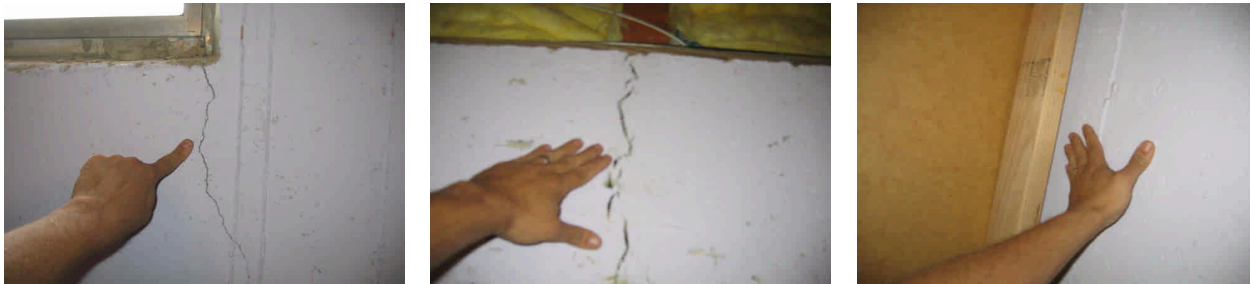
There are cracks in the foundation that is visible. Located on the right-side wall, left-side wall near window, and rear wall near stud board.

Foundation cracks can be repaired using an epoxy ejection method. Epoxy ejection repairs are considered affordable and effective. Epoxy ejections make a bond between the cracked sections of the foundation that is actually stronger than the concrete itself. Further evaluation and correction to the foundation cracks by a professional (one familiar with epoxy injection repairs) is recommended.

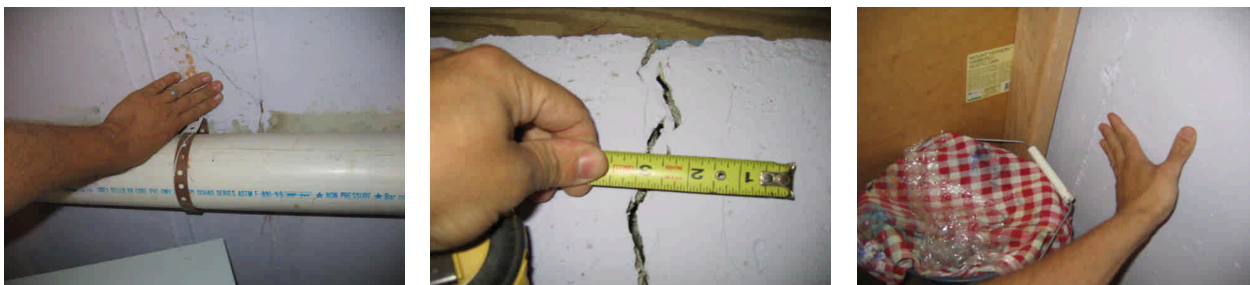
There is a patch in the right-side foundation wall. The patch appears to be in poor condition. Does not appear to be a structural repair. May have been patched because of water penetration. Cracked open. May not be reliable. Recommend a correction of the crack with an injection of epoxy.

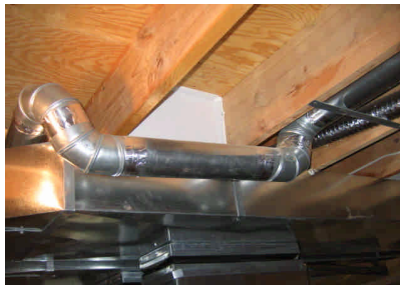
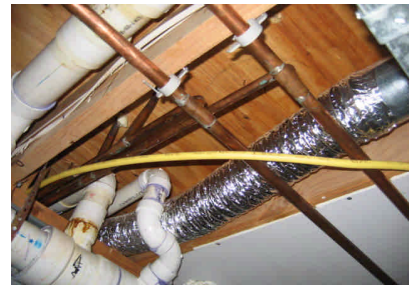
The dryer exhaust pipe is too long. The current standard limits the length of the dryer exhaust to 25 linear feet. For every 90 degree bend, minus 5 feet. Presently, the length of the dryer exhaust pipe is about 15 feet. With four 90 degree bends. Therefore, the length of the dryer exhaust pipe should be only 5 feet. Presently the dryer vent pipe is too long.

If the dryer exhaust pipe stays the way it is installed presently, being too long, then it needs to be inspected and cleaned every 6 months (twice a year). To prevent lint from building up and clogging the pipe. And to prevent fire hazards from developing in a clogged pipe.

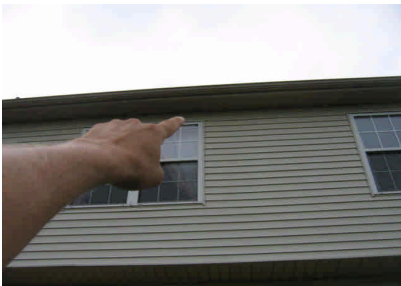
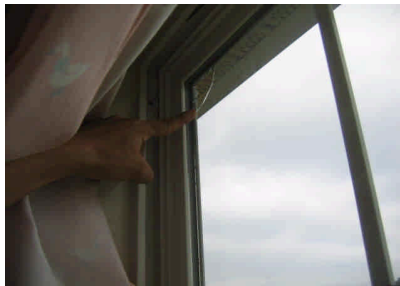
There is one cracked window. Replacement needed. Located at the 2nd floor rear bedroom.
