CERTIFIED
INSPECTION SERVICES, LLC
INTERNACHI CERTIFIED

Home Inspection Report

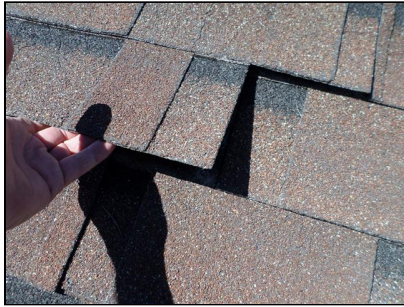
1.2 Item 1(Picture) Not sealed

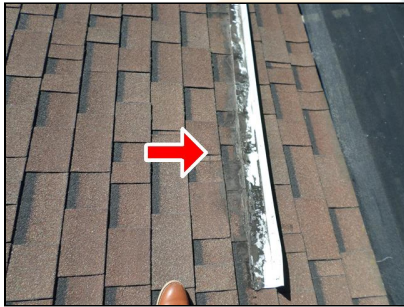
1.3 Item 1(Picture) Diverter

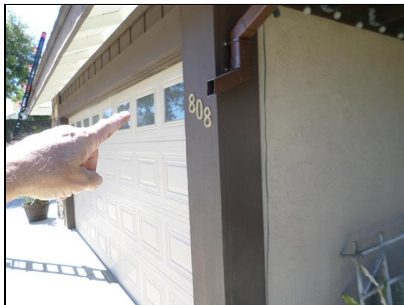
1.4 Item 1(Picture) Downspout too high

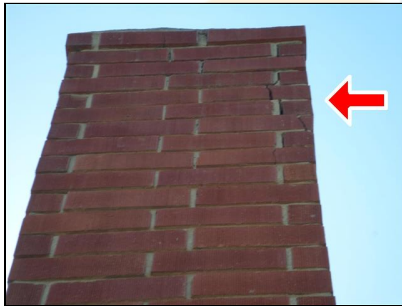
1.6 Item 1(Picture) Cracked mortar & brick

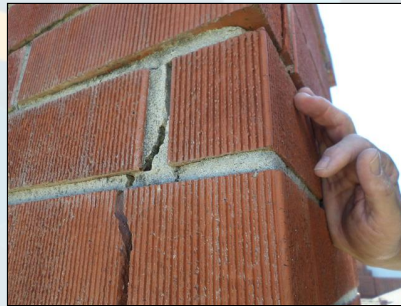
1.6 Item 2(Picture) Cracks

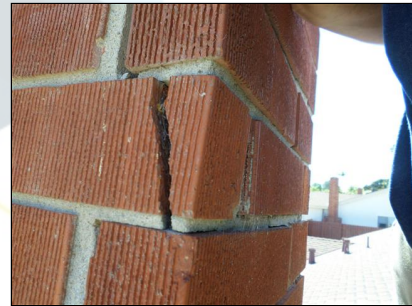
1.6 Item 3(Picture) Cracks

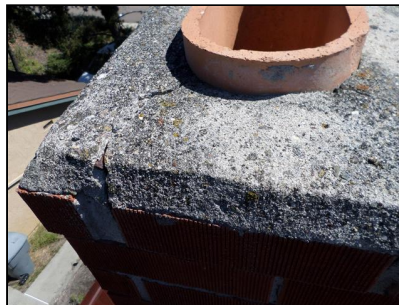
1.6 Item 4(Picture) Crown

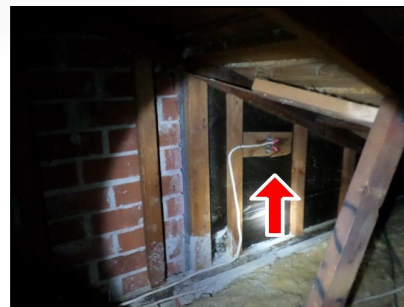
2.4 Item 1(Picture) Improper Wire Termination

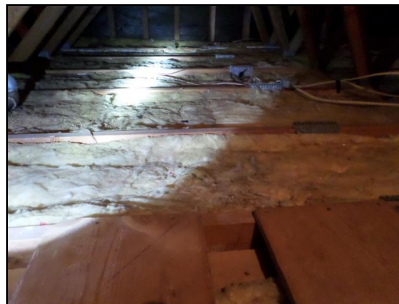
2.5 Item 1(Picture) Approx. 3" Insulation

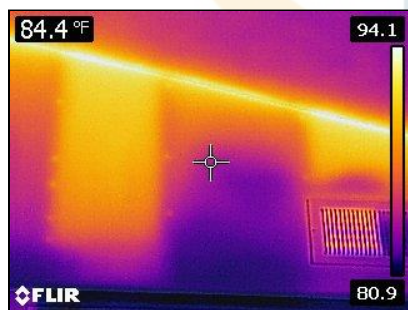
2.5 Item 2(Picture) Yellow area is missing insulation

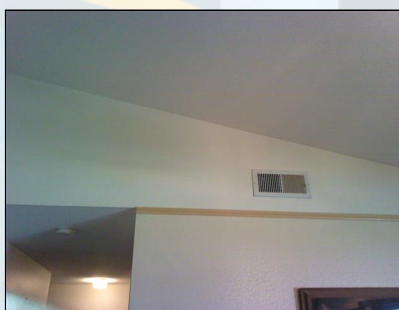
2.5 Item 3(Picture) Family room

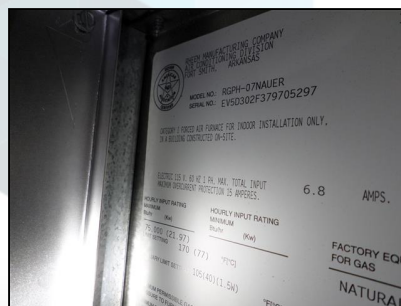
5.1 Item 1(Picture) Data plate

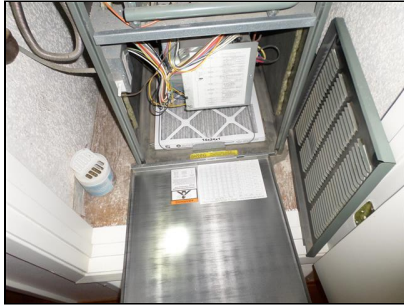
5.1 Item 2(Picture) Filter location

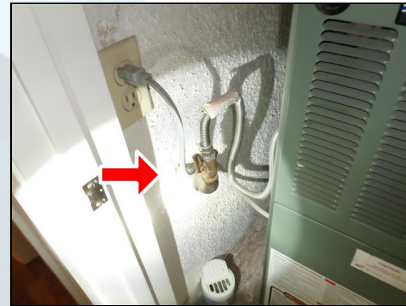
5.2 Item 1(Picture) Shut-off

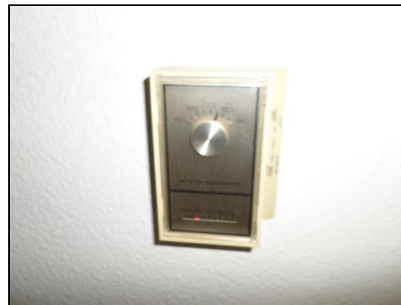
5.3 Item 1(Picture) Thermostat

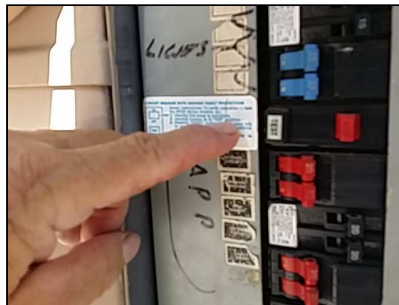
6.7 Item 1(Picture) GFCI breaker

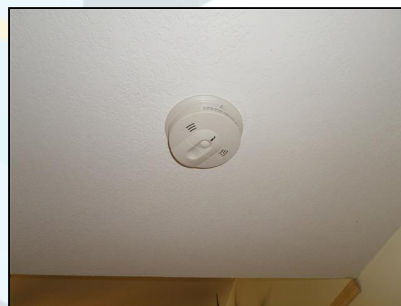
6.16 Item 1(Picture) Smoke detector

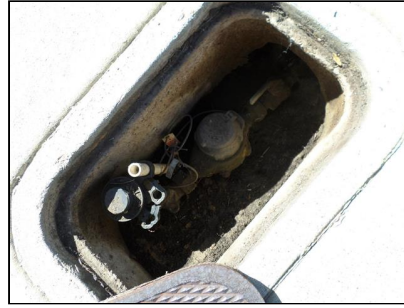
7.2 Item 1(Picture) Meter & shut-off

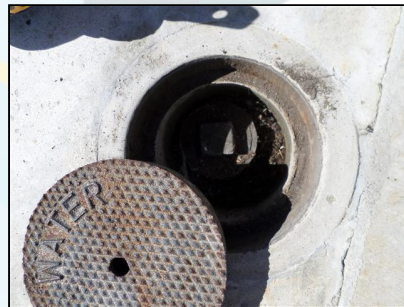
7.3 Item 1(Picture) Sewer clean-out

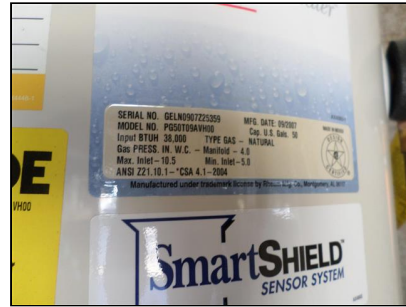
.At the time of the inspection, the Inspector observed no deficiencies in the condition or operation of the water heater.

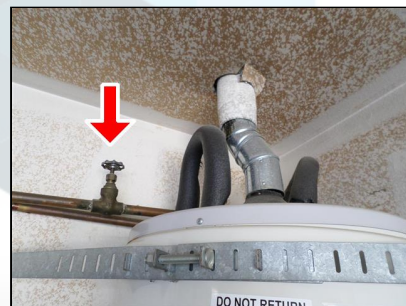
7.4 Item 3(Picture) Shut-off

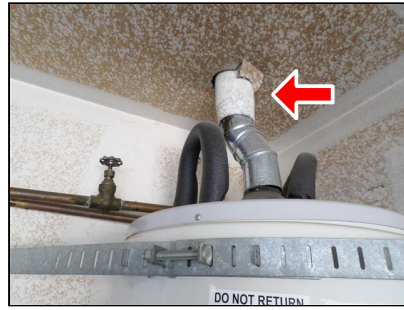
7.4 Item 4(Picture) Possible asbestos

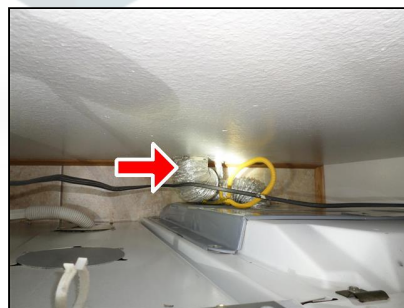
7.5 Item 2(Picture) Shut-off for dryer

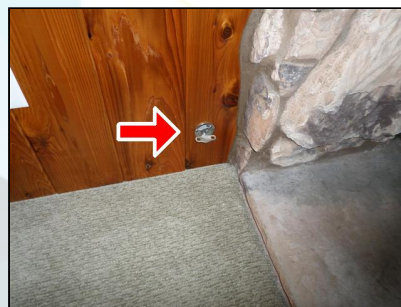
8.0 Item 1(Picture) Shut-off

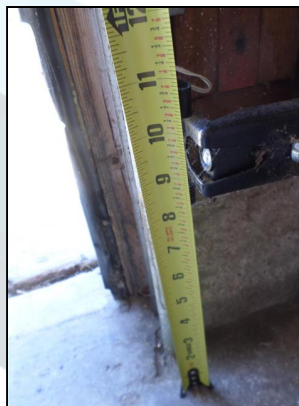
9.0 Item 1(Picture) Sensor too high

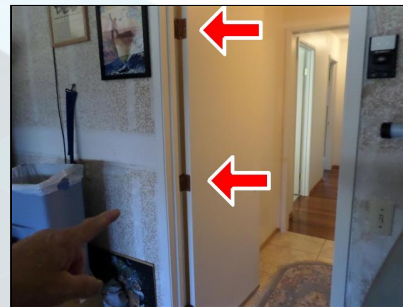
9.5 Item 1(Picture) Not self-closing

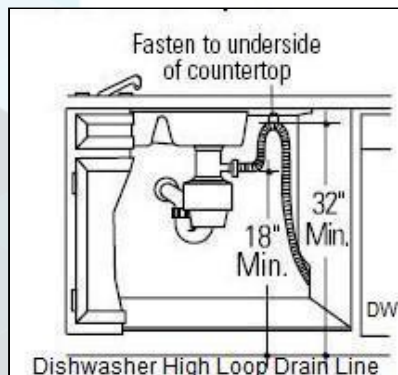
12.13 Item 1(Picture) High loop
