# Property Inspection Report

## Smelly HomeBuyer

**Property Address:**  
123 Bobs-a-Troll Lane  
Knoxville FL

<b>Date:</b> 11/7/2015	<b>Time:</b> 09:00 AM	<b>Report ID:</b>
<b>Property:</b> 123 Bobs-a-Troll Lane Knoxville FL	<b>Customer:</b> Smelly HomeBuyer	<b>Real Estate Professional:</b>

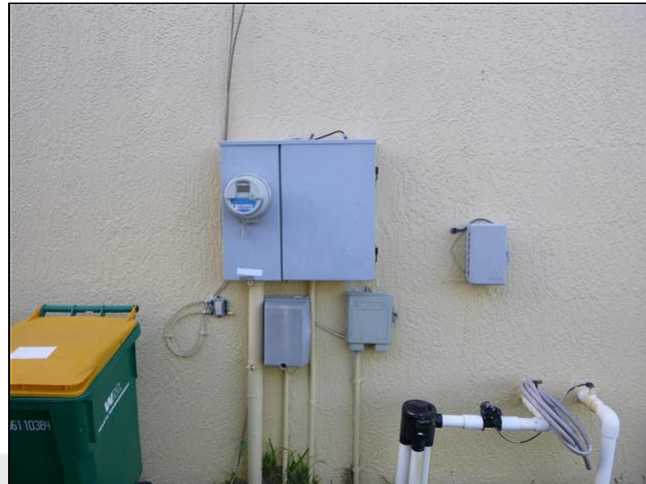
2.0 Item 1(Picture)

Image(s) show shut off location.

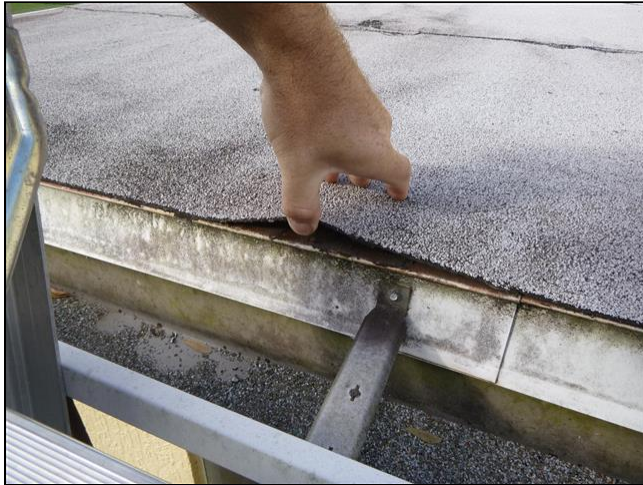
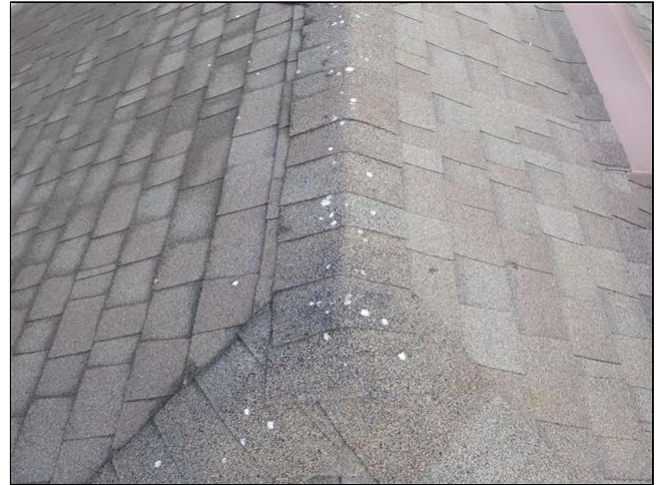
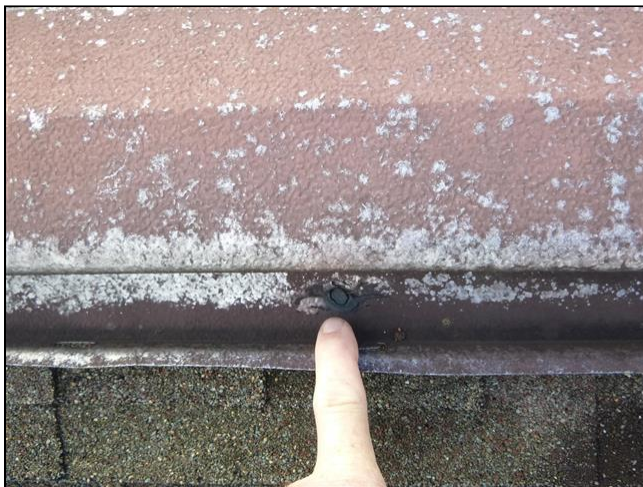
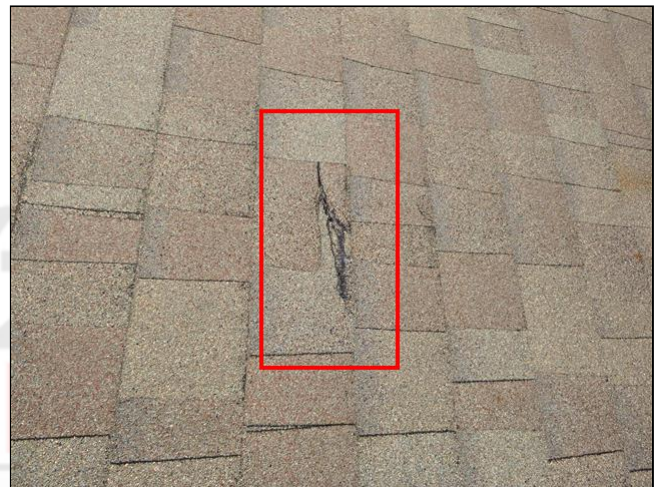
3.1 Item 1(Picture)

(1) The exposed nails in the ends of the ridge caps need sealing to prevent leaks.

Inspection of the roof found areas where general maintenance and sealing are recommended. Some visible wear along ridge areas was also noted. Any places where nails or roof penetrations are found should also be properly sealed.

Lower edges at the back roof and other areas were also starting to separate. A roofing professional can review and perform repairs.

(1) The exposed nails in the ends of the ridge caps need sealing to prevent leaks.

1. Inspection of the roof found areas where general maintenance and sealing are recommended. Some visible wear along ridge areas was also noted. Any places where nails or roof penetrations are found should also be properly sealed.

Lower edges at the back roof and other areas were also starting to separate. A roofing professional can review and perform repairs.

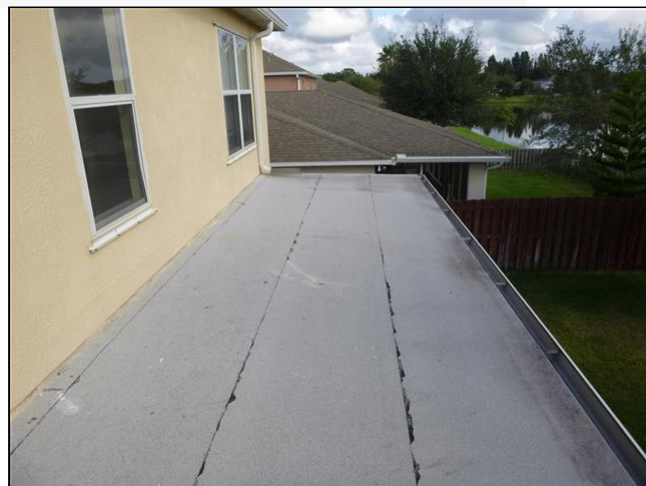
3.1 Item 5(Picture)

(2) The back porch roof was serviceable, but was showing signs of wear. Adding a specialty seal coat to this system will prolong the life of the system, and prevent leaks.

2. (2) The back porch roof was serviceable, but was showing signs of wear. Adding a specialty seal coat to this system will prolong the life of the system, and prevent leaks.

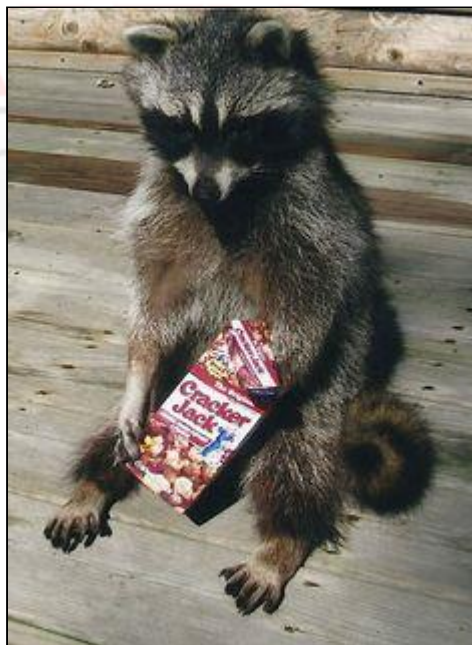
4.4 Item 1(Picture)

A racoon was found on the back deck eating a box of cracker jacks. Said he lived next door and was just visiting.

We suggest you get trash cans with locking lids just in case. Guy looks suspicious.

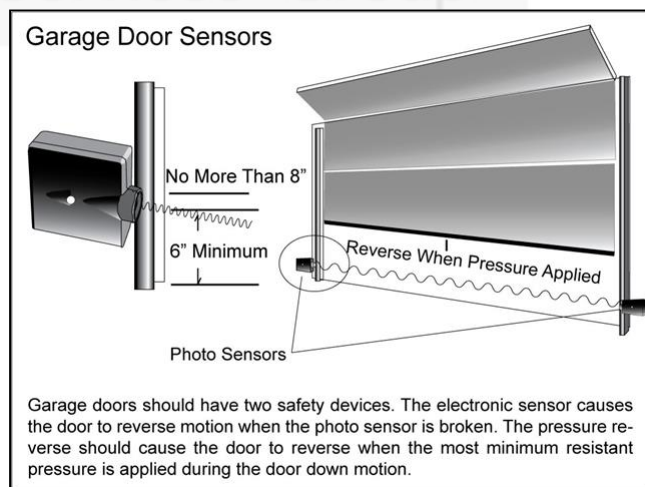
5.6 Item 1(Picture)

(1) The electronic safety sensors on each side of the garage door exceed the minimum 6 inch height. Objects in the doors closing path may not trip the sensors. We suggest for safety you lower them to the manufactures recommended height.

3. (1) The electronic safety sensors on each side of the garage door exceed the minimum 6 inch height. Objects in the doors closing path may not trip the sensors. We suggest for safety you lower them to the manufactures recommended height.

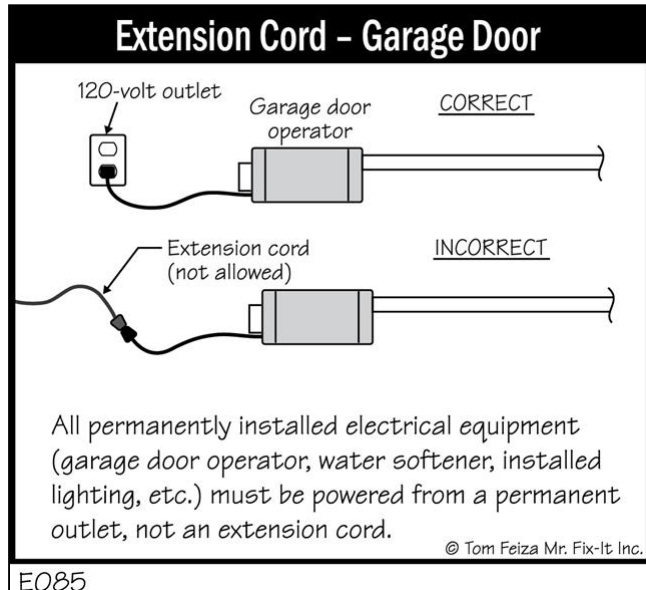
5.6 Item 2(Picture)

(2) Temporary wiring or extension cords were used to supply power to the garage door motor(s). It is recommended you have the wiring corrected and permanently install electrical outlets for all garage door motors.

4. (2) Temporary wiring or extension cords were used to supply power to the garage door motor(s). It is recommended you have the wiring corrected and permanently install electrical outlets for all garage door motors.

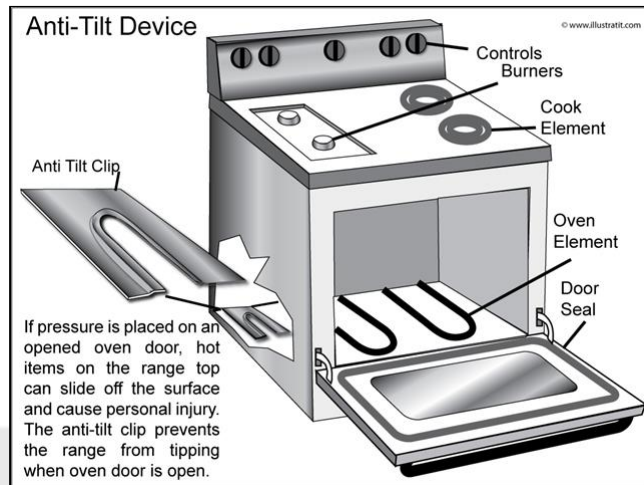
7.1 Item 1(Picture)

There is no anti tip bracket installed for the stove. These are required by the manufacturer to prevent the stove from tipping over onto small children. A bracket should be retro-fitted if you have small children.

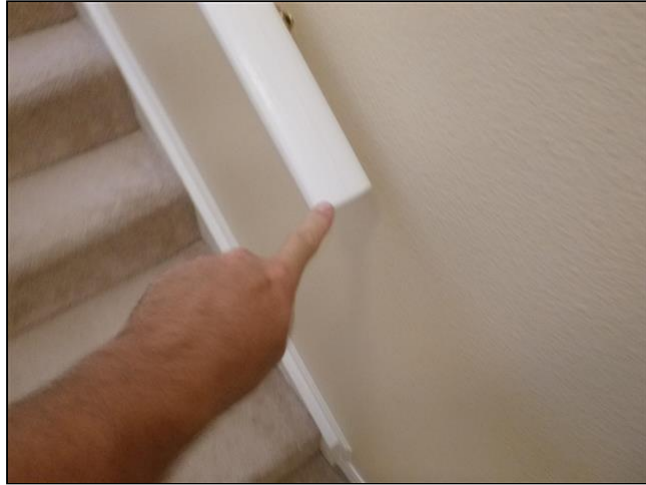
8.8 Item 1(Picture)

Handrails for the stairwell were missing what is called a return. ( as seen in image) A return prevents objects or clothes from becoming caught or hung on the ends of the railing, which could cause personal injury.

9. Handrails for the stairwell were missing what is called a return. ( as seen in image) A return prevents objects or clothes from becoming caught or hung on the ends of the railing, which could cause personal injury.

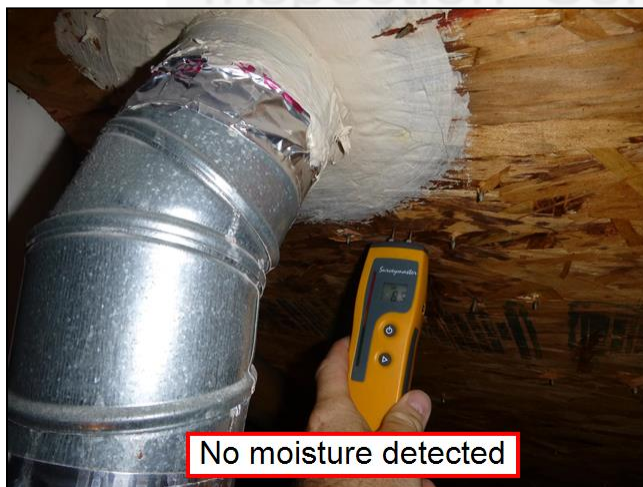
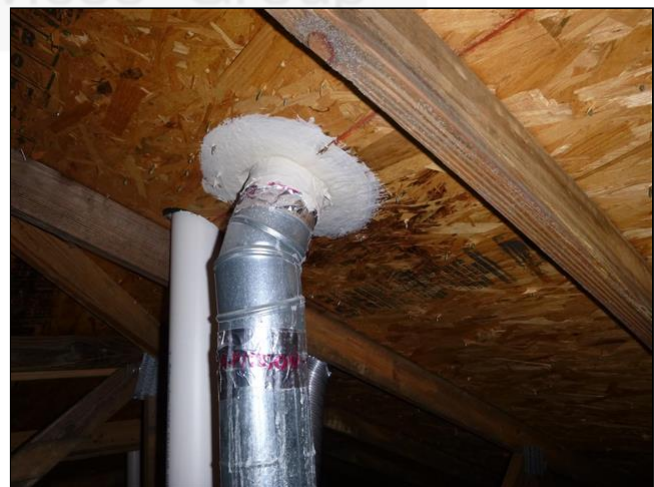
9.1 Item 1(Picture)

A stain was noted around the dryer vent pipe in the attic space. This area was tested and found dry, which may indicate an old leak.

We recommend monitoring this area during the next heavy rain for possible issues.

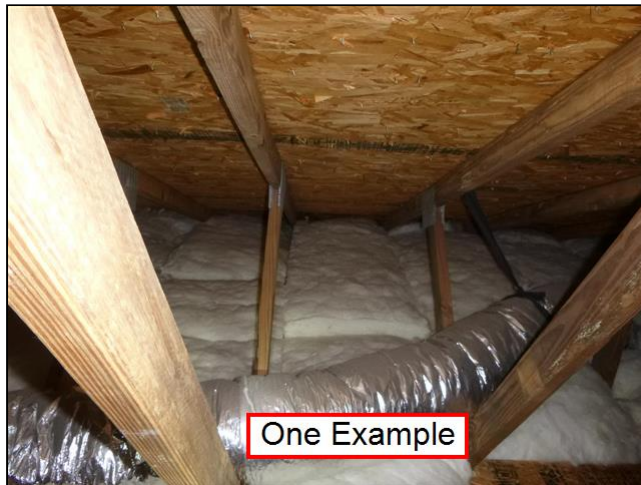
9.2 Item 1(Picture)

Soffit vents had been blocked by insulation. Ventilation in the attic was poor and should have improvements made. This will promote air circulation to keep the attic space cooler and prolong the life of the shingles.

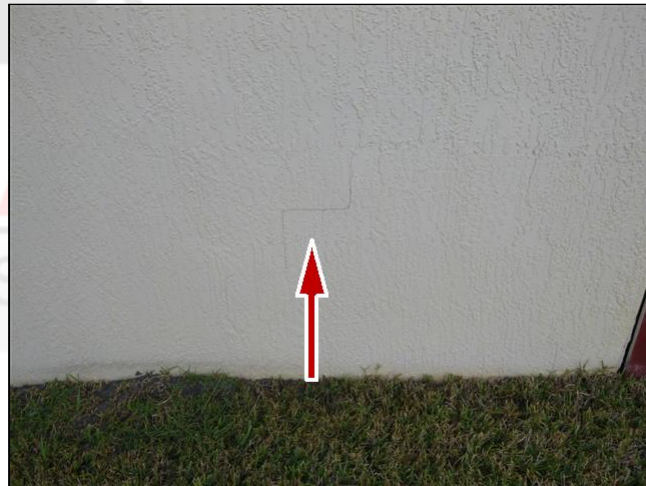
10.2 Item 1(Picture)

Common settlement or shrinkage cracking was noted at the back right corner. Patching/sealing and repairs recommended.

12. Common settlement or shrinkage cracking was noted at the back right corner. Patching/sealing and repairs recommended.

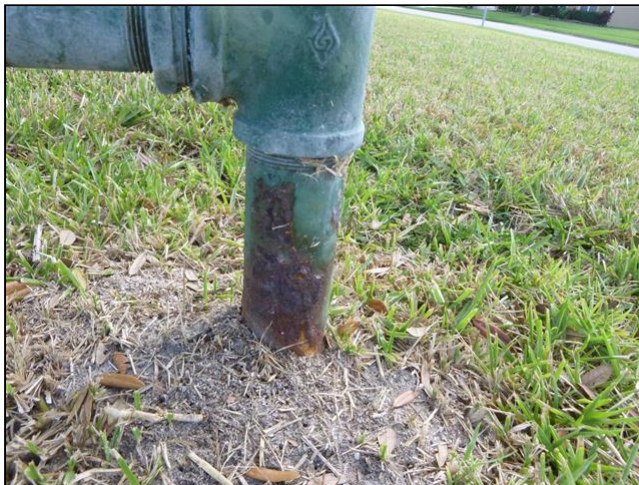
11.1 Item 1(Picture)

The main well casing was showing corrosion or scaling. Maintenance is needed to prevent pipe rot.

13. The main well casing was showing corrosion or scaling. Maintenance is needed to prevent pipe rot.

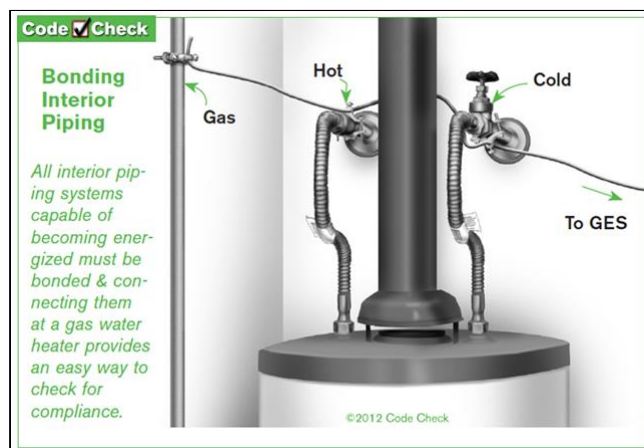
12.3 Item 1(Picture)

The clamp that bonds the plumbing system to the electrical could not be located. A tradesman should try and locate this, and if not present make needed repairs. Copper or metal plumbing supply systems should be bonded to the main electrical panel to prevent stray electrical issues from injuring occupants.

20. The clamp that bonds the plumbing system to the electrical could not be located. A tradesman should try and locate this, and if not present make needed repairs. Copper or metal plumbing supply systems should be bonded to the main electrical panel to prevent stray electrical issues from injuring occupants.

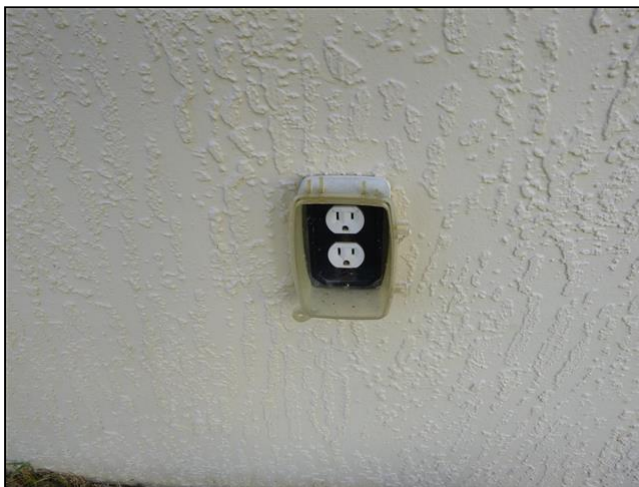
12.6 Item 1(Picture)

(1) Right side outlet was missing the weather cover.

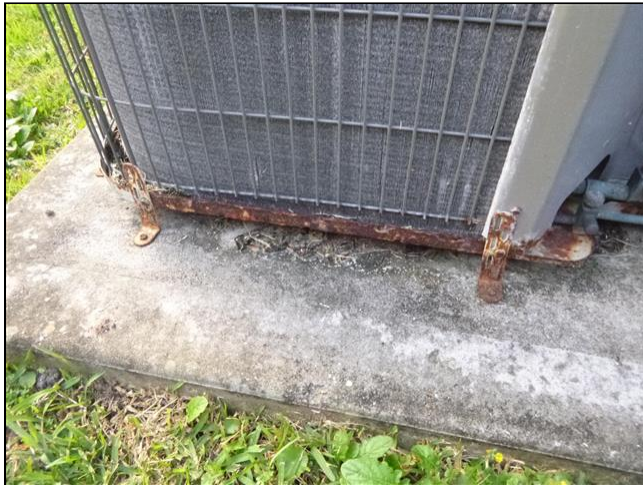
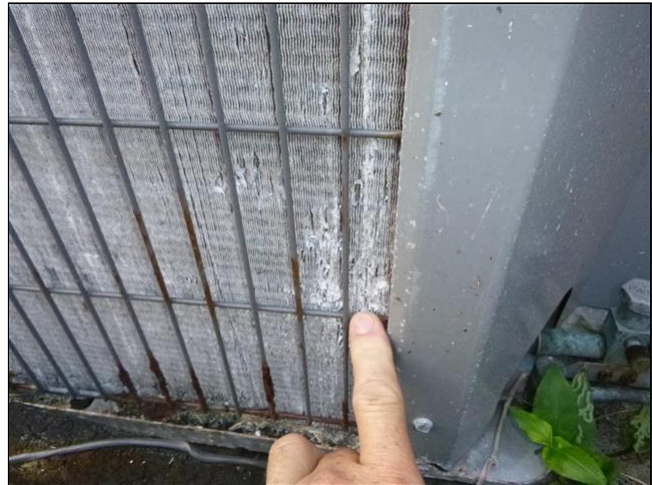
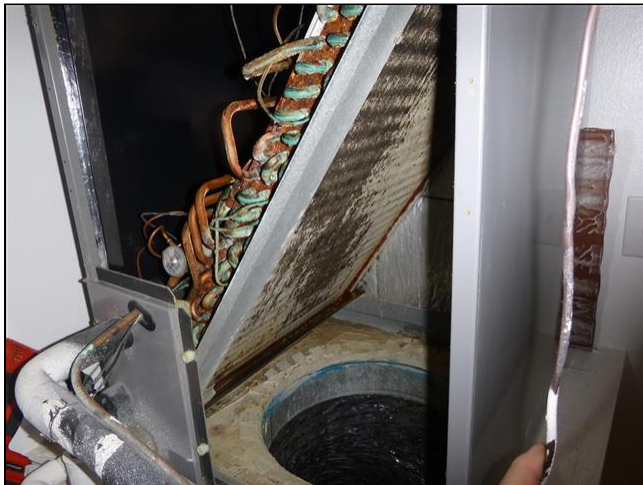
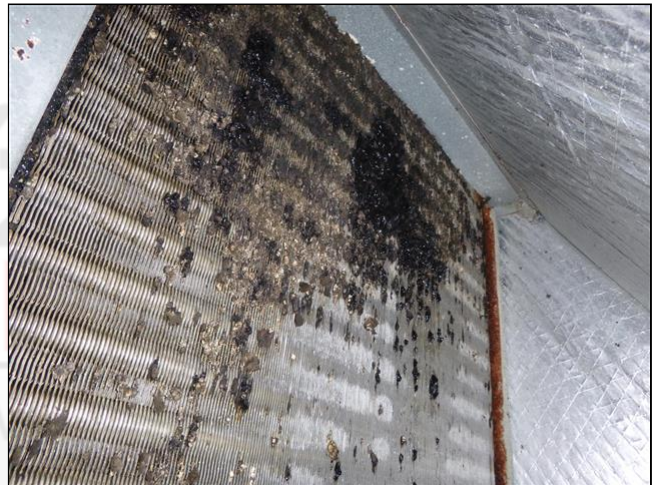
13.1 Item 1(Picture)

The irrigation system had been spraying the outside a/ compressors. This has caused rust or corrosion of the units themselves. While currently working, deterioration or rust will shorten the service life of the equipment. We cannot determine life remaining.

Inspection of the inside air handlers found coil build up or slime covering the coils. This will prevent air flow or reduce efficiency.

General cleaning and service of the equipment is recommended.

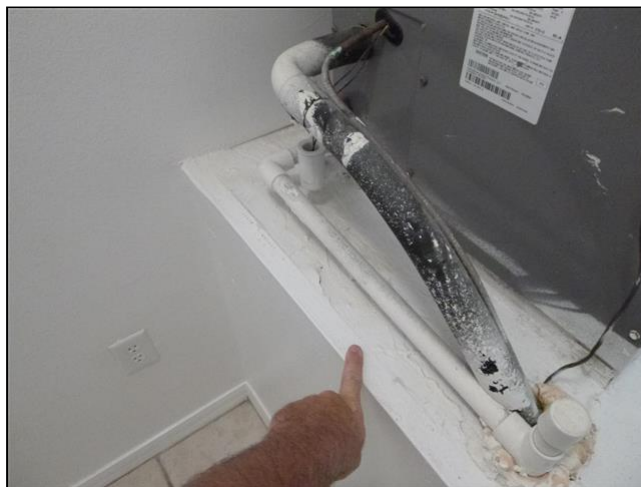
13.3 Item 1(Picture)

The plywood return cabinet had visible water damage from suspected past condensation clogs or leaking. Replacement of this lid is recommended when the unit is upgraded.

If you have allergy concerns, sanitizing or cleaning the entire return cabinet should also be a consideration.

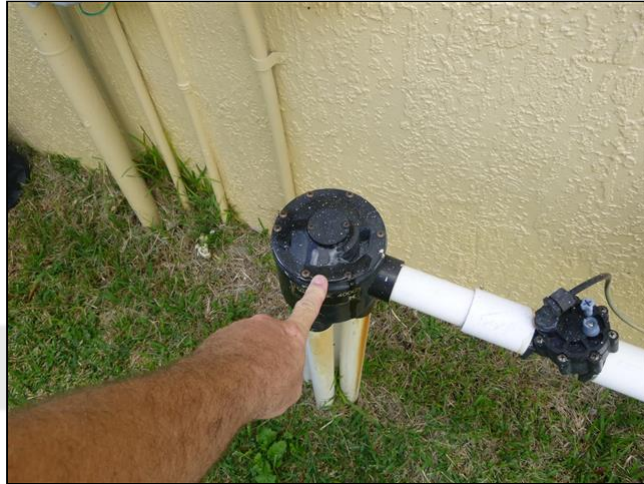
15.3 Item 1(Picture)

The main indexing valve was leaking at the top.

24. The main indexing valve was leaking at the top.
