PEACH Inspections

THE HOME INSPECTION REPORT

07100401B - Joe Client

123 Gromicko Road, Wayne, PA 19087

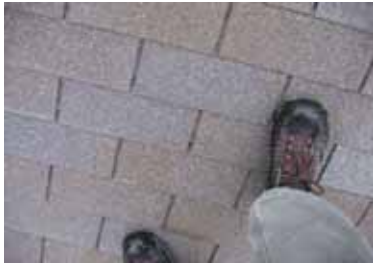
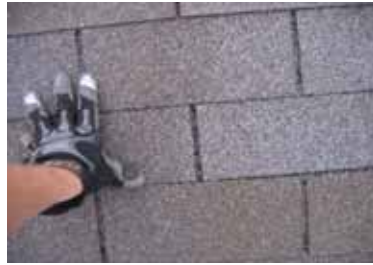
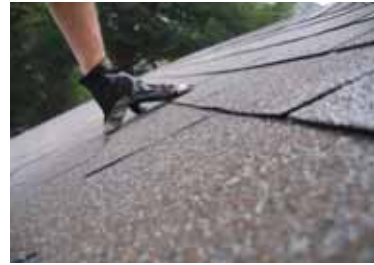
The exact age is undetermined. I would guess between 10 and 15 years. Ask seller about exact age and warranties.

The asphalt shingle roof covering appears to be in good, functional condition. No major material defects. No major cracked, damaged, or missing shingles. Good. But this is not a guarantee against leaks in the future.

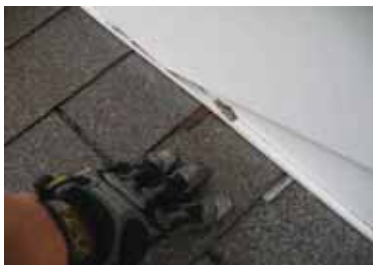
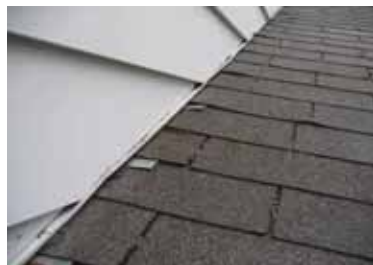
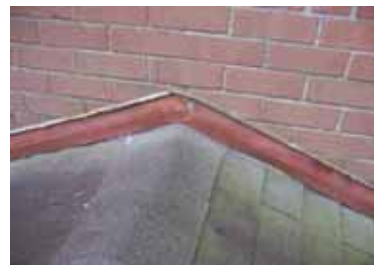
The flashing around each vent stack pipe is in poor condition. Cracked, damaged. Repair is needed.

CORRECTION AND FURTHER EVALUATION RECOMMENDED:

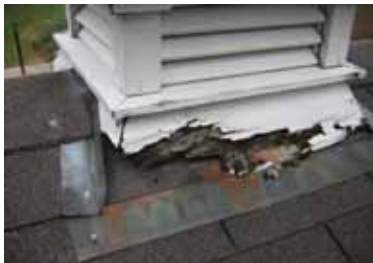
There's rot on the cupola.

IMPROVEMENT AND REPAIR RECOMMENDED:

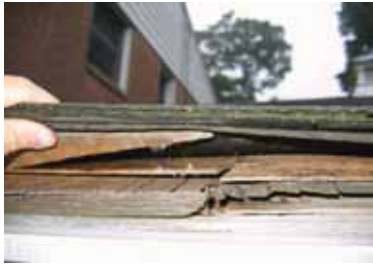
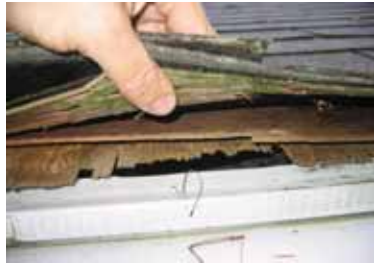
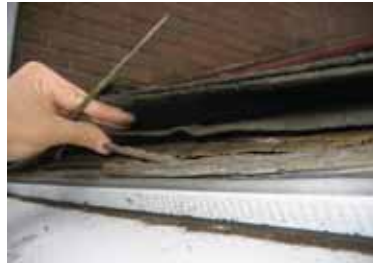
There is delamination of the plywood decking under the shingles, at the drip edges. Found at the garage roof. It is caused by water and missing drip edge flashing.

CORRECTION AND FURTHER EVALUATION RECOMMENDED:

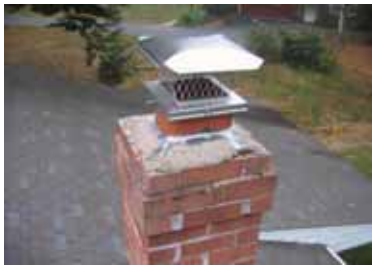
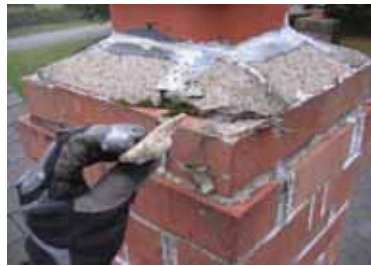
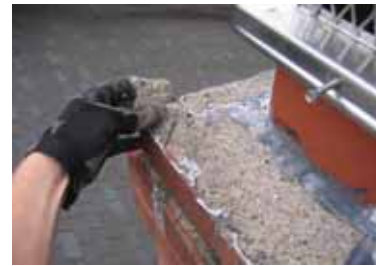
The chimney is a terra-cotta, clay tile lined masonry type. A clay conduit installed inside of a chimney, intended to contain the combustion products, direct them to the outside atmosphere, and protect the chimney walls from heat and corrosion. We recommend getting a professional cleaning and inspection of the interior flue liner to determine if the flue is safe to use. We do not inspect interior flues.

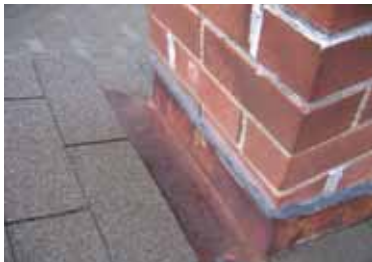
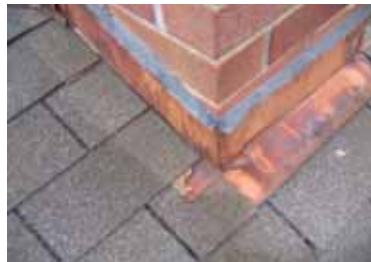
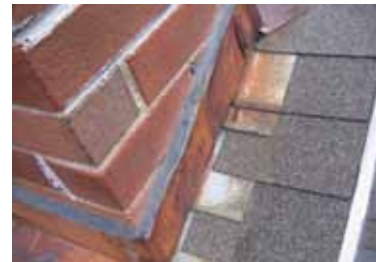
Chimney Flashings

A representative number of areas of chimney flashing were inspected. There is visible metal flashing installed around the chimney, where the chimneystack intersects the roof covering material.

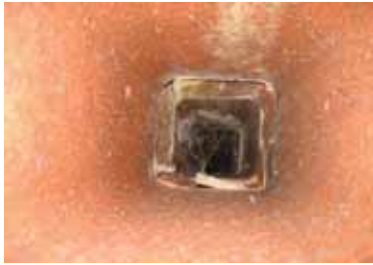
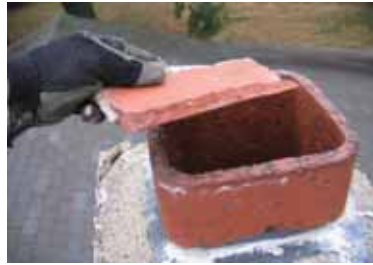
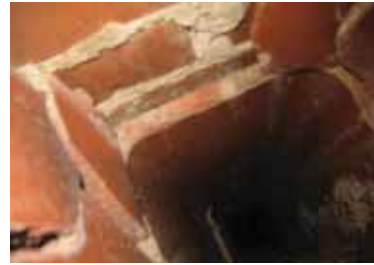
There is damage to an interior flue liner section. Visible from the top of the stack. Potentially hazardous. The liner appears cracked and damaged. Missing piece. Correction and further evaluation by a certified chimney sweep is recommended. Major repairs likely.

CORRECTION AND FURTHER EVALUATION RECOMMENDED:

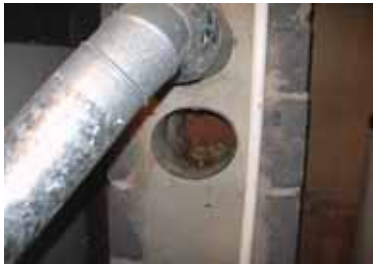
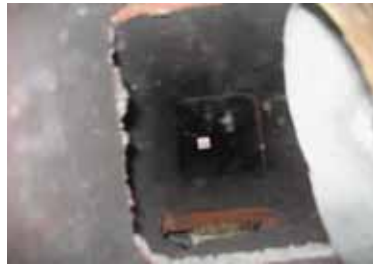
Clean Out

The clean-out door is functional and appears to be relatively clean.

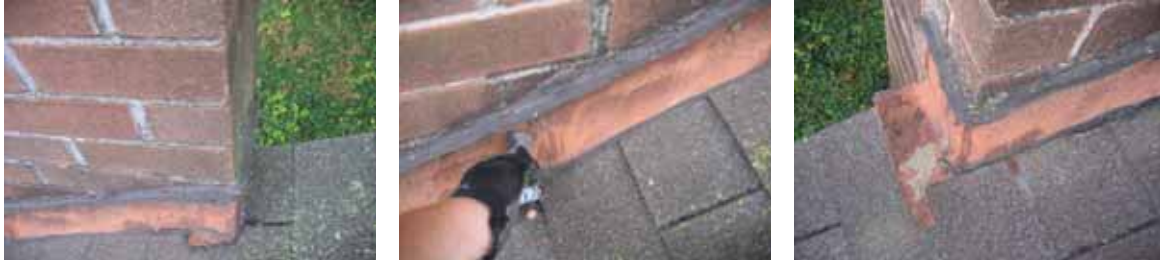
Chimney Flashings

A representative number of areas of chimney flashing were inspected. There is visible metal flashing installed around the chimney, where the chimneystack intersects the roof covering material.

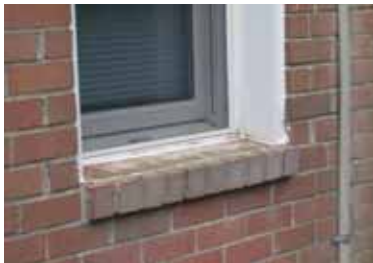
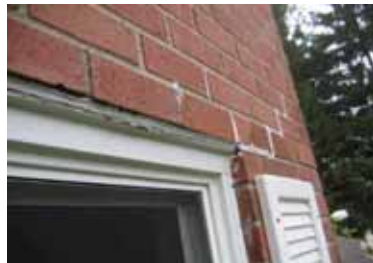
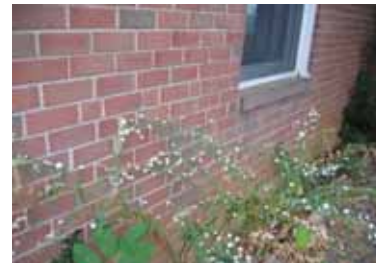
I moved around the structure exterior several times, inspecting the brick exterior of the house. Checked for loose bricks or mortar joints, missing pieces, damaged sections, deterioration, or failure. This inspection does not include determining whether the siding has been installed to code, rule, or manufacturer's recommendations.

The brick exterior covering appears functional. No major damage or deterioration apparent.

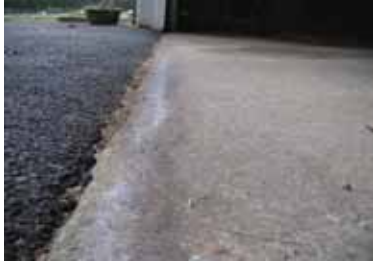
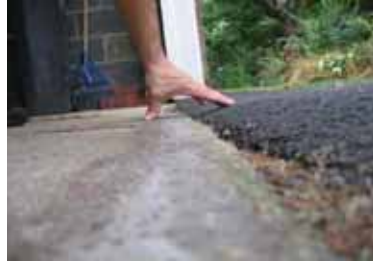
The driveway may direct water towards the garage door, since the driveway is higher than the concrete floor.

MONITORING RECOMMENDED:

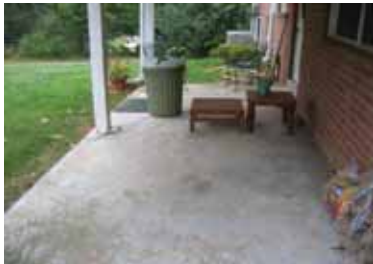
Cracked masonry.

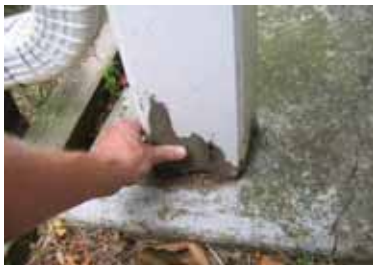
Wood rot at the porch post.

CORRECTION AND FURTHER EVALUATION RECOMMENDED:

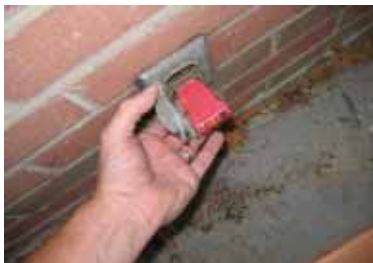
None of the exterior receptacles are testing as being GFCI-protected.

CORRECTION AND FURTHER EVALUATION RECOMMENDED:

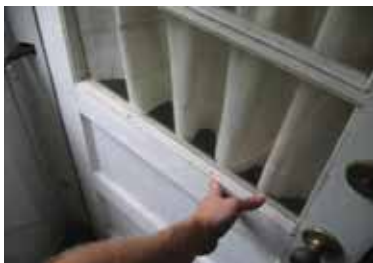
The finish on the rear door is weathered, and should be refinished or monitored.

IMPROVEMENT AND REPAIR RECOMMENDED:

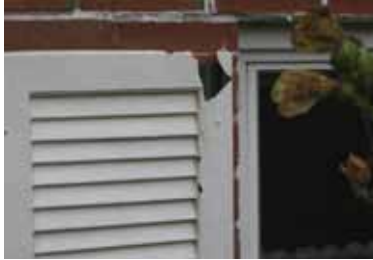
Damaged shutter in front.

IMPROVEMENT AND REPAIR RECOMMENDED:

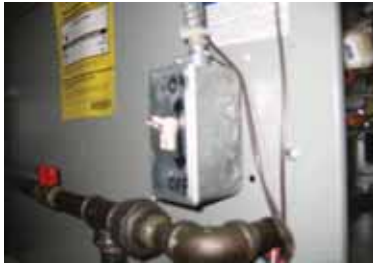
Electric shut-off switch

There is an electrical shut-off switch located on the side of the heating system.

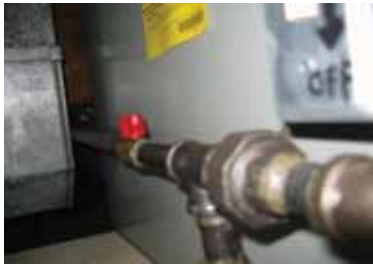
Gas shut-off valve

There is a gas shut-off valve near the heating system. Good.

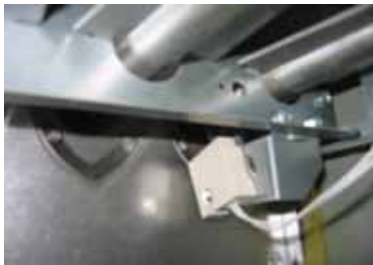
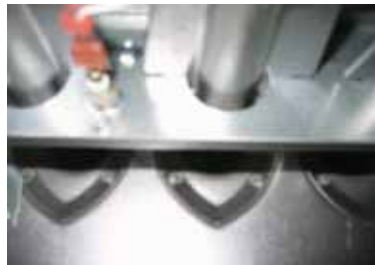
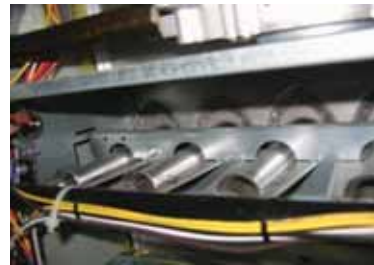
Gas Burners

The gas burners of the heating system appear relatively clean. Good.

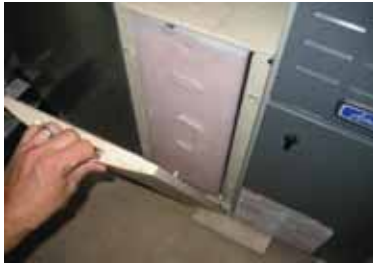
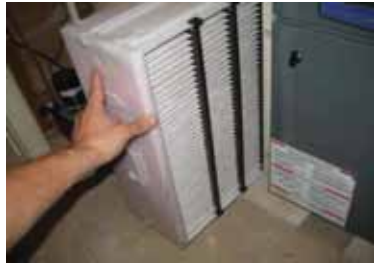
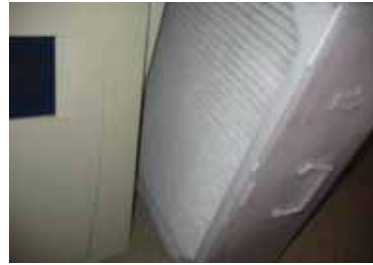
Air filter

The air filter is high-efficiency and apparently clean.

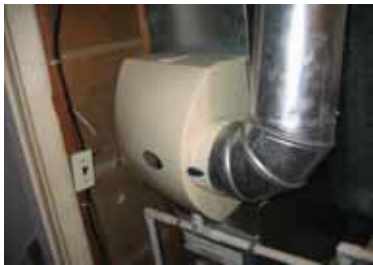
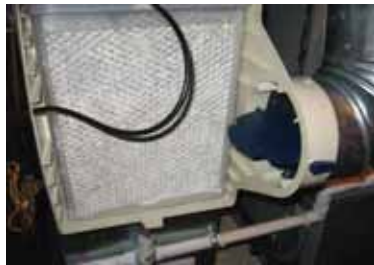
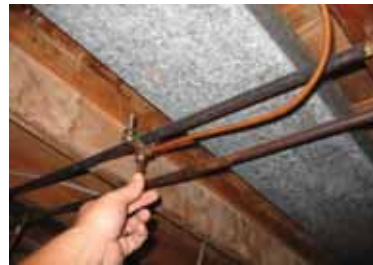
Humidifier

The by-pass humidifier needs to be serviced and cleaned every year. In the wintertime, when not in use, turn off the water valve, shut the damper closed, and turn off the humidity level control.

The humidifier appears functional. Good.

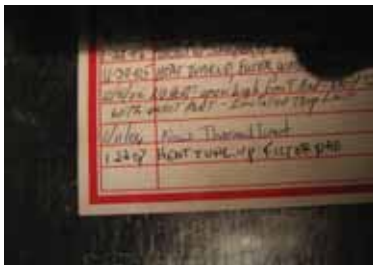
Service record

The last time the heating system was service has been recorded. Dated in 1/22/07. The heating system should be serviced every year.

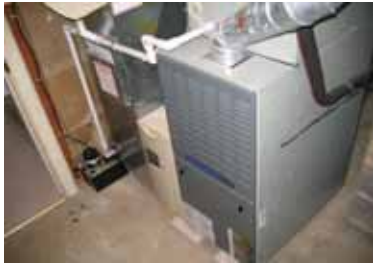
Estimated Age

The estimated age of the heating system is a few years old. With estimated 15 years of service life expected.

The average life expectancy is estimated from 15 to 25 years. Any system that is 15 years or older should be closely maintained, and budgeting for a replacement is recommended.

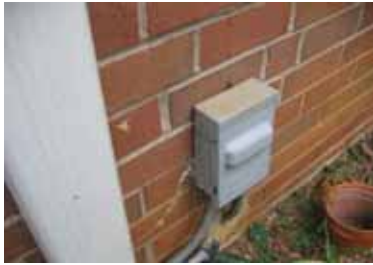
Electrical Disconnect

There is an electrical disconnect near the exterior condenser unit.

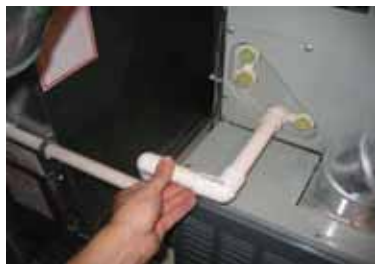
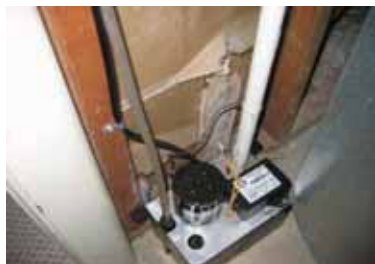
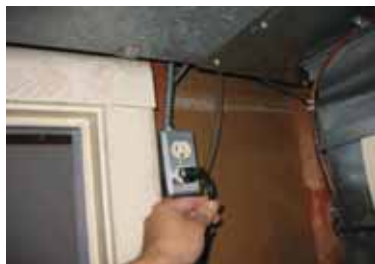
Condensate Drainage

The condensation drains from the unit to a condensate pump. Appears to be functional.

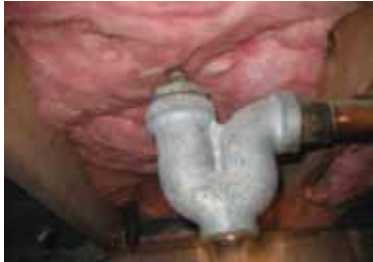
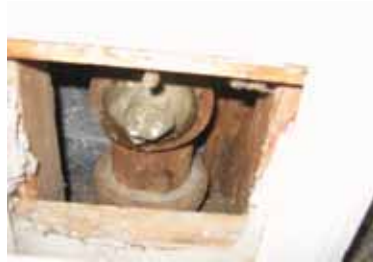
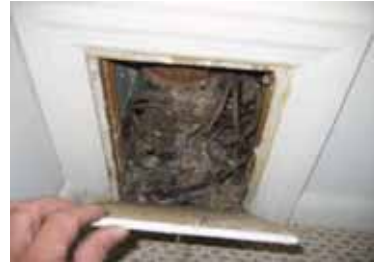
Drain Waste Vent Pipes Type of Material

Visible drain pipes are made of copper.

Not all of the drain pipes were readily visible. Much of the pipes are inside the walls.

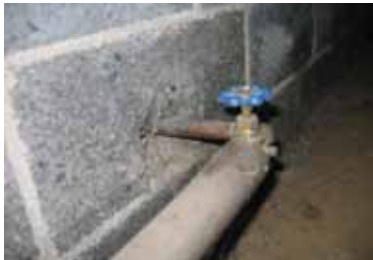
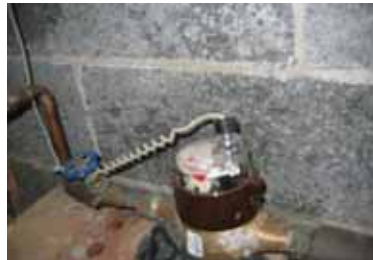
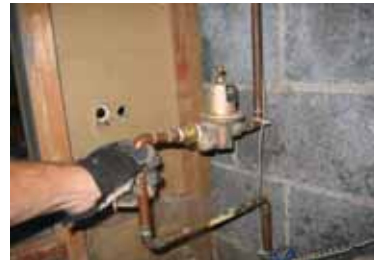
Public Water Supply Main Water Shut-off Valve

The main water shut-off valve is located in the crawlspace.

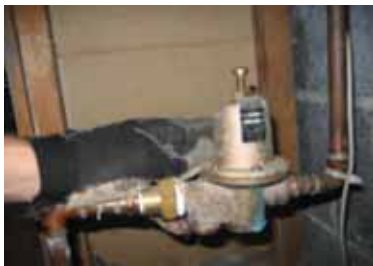
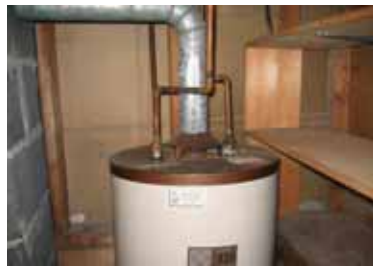
There is a pressure regulator installed on the main water supply line coming into the house. This regulator has a valve that prevents water from pushing back out to the street, and makes the plumbing system a closed water system. When the water heater makes hot water, the water in the system expands. The expansion of the warm water increases the pressure on the homes water pipes. An expansion tank installed on the water line would absorb the extra pressure. There isn't one installed through. The relief valve on the water tank may start to drip, because of the lack of an expansion tank. The action of the expansion tank also reduces knocking of the pipes, and wear and tear on the faucets and shut-off valves in the home. We recommend installing an expansion tank.

CORRECTION AND FURTHER EVALUATION RECOMMENDED:

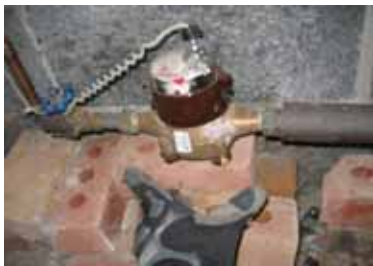
A jumper cable over the water meter is needed. It is part of the electrical bonding system. The electrical panel is bonded to the water line. So a jumper cable over the meter is necessary.

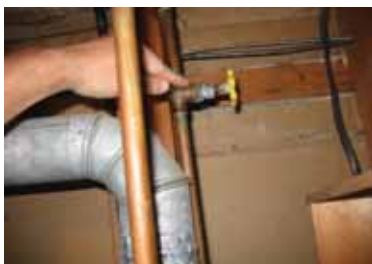
Water Shut-Off Valve & Connectors

The water shut-off valve to the water heater tank is installed. Not leaking.
This valve turns off the cold water supply to the tank. Good.

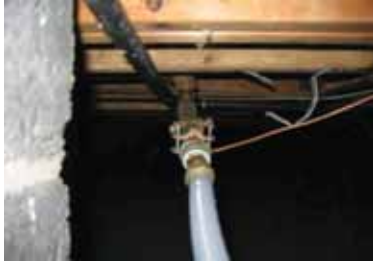
Gas Shut-Off Valve

The gas shut-off valve at the water heater is installed within reach of the tank. This valve turns off the gas supply to the tank. Good.

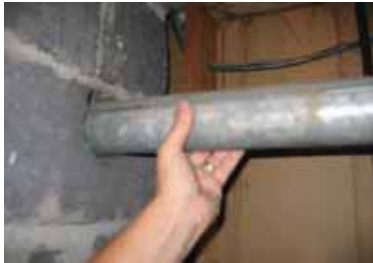
Vent Pipe

The vent pipe has pipe connections that are loose - not screwed securely - potential hazard. And it is not sealed well where the pipe penetrates the chimney.

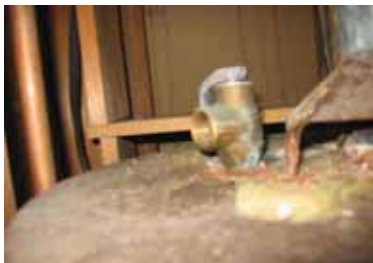
Relief Valve & Discharge Pipe

The pressure relief valve on the water heater does not have a discharge pipe. One should be installed that terminates within six inches of the floor. For safety.

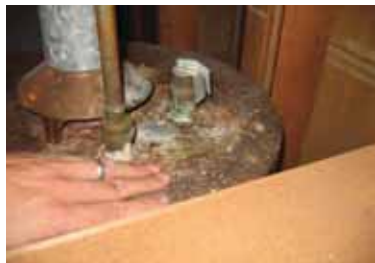
There are rusty water marks and water damage on top of the water heater. Which is an indication of a failure or prior water leak possibly.

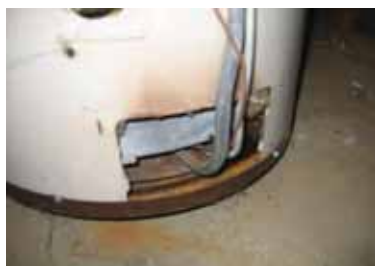
There are scorch marks on the hot water tank. Indicating a prior hazardous situation. Further evaluation by a plumber is recommended. Ask seller about the tank.

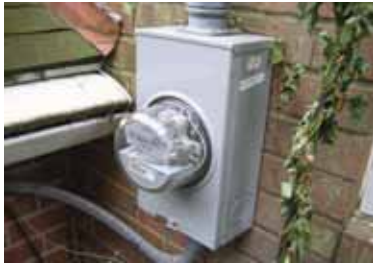
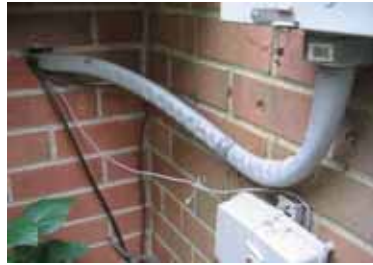
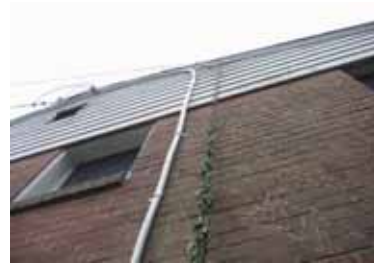
There is one electric meter.

The meter is located at the rear of the house.

The meter box exterior appears functional. No major rust or damage. Not loose. Good.

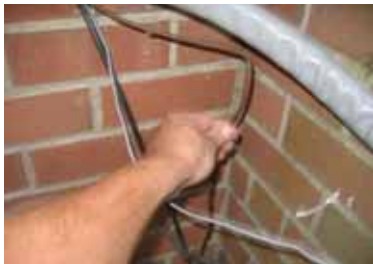
There is a grounding wire visible outside. Good.

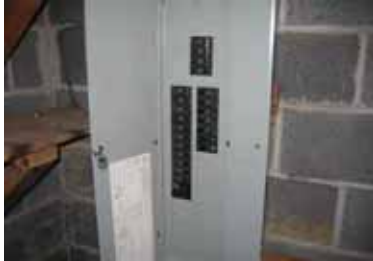
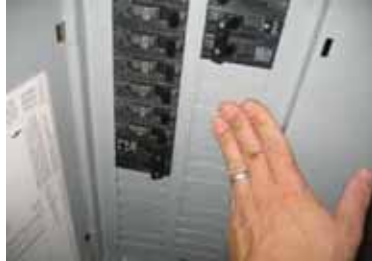
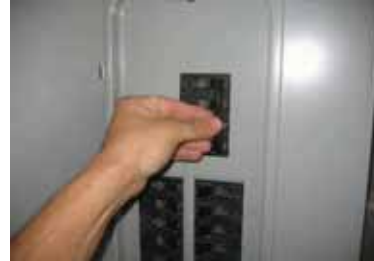
The main panel is located in the garage.

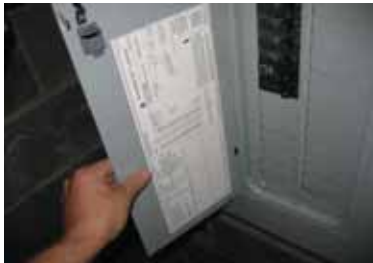
None of the breakers are labeled, and they should be.

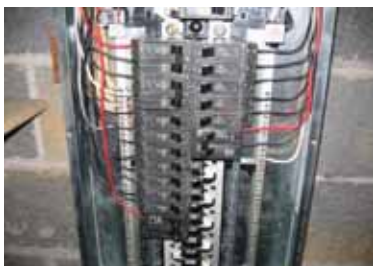
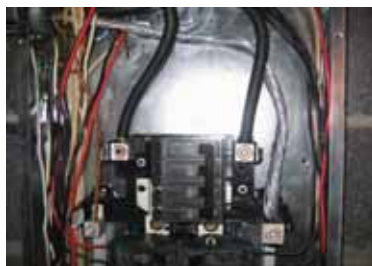
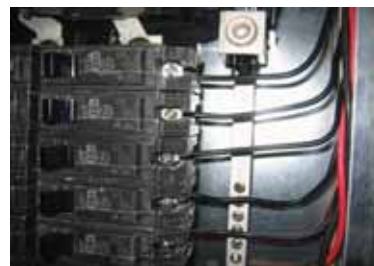
The residence has old, cloth-covered, tin-coated, wiring. Indication of the house's age.

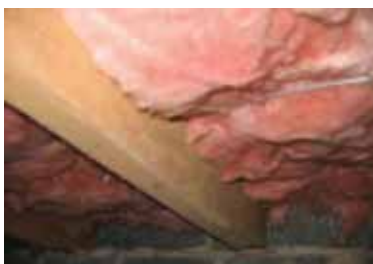
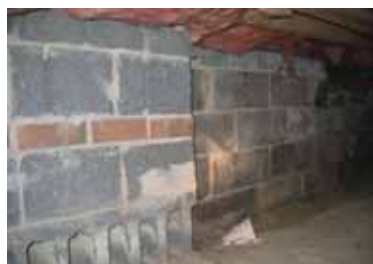
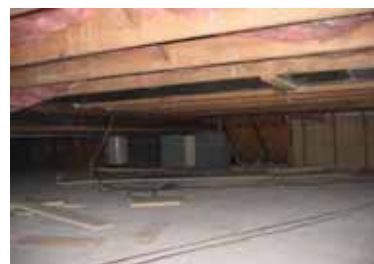
There's insulation hanging from the ceiling of the crawlspace. Inspection restriction - blocking components that I can not see. The crawlspace should be cleaned up for further inspection prior to closing.

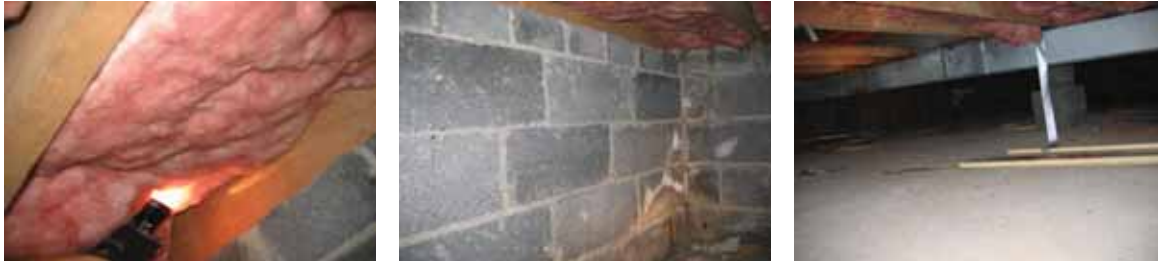
The floor joist dimension is 2 by 10s, 16 inches on center. Readily accessible areas were inspected.

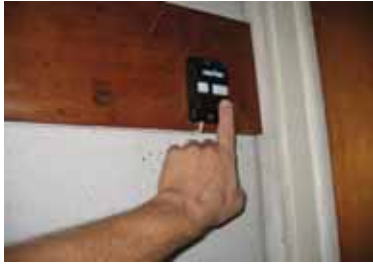
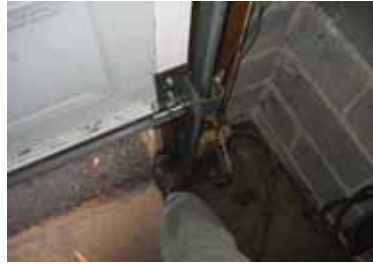
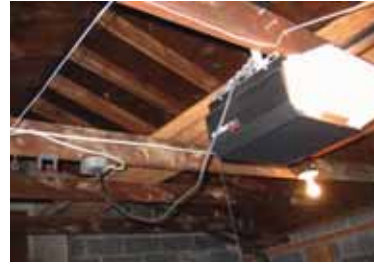
The garage door opener is functional. With functional infra-red sensors.

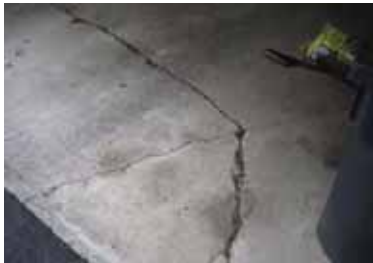
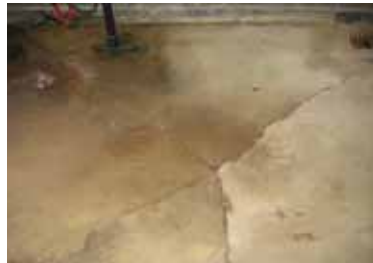
The slab floor is significantly cracked and uneven. Settled downwards.

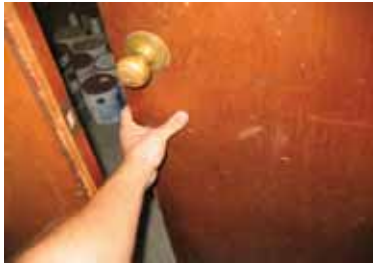
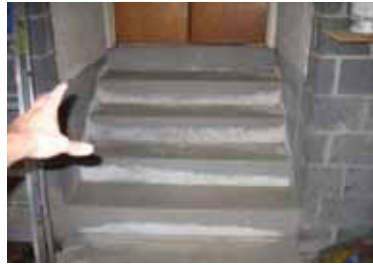
The garage door between the house and the garage is apparently hollow-core and required to be solid-core or metal, and fire-rated, to maintain the necessary firewall separation between a garage and the residence, and should be replaced.

The steps leading from the garage to the house have three or more risers and, as such, there should be a handrail installed.

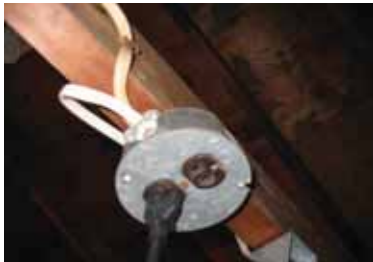
The receptacles in the garage should be upgraded to have GFCI or ground-fault protection, which is required by current standards and is an important safety feature.

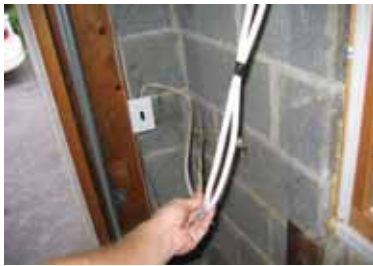
Loose electrical wires near front corner.

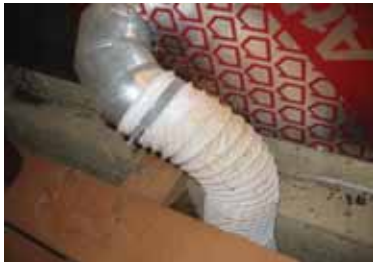
Faulty dryer vents have been responsible for thousands of fires, hundreds of injuries, and even deaths. The best vents are a smooth-walled metal type that travels a short distance; all other types should be regarded as suspect, and should be inspected bi-annually to ensure that they do not contain trapped lint or moisture.

The dryer vent is a flexible plastic type that traps lint more easily than a smooth metal type, which can compromise the performance of the dryer and can facilitate a fire. Replacing the vent pipe with smooth metal is recommended.

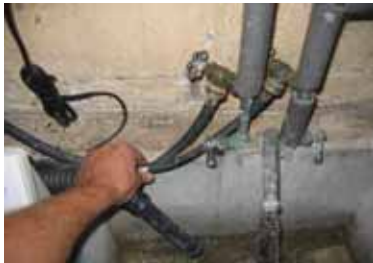
Rubber hoses should be replaced with more reliable ones - pressure-tested hoses. Such as stainless-steel, braided mesh hoses.

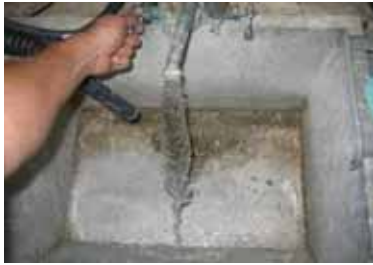
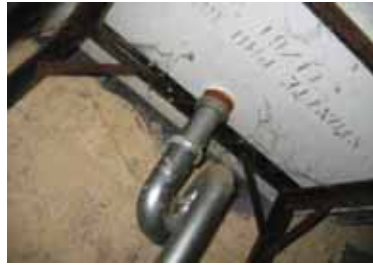
Tub has running water. No active leaks.

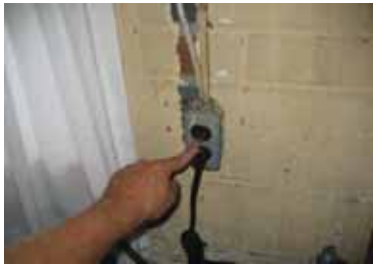
Missing GFCI protection at the electric receptacles near the tub.

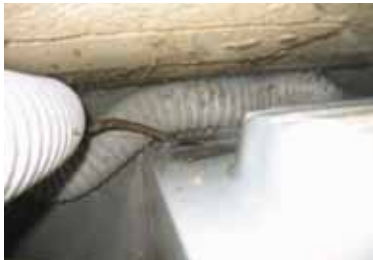
The dryer is hard-wired. There is no wall outlet to plug the dryer into. The electric line from the electric panel runs directly into the back of the dryer. There should be a wall outlet installed, so that the appliance can be safely unplugged if needed.

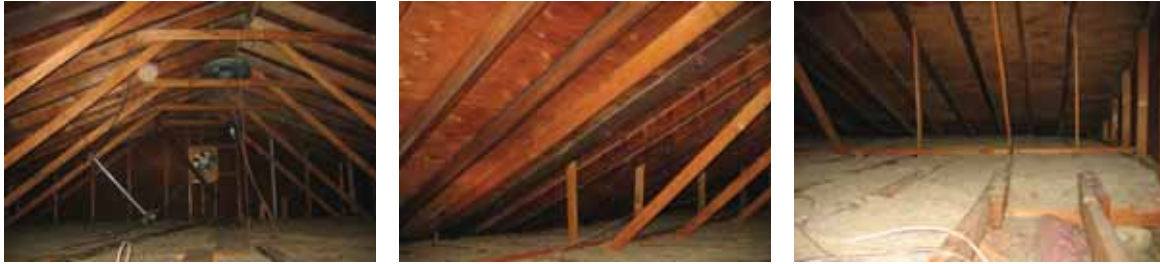
Unable to enter the attic space. Inspection restriction. Located above the upper bedrooms.

There is some flooring in the lower space. Not all of the attic is floored which restricts my inspection.

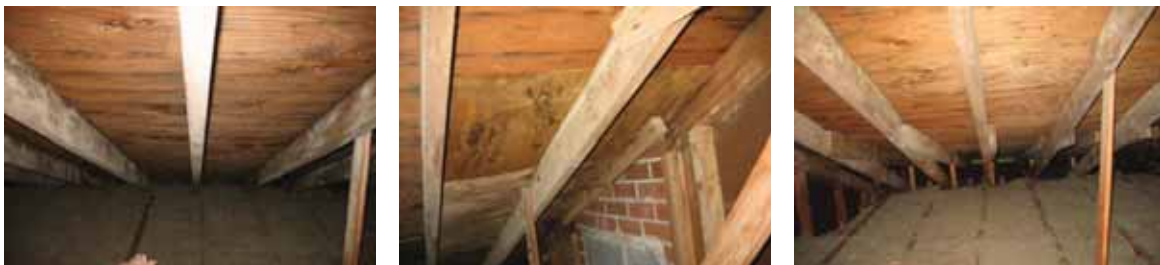
The house has had roof leaks in the past, indicated by the water marks or stains on the roof decking and components here and there. Visible from the attic space. This is commonly found in older homes. No major structural damage. Ask seller about prior roof leaks. Monitoring recommended.

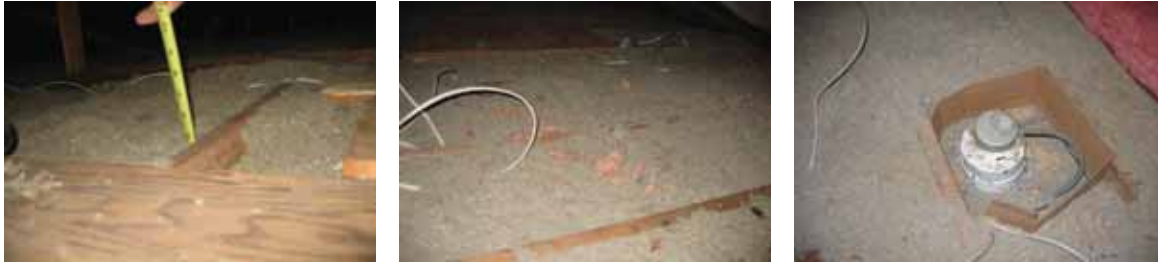
Cellulose insulation is installed. Cellulose building thermal insulation is a recycled product made from recovered newsprint, the largest single component of the residential waste stream in most communities.

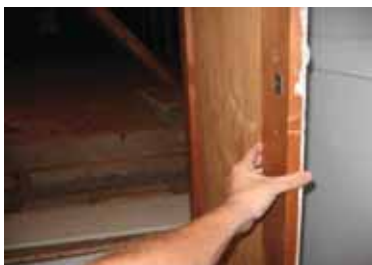
There is no insulation installed at the attic access door. Not an insulated door. According to the U.S. Department of Energy, an attic access that is not insulated is a big hole and deficiency in the thermal barrier between the attic and condition space. TRecommend adding insulation and weather stripping to the attic access door.

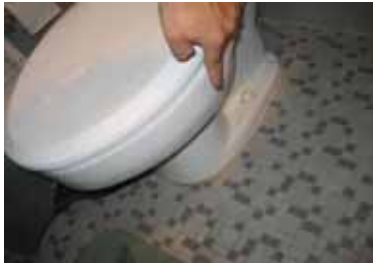
The master bath toilet wobbles. Not stable on the floor. May need to be pulled up to replace the wax seal.

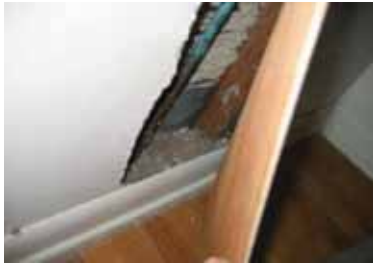
There is an access panel for the shower. Opened it. No active leaks. Good.

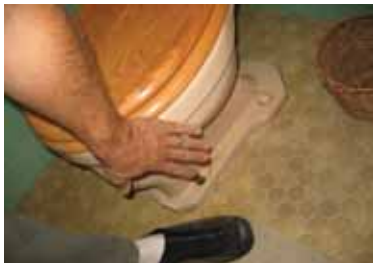
The 2nd floor toilet wobbles. Not stable on the floor. May need to be pulled up to replace the wax seal. Correction and further evaluation is recommended.

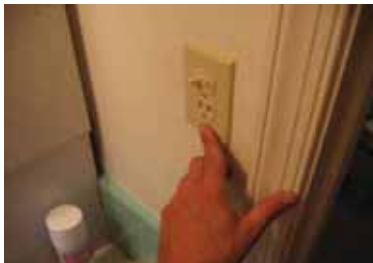
The receptacles in this 2nd floor bath are not protected by a functional GFCI (or ground fault circuit interrupter).

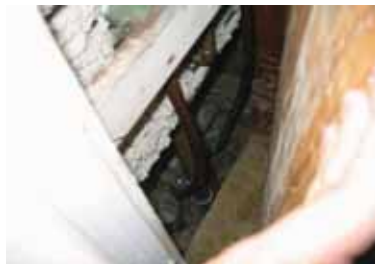
There is an access panel for the tub. It was opened. No water leaks. Good.

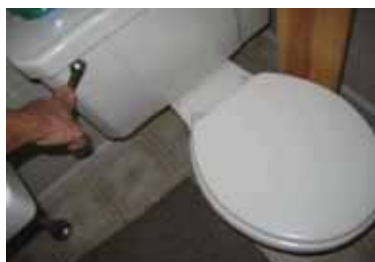
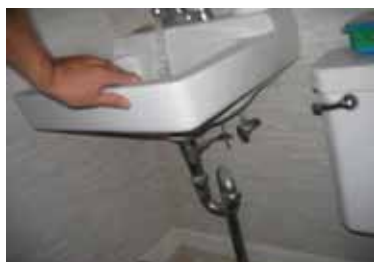
We inspected the 1/2 bathroom, and found no major defects. Toilet flushed a couple times. Sink drained.

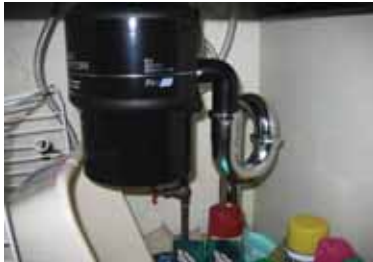
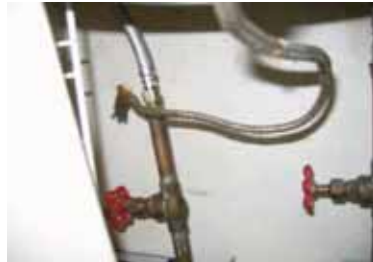
The sink faucet is functional. No active leaks seen.

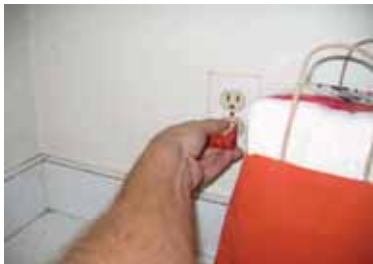
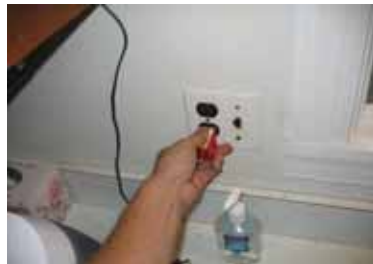
Missing GFCI-protection at the kitchen counter receptacles. All of the countertop and island receptacles should be upgraded to have ground fault GFCI protection, which is mandated by current standards and is an important safety feature.

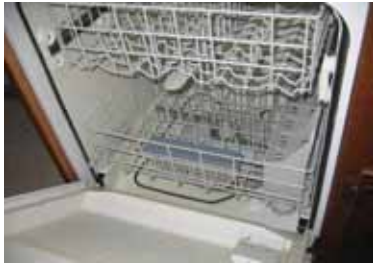
Ran a short cycle with no leaks. (This is no guarantee against future problems.)

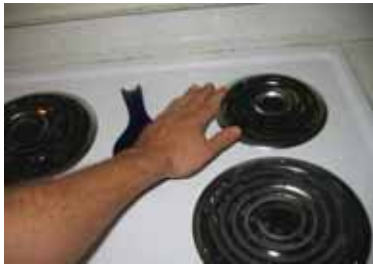
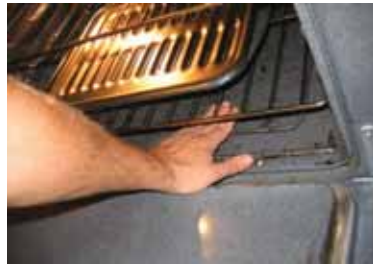
Electric stove elements are functional. Turned on and warmed up. Good.

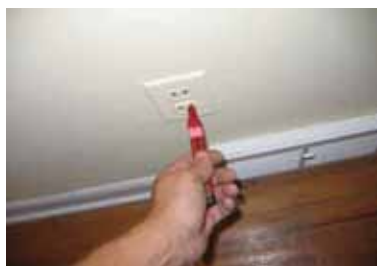
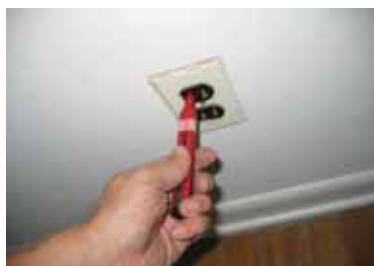
A representative number of readily accessible electrical wall outlets were tested. There are outlets that are not grounded. The receptacles are 2-prong receptacles, which have a hot and a neutral prong and wire connection, but not a grounding wire nor grounding wire connection. These older wall receptacles indicate older wiring in the house. They are still functional. However, if the fixture (lamp, TV, computer, etc.) needs a three-pronged receptacle (with a ground), then do not use the 2-prong receptacle.

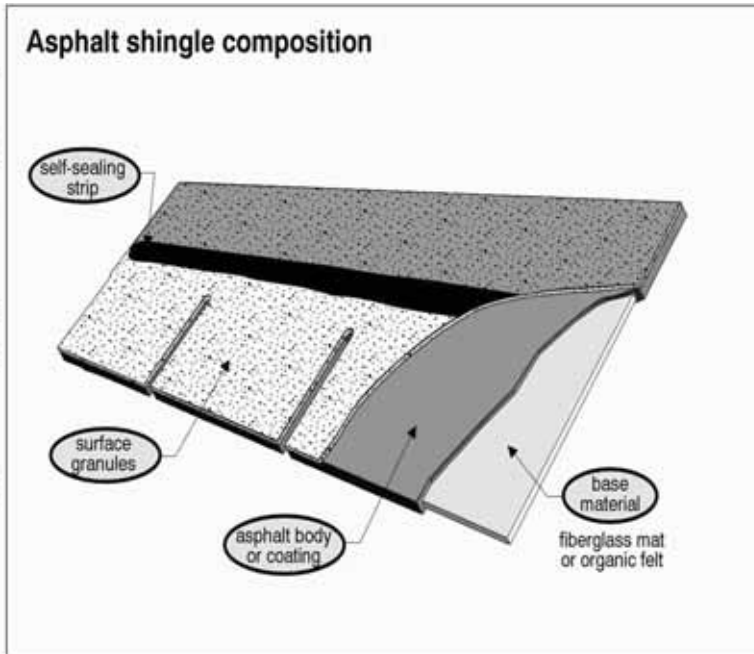
Illustration - 1 Asphalt Shingle Roof Installed - Illustration

The shingles are comprised of asphalt or fiberglass materials impregnated with mineral granules that are designed to deflect the deteriorating ultraviolet rays of the sun. The most common of these roofs are warranted by manufacturers to last from fifteen to twenty-five years. The actual service life of the roof will vary, depending on a number of interrelated factors including the quality of the material and the method of installation. Regular maintenance will certainly extend the life of any roof.

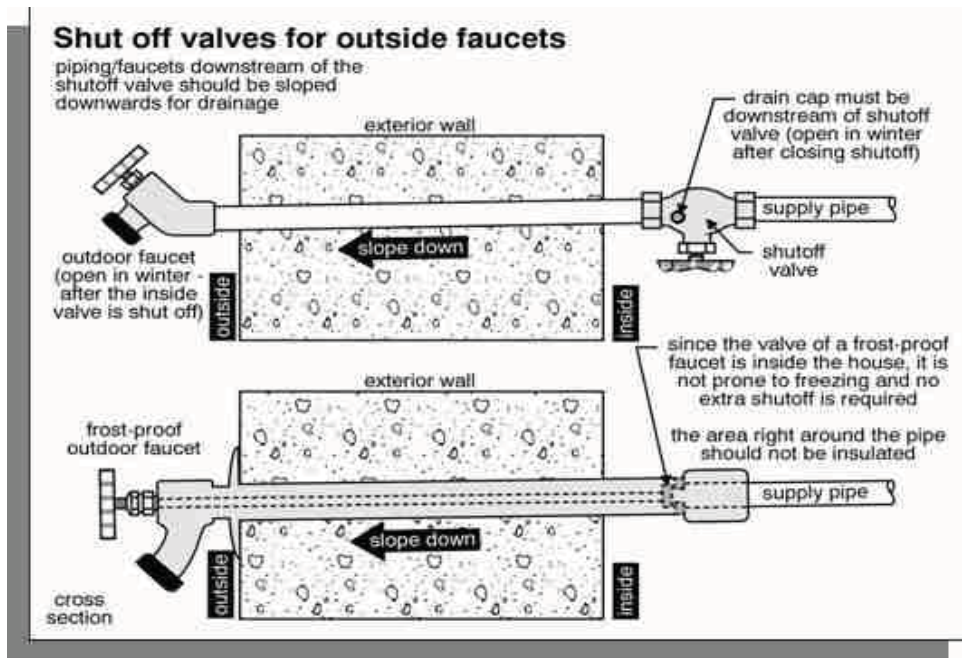
Illustration - 4 Not frost-free

The faucet is not frost-free. Consider replacing the faucet with frost-free hose bibs. To prevent freeze-burst problems in the winter. Or be sure remove the hoses and drain the faucets before winter, to prevent freezing and bursting problems.

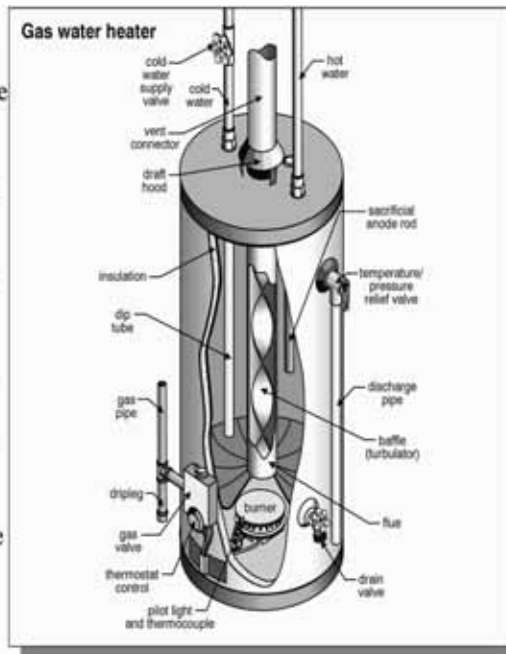
Illustration - 8 For Your Information - Gas Water Heater Tank

Water heaters can be dangerous if they are not equipped with a pressure/temperature relief valve and its discharge pipe extended to within 6 inches of the floor.
