# InterNACHI Monthly Hangout

# “Inspection Tips for Gas-Fired Furnaces”

Go over a few inspections by reviewing inspection images and inspection reports.

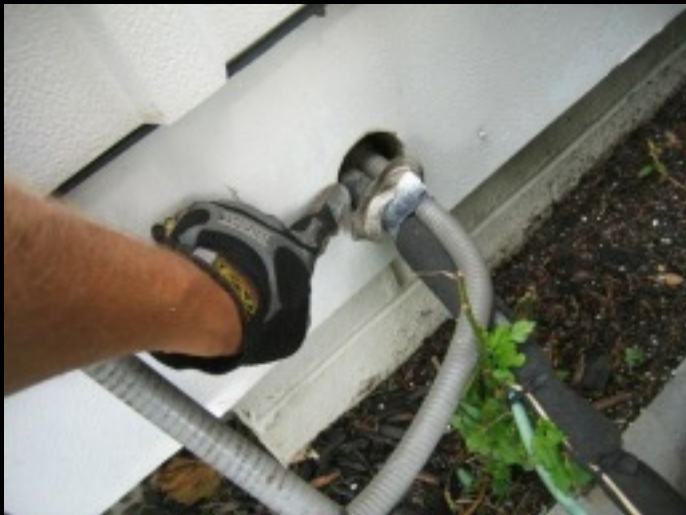
# AIR CONDITIONER

MODEL NO. TCA430AKA1  
 MODEL NO. \_\_\_\_\_  
 SERIAL NO. L0120 34259  
 STYLE NO. \_\_\_\_\_  
 NPR. NO. TCA430AKA1  
 MAX FUSE OR CNT. BKR. (HACH TYPE IN SIZE) 25 AMPS  
 RATED VOLTAGE 208/230 PH 1 HZ 60  
 VOLTAGE: MIN. 197 MAX. 253

MINIMUM CIRCUIT CAPACITY:  
 HP PH FLA RLA LRA  
 COMPRESSOR: — 1 — 12.2 81.0  
 FAN: 1/8 1 .8 — 1.8

OUTDOOR UNIT SHIPPING CHARGE R22: 190 02.  
 TOTAL OPERATING CHARGE:

DESIGN PRESSURE (PSIG): HIGH 350 LOW 150 FOR OUTDOOR USE

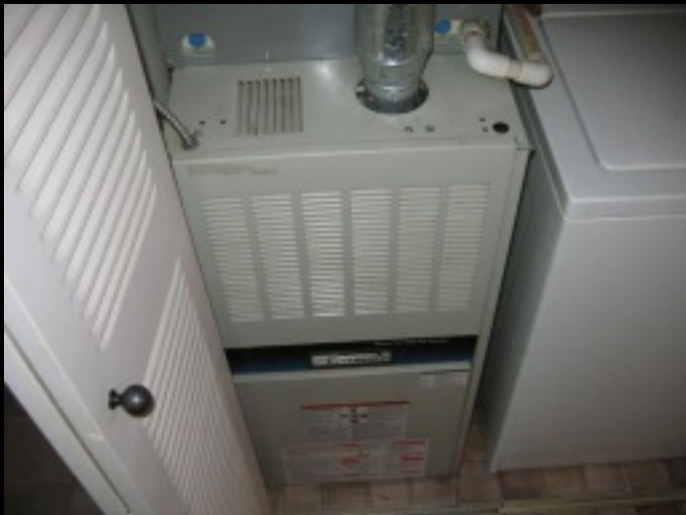
## low, medium, high efficiency

**low:** pilot, 60-65%

**medium:** ignition, 78-82%

**high:** plastic, condensate, 88-97%

Amount of heat delivered to the house compared to the amount of fuel that must be supplied to the furnace. Thus, a furnace that has an 80% AFUE rating converts to heat 80% of the fuel that is supplied. The other 20% is lost and wasted. (consider the energy wasted)

**low:** standing pilot  
**medium:** intermittent pilot or direct spark  
**high:** hot-surface ignition

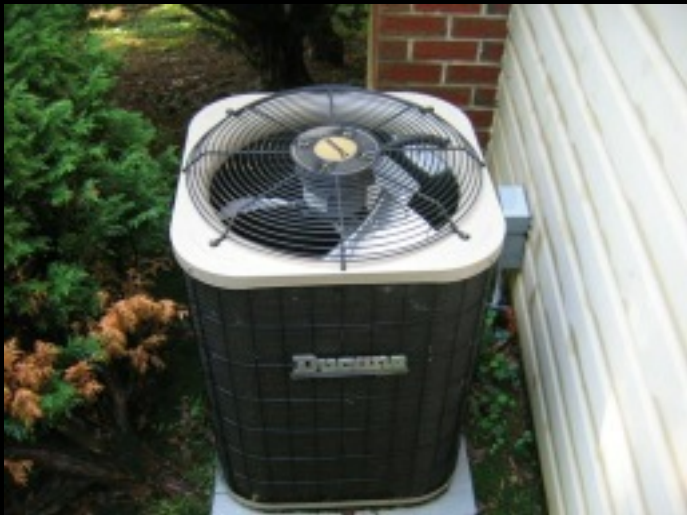
**Ducora**

| Model Number: | AC12B-36PA | Serial Number: | 583320521 |

| Line Electrical: | 208-230 | Volts | 1 | Ph | 60 | Hz |

| Power Supply: | 19.9 | Minimum Circuit Ampacity | | | | |
| | 30 | Max Fuse | | | | |
| | 30 | Max Ckt Breaker (HACR) Type per NEC | | | | |

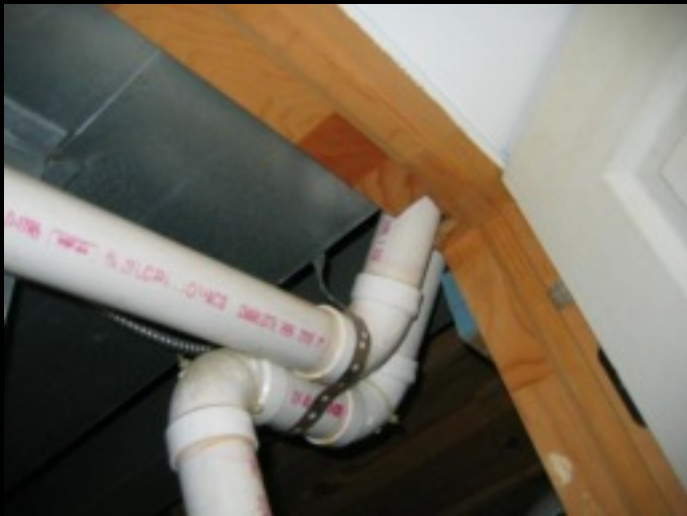
HAS SEVERELY

RUSTED

CONDENSATE

PAN

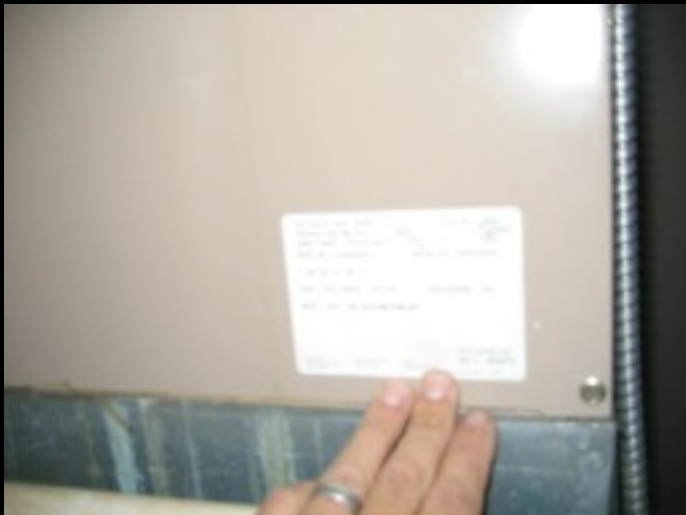
SECTION OF NEW YORK  
CENTRAL COOLING AIR  
CONDITIONER LISTED 409C  
MODEL NO. 6700400A

REFRIGERANT R22

FACILITY TEST PRESS. 475 PSI

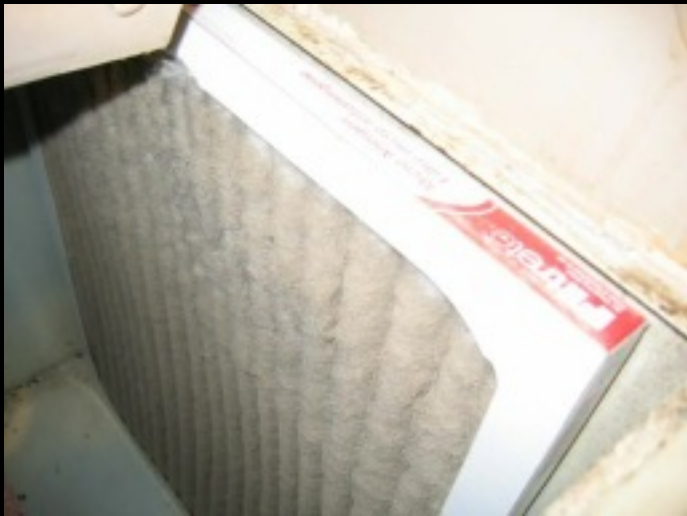
| LINE SET LENGTH | FT. | ORICE SIZE |

| DATE | REMARKS | TECHNICIAN |
|---|---|---|
| 10/17/97 | New HSS P7/22 | 601/60 |
| 10/11/98 | Heat inspection | John |
| 2/6/01 | New Gas Bag | Joe D |
| 2/28/03 | Chg. serv. & new filter | Joe D |

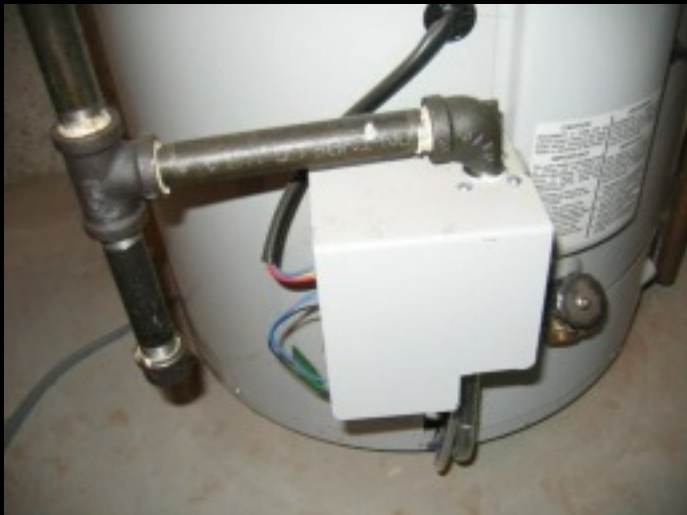
LOCHINVAR CORPORATION  
2005 ELM HILL PIKE, NASHVILLE, TN  
Model No: DUN041

Serial No: UM2780878 Dash No:  
Cap. 40.0 (Gal.)

Input: 40,000 (Btu/hr.) Gas: NATU

Gas Press. Manifold: 4.0 (w.c.)

Supply Max: 14.0 (w.c.) Min 5.0

MINIMUM CLEARANCES FROM COMBUSTIBLE  
CONSTRUCTION: 1 INCHES FRONT, 0
