# Western States Inspections & Services, Inc.

2523 S. Eastover St. Bennett, CO 80102

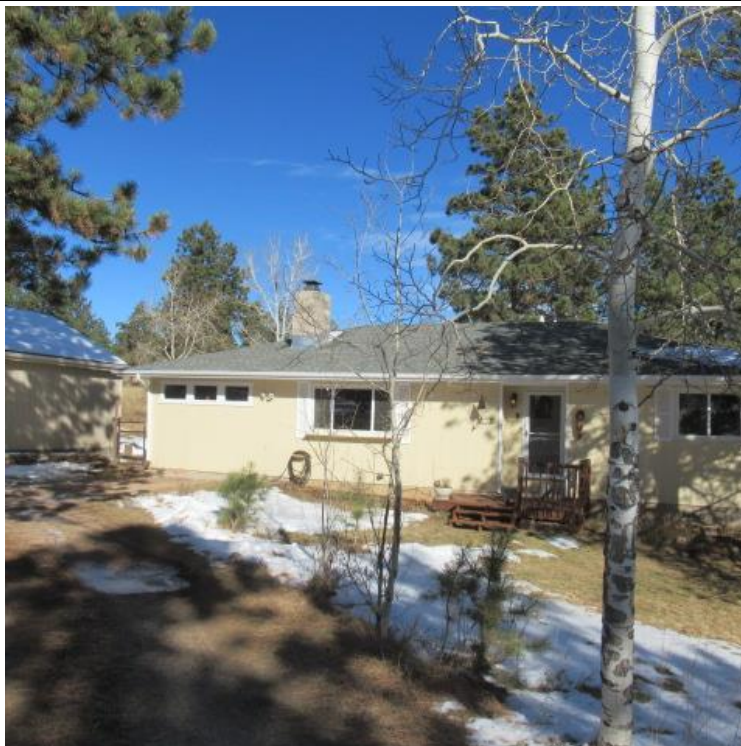
- Client or representative was not present for entire inspection  
 Snow covering some features and limiting inspection  Raining (may limit inspection)  Recent rain  
**Average temps during inspection:**  Cold <32°  Cool 32°- 65°  Warm 65°- 85°  Hot >85°  
**Property type:**  Single family  Condo  Townhome  Attached  Multi-unit  Commercial  
**Status:**  Occupied  Vacant  Furnishings present and limit inspection (furniture, etc. is not moved)

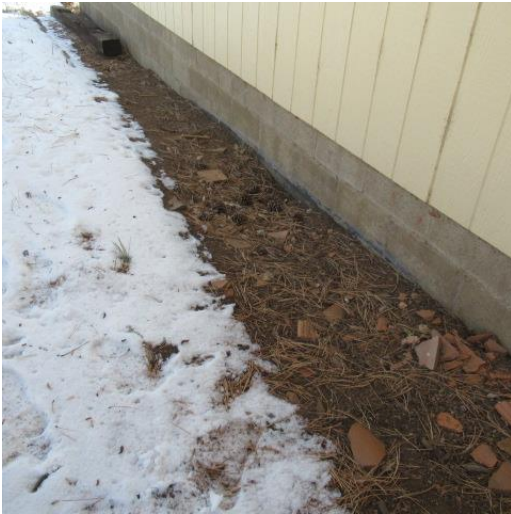
\*Flat drainage may only become a problem during periods of heavy rain or changes in yard irrigation or other surrounding drainage changes. Positive drainage is required. Surface water should flow away from the foundation at least 5' whenever possible.

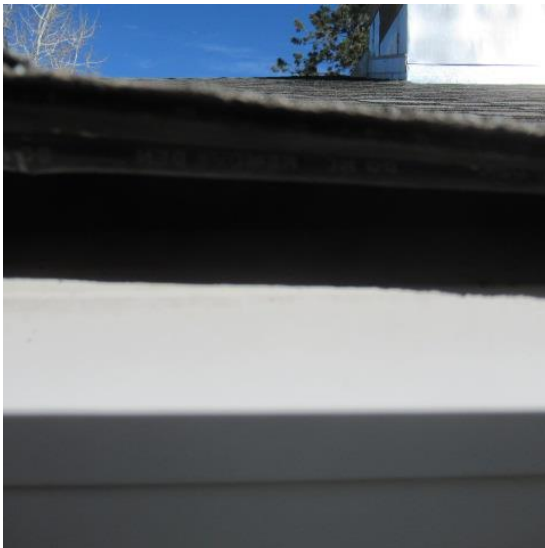
\*Depending on municipality, only one or two layers of shingles are allowed whenever shingles are replaced.

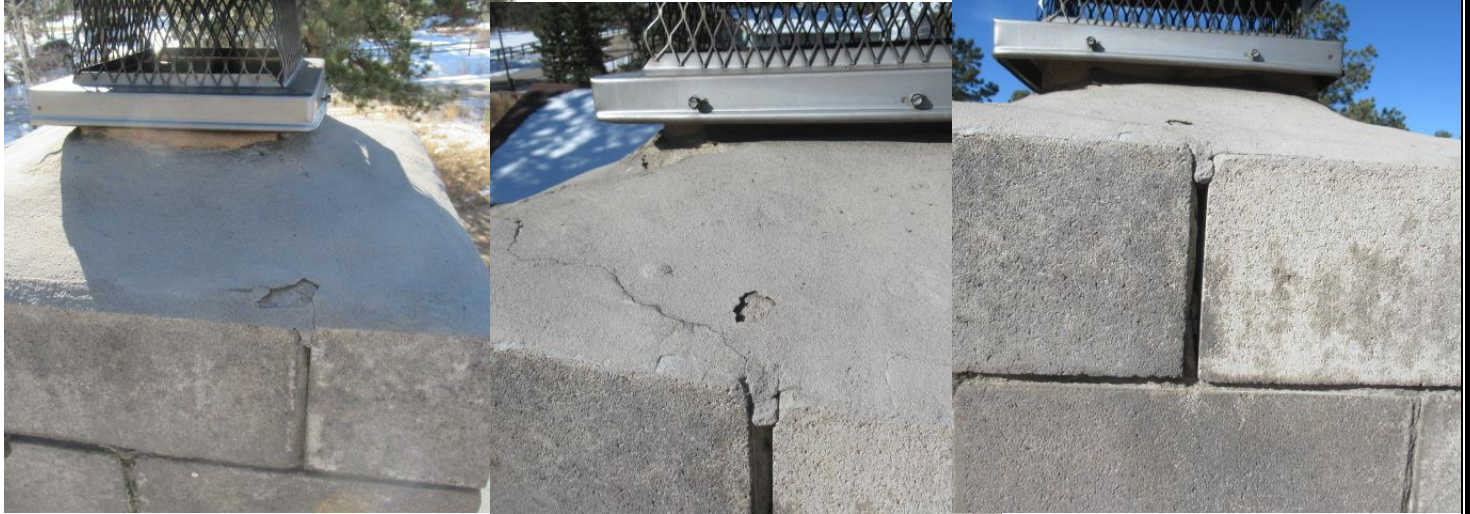
Common and major cracks in mortar crown/cap need sealing every few years. Hairline cracks in flue tile should be monitored for gapping.

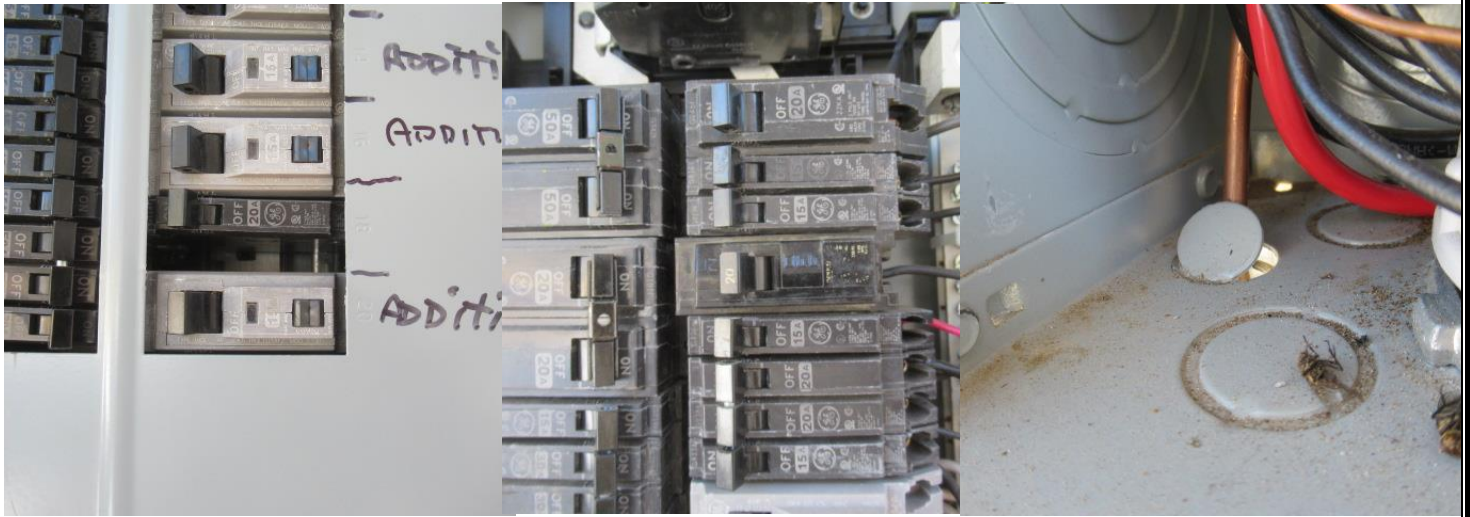
**Sub-Panel(s)**  N/A Locations: A: **garage** B: Location C: Location  
 (Some issues noted for main panel may apply to sub panels)

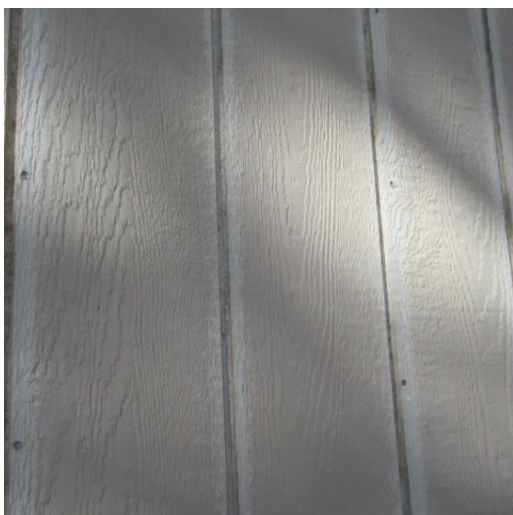
**The exterior siding has never been painted and needs paint**

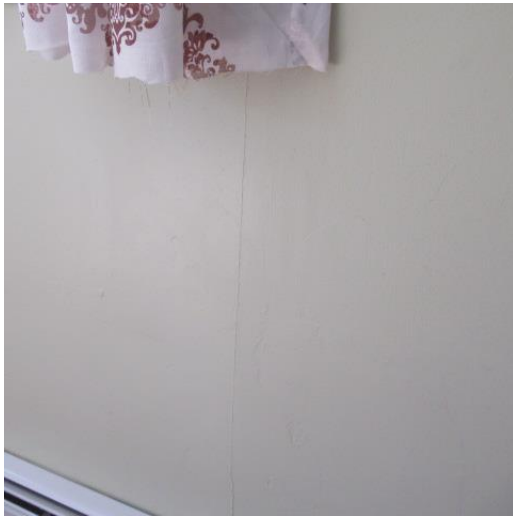
**25 CEILINGS**  Acoustic (popcorn) spray\*  Ceiling tile\*  Wood / beam  Drop ceiling

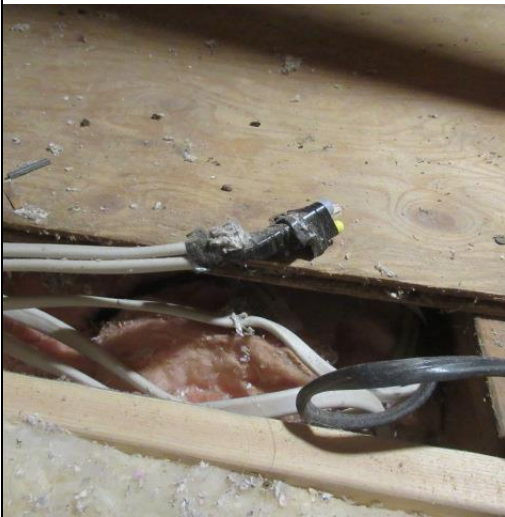
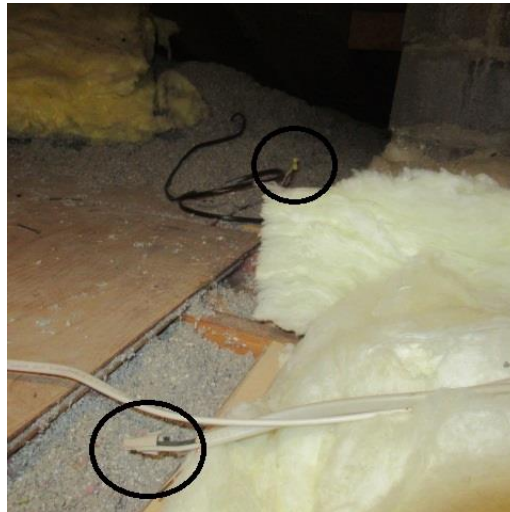
**'GFCI' outlets are a safety device recommended at exterior, garage, bathroom, kitchen, and wet bar locations and required in remodels or electrical changes (consult local authorities having jurisdiction).** An ungrounded 'GFCI' can provide 'GFCI' protection if wired correctly.

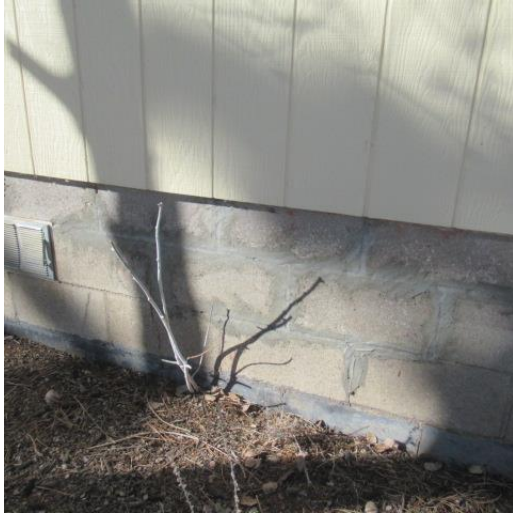
\*Inspector's observations and conclusions are based on observable components.

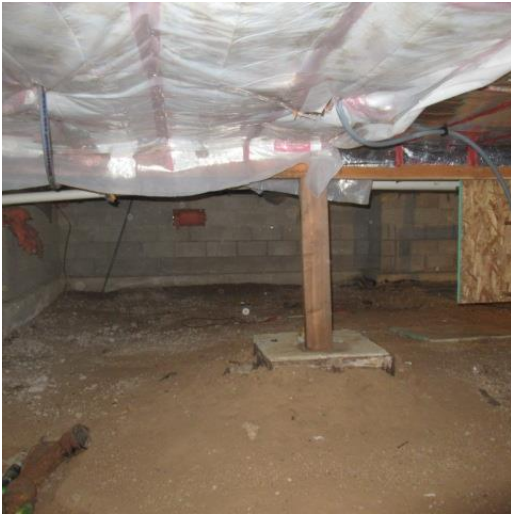
It's common for basements to be finished without construction permits from the Authorizing Housing Jurisdiction (AHJ). The inspector does not determine if work was done to period codes or inspected by the AHJ.

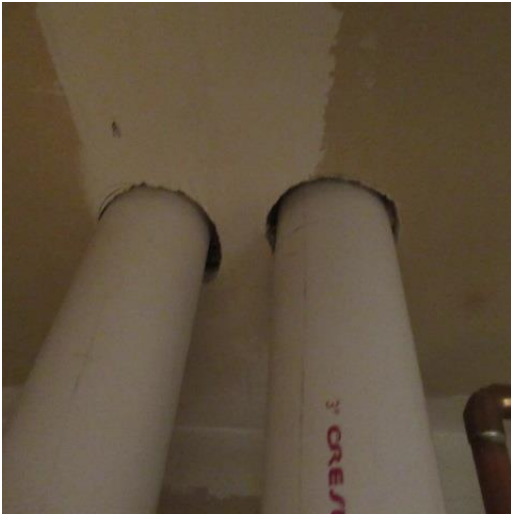
**HEAT EXCHANGER** (Not fully visible) Air or water flows over the heat exchanger and is warmed for distribution.

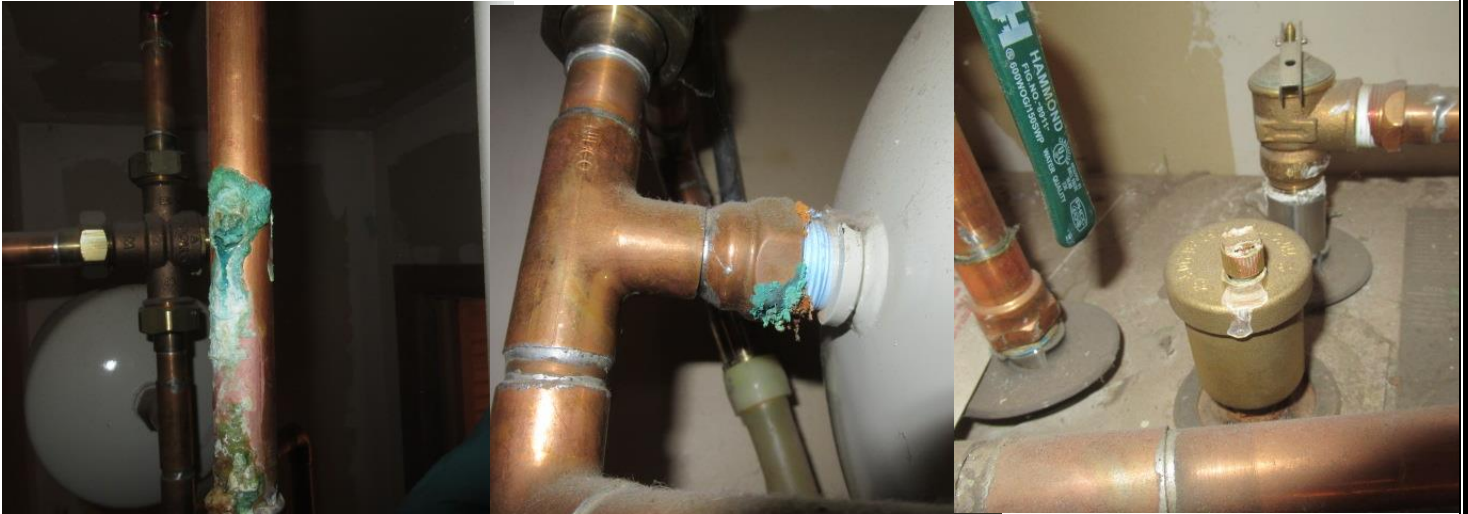
### **OPERATION AND SUMMARY** (Reported defects should be repaired by HVAC technician)

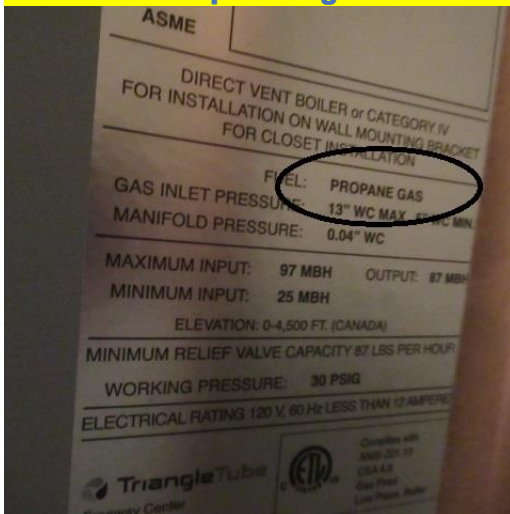
- Repairs or modifications needed** (Reference all defects noted in Heating Section 31)
  - Recommend complete system evaluation (certify safe and operational) by HVAC technician**
- Unit has a Propane tag but there is no evidence of conversion to Natural Gas**

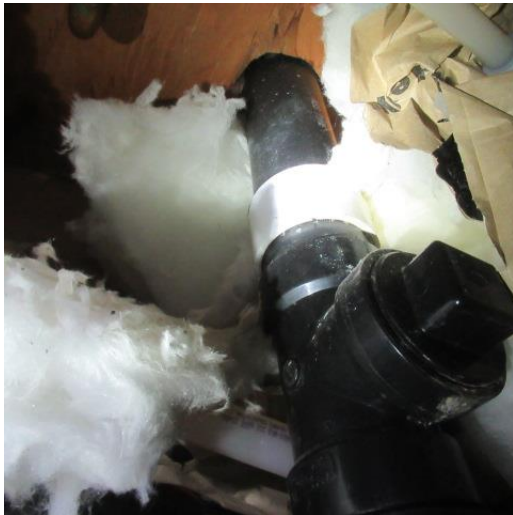
Some 'ABS' black plastic piping made between 1984 to 1990 have documented problems. It is recommended to replace lead DWV lines, but not required. **Some leaks and other drainage problems require much more water to be run than can be done during this inspection, to reveal hidden problems.**

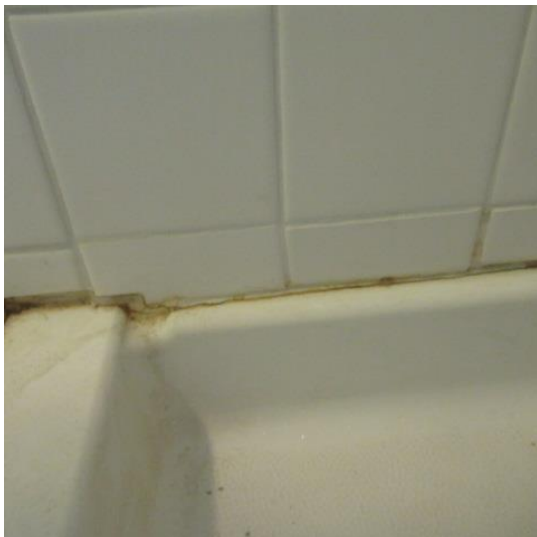
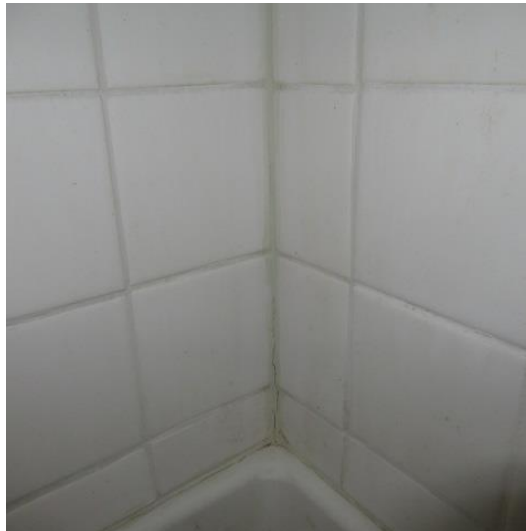
Identifying mold or type or toxicity of mold is not within the scope of this inspection. "Mold-like substance" or "moldy" means that observed substance has the appearance of mold. Damaged/wet wall may have hidden mold/rot inside.

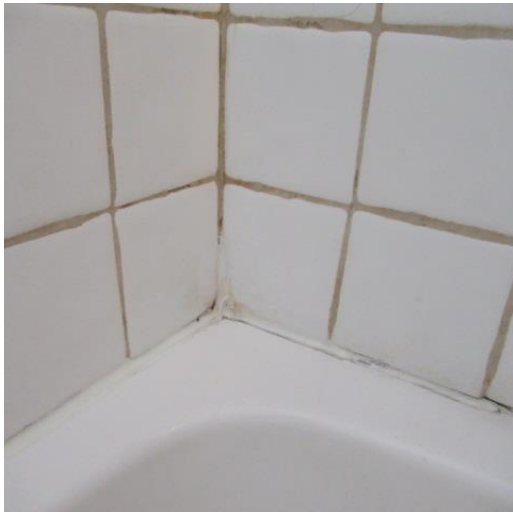
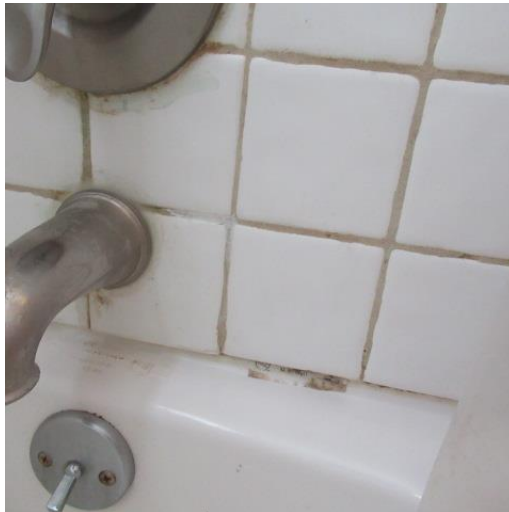
Identifying mold or type or toxicity of mold is not within the scope of this inspection. "Mold-like substance" or "moldy" means that observed substance has the appearance of mold. Damaged/wet wall may have hidden mold/rot inside.
